Isle of Palms City Hall Assessment

May 2024

RE: IOP City Hall Assessment

Trident Construction and a team of consultants performed a thorough investigation and assessment of the existing Isle of Palms City Hall building. The assessment included a detail look into the structural, building envelope, mechanical, electrical, plumbing and programming layout requirements.

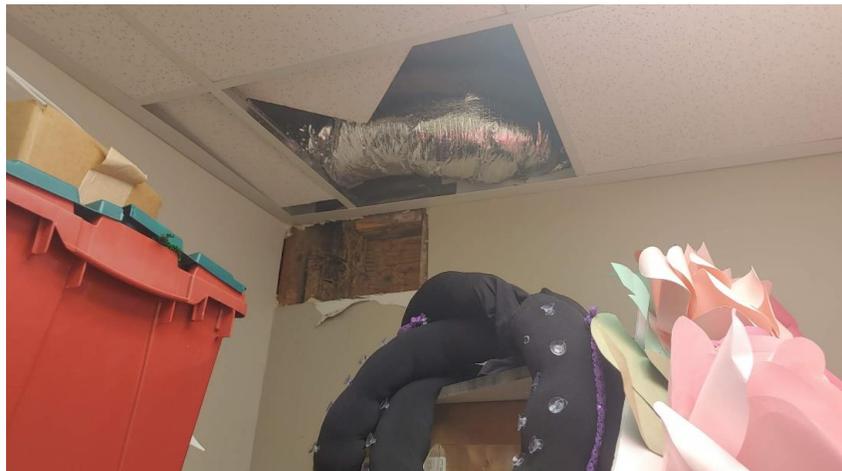
Photograph No. 4
Deteriorated Wall Framing below HVAC Unit

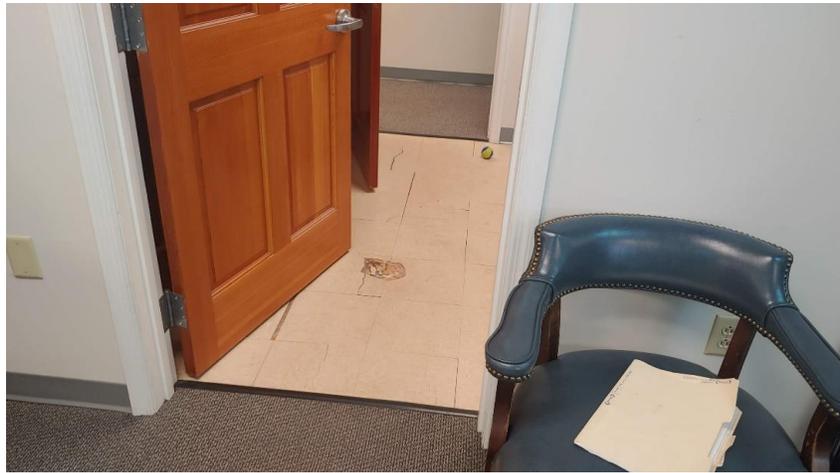
Photograph No. 5
Water damage to floor: below HVAC Unit

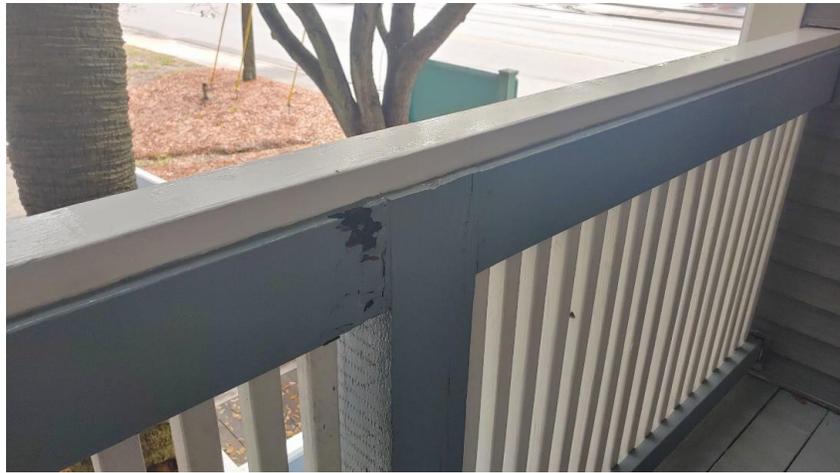
Photograph No. 15
Guardrail at Second Floor Level, Note deterioration.

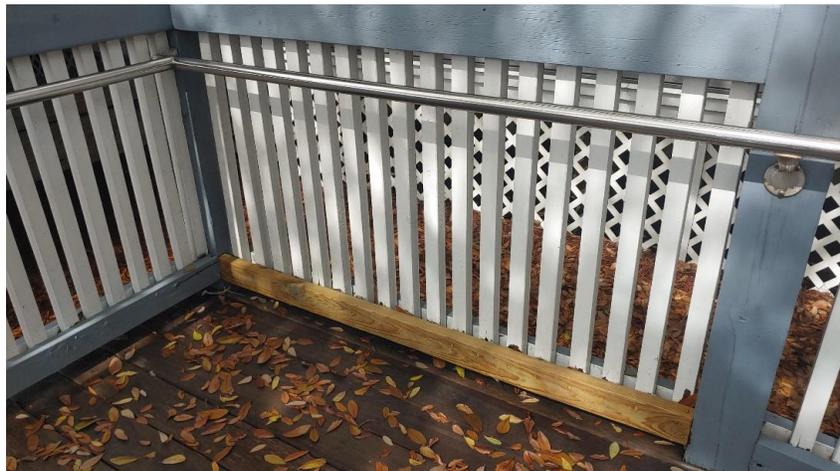
Photograph No. 16
Guardrail at First Floor Level, Repairs in progress

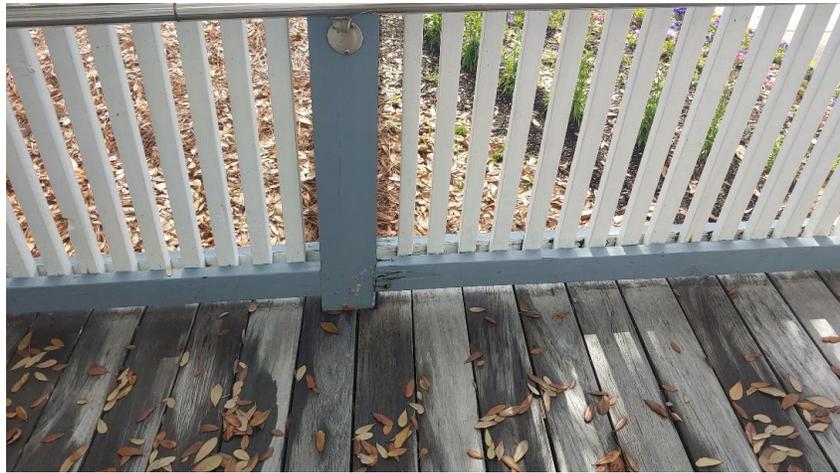
Photograph No. 17
Guardrail at First Floor Level, Note deterioration.

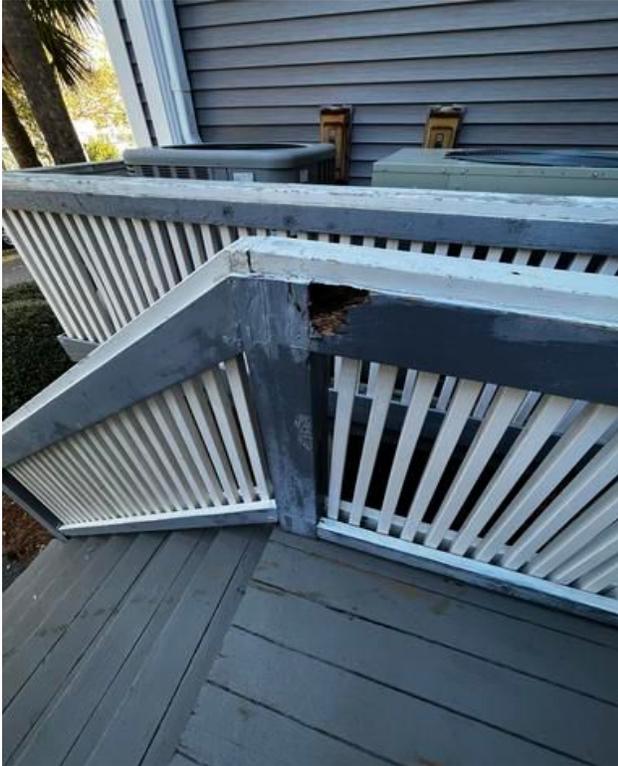
[IMG_0418](#)

Description	Wood rot on railing
Assigned to	—
Created by	Jarret Hudson (McMillan Pazdan Smith Architecture)
Created on	Mar 22, 2024
Location	01 CITY HALL > EXTERIOR > STAIRS
Location details	—
Due date	—
Start date	—
Placement	A110 (LEVEL 1 OVERALL PLAN)
Root cause	—

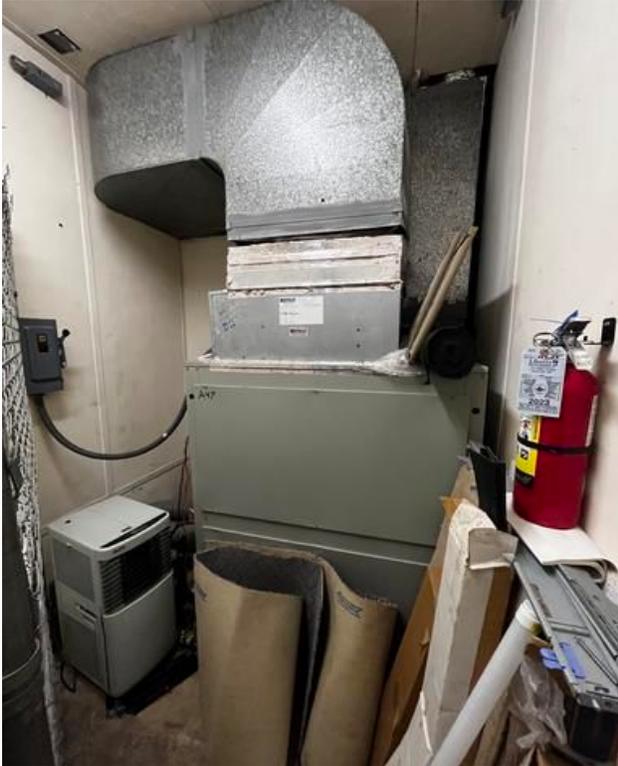
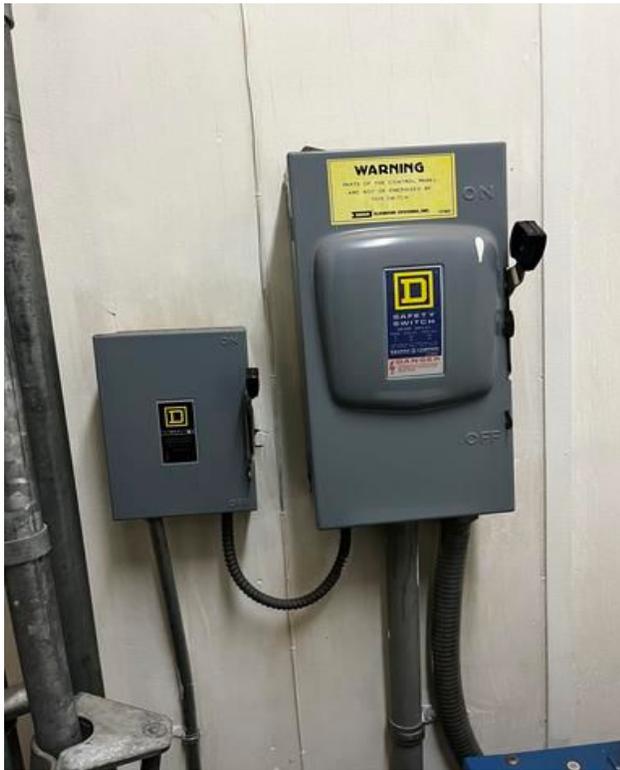
Description	Main trunk line of mechanical system
Assigned to	—
Created by	Jarret Hudson (McMillan Pazdan Smith Architecture)
Created on	Mar 22, 2024
Location	01 CITY HALL > INTERIOR > LEVEL 1 > MECHANICAL ROOM 108
Location details	—
Due date	—
Start date	—
Placement	A110 (LEVEL 1 OVERALL PLAN)
Root cause	—

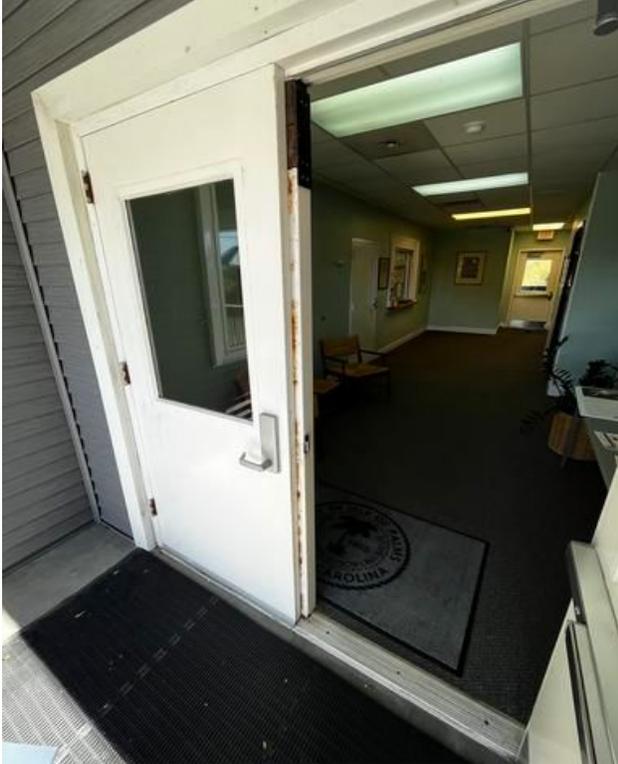
[IMG_0403](#)

Description	Rust present on hollow metal door frame
Assigned to	—
Created by	Jarret Hudson (McMillan Pazdan Smith Architecture)
Created on	Mar 22, 2024
Location	01 CITY HALL > INTERIOR > LEVEL 1 > STAIR + LANDINGS S101
Location details	—
Due date	—
Start date	—
Placement	A110 (LEVEL 1 OVERALL PLAN)
Root cause	—

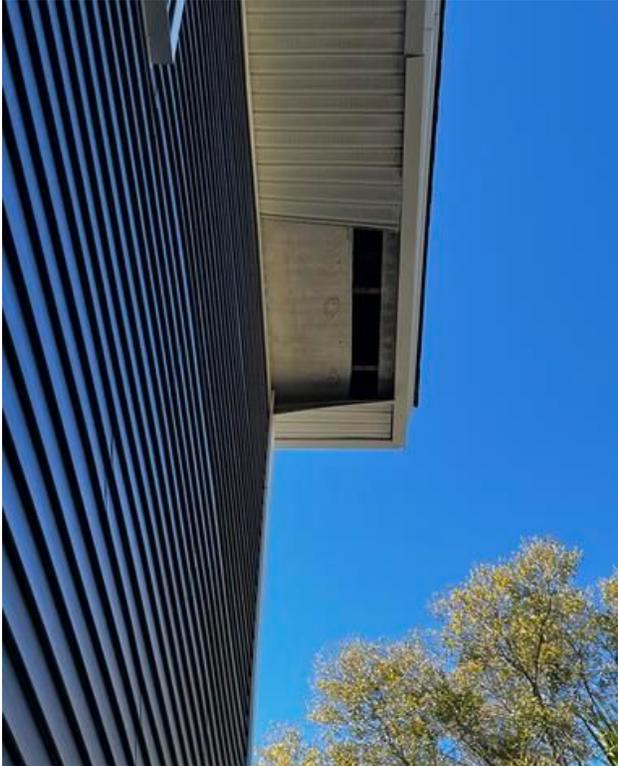
[IMG_0424](#)

Description	Roof soffit is open to elements
Assigned to	—
Created by	Jarret Hudson (McMillan Pazdan Smith Architecture)
Created on	Mar 22, 2024
Location	01 CITY HALL > EXTERIOR > ROOF
Location details	—
Due date	—
Start date	—
Placement	A130 (ROOF OVERALL PLAN)
Root cause	—

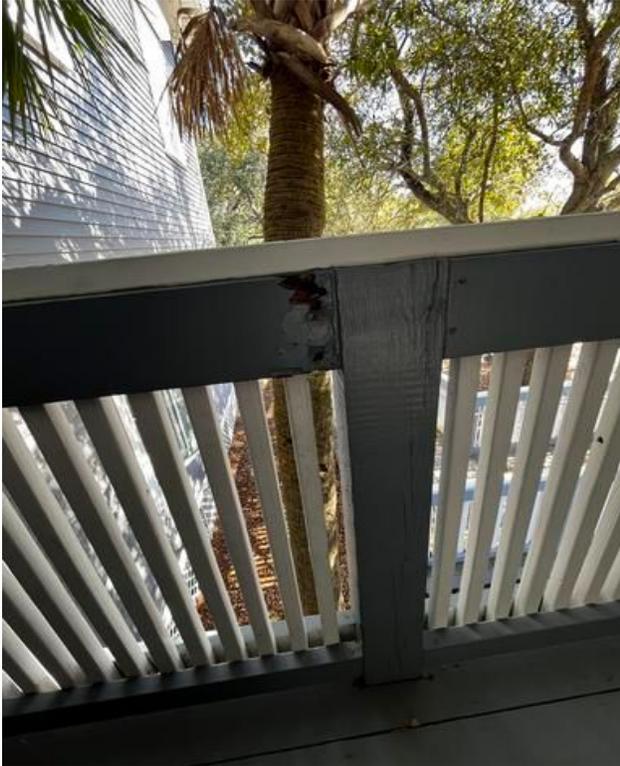
[IMG_0405](#)

Description	Wood rot at exterior railings, present in multiple locations
Assigned to	—
Created by	Jarret Hudson (McMillan Pazdan Smith Architecture)
Created on	Mar 22, 2024
Location	01 CITY HALL > EXTERIOR > STAIRS
Location details	—
Due date	—
Start date	—
Placement	A120 (LEVEL 2 OVERALL PLAN)
Root cause	—

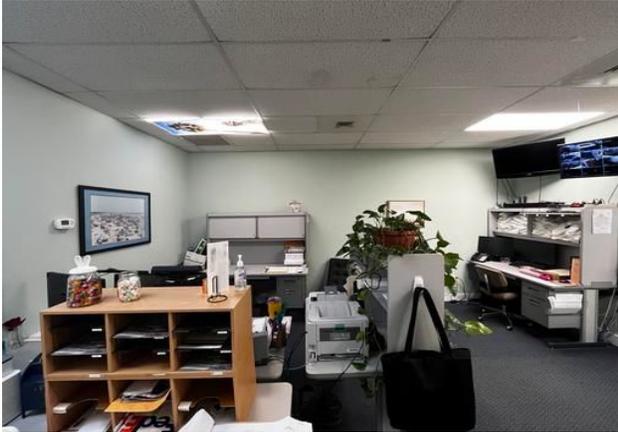
IMG_0399

Description	Ceiling tiles are stained indicating presence of water at some point in time.
Assigned to	—
Created by	Jarret Hudson (McMillan Pazdan Smith Architecture)
Created on	Mar 22, 2024
Location	01 CITY HALL > INTERIOR > LEVEL 2 > OPEN OFFICE 219
Location details	—
Due date	—
Start date	—
Placement	A120 (LEVEL 2 OVERALL PLAN)
Root cause	—

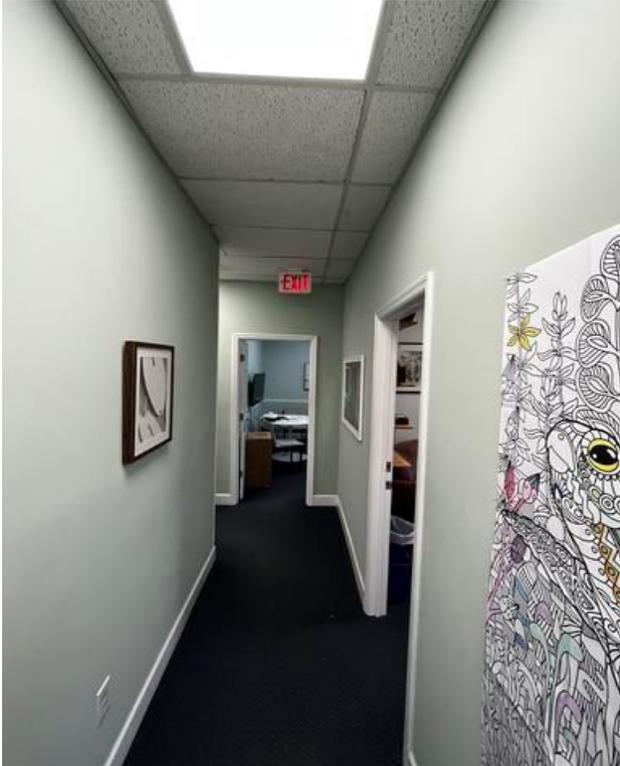
[IMG_0397](#)

Description	Ceiling tiles are stained, indicating moisture presence at some point in time
Assigned to	—
Created by	Jarret Hudson (McMillan Pazdan Smith Architecture)
Created on	Mar 22, 2024
Location	01 CITY HALL > INTERIOR > LEVEL 2 > CORRIDOR C203
Location details	—
Due date	—
Start date	—
Placement	A120 (LEVEL 2 OVERALL PLAN)
Root cause	—

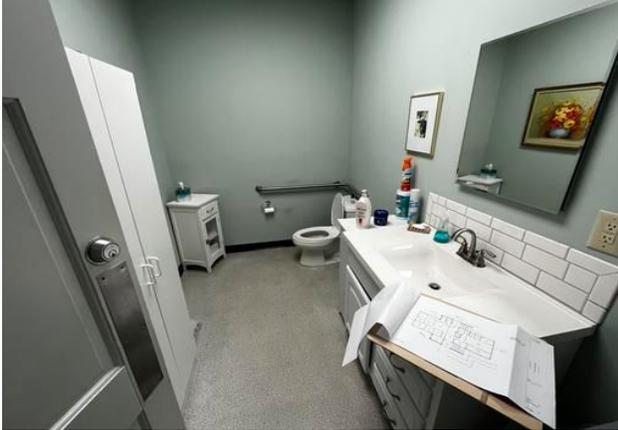
[IMG_0393](#)

Description	Grab bars non-compliant with current IBC
Assigned to	—
Created by	Jarret Hudson (McMillan Pazdan Smith Architecture)
Created on	Mar 22, 2024
Location	01 CITY HALL > INTERIOR > LEVEL 2 > RESTROOM 220
Location details	—
Due date	—
Start date	—
Placement	A120 (LEVEL 2 OVERALL PLAN)
Root cause	—

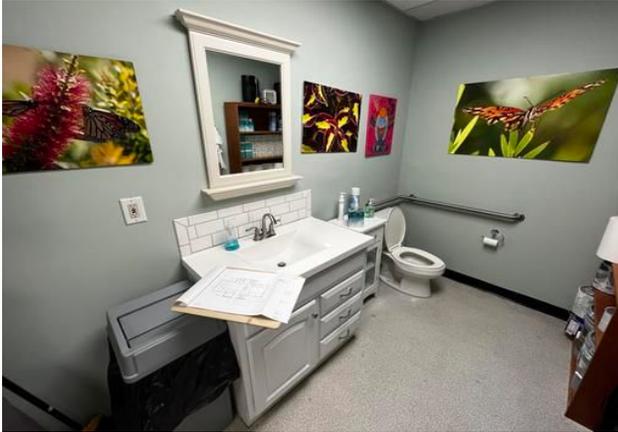
[IMG_0392](#)

Description	Grab bars non-compliant with current IBC
Assigned to	—
Created by	Jarret Hudson (McMillan Pazdan Smith Architecture)
Created on	Mar 22, 2024
Location	01 CITY HALL > INTERIOR > LEVEL 2 > RESTROOM 221
Location details	—
Due date	—
Start date	—
Placement	A120 (LEVEL 2 OVERALL PLAN)
Root cause	—

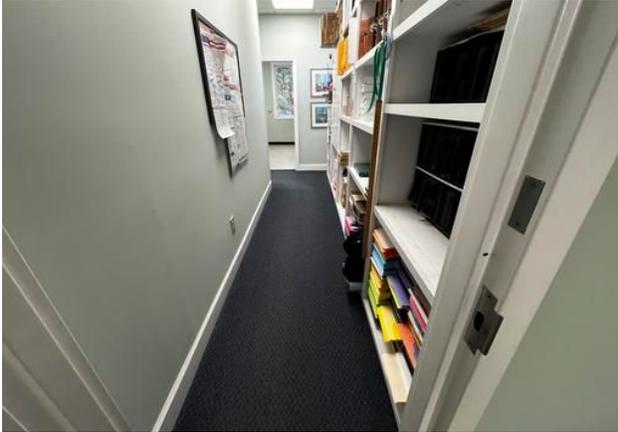
[IMG_0390](#)

Description	Existing corridor finishes and casework
Assigned to	—
Created by	Jarret Hudson (McMillan Pazdan Smith Architecture)
Created on	Mar 22, 2024
Location	—
Location details	—
Due date	—
Start date	—
Placement	A120 (LEVEL 2 OVERALL PLAN)
Root cause	—

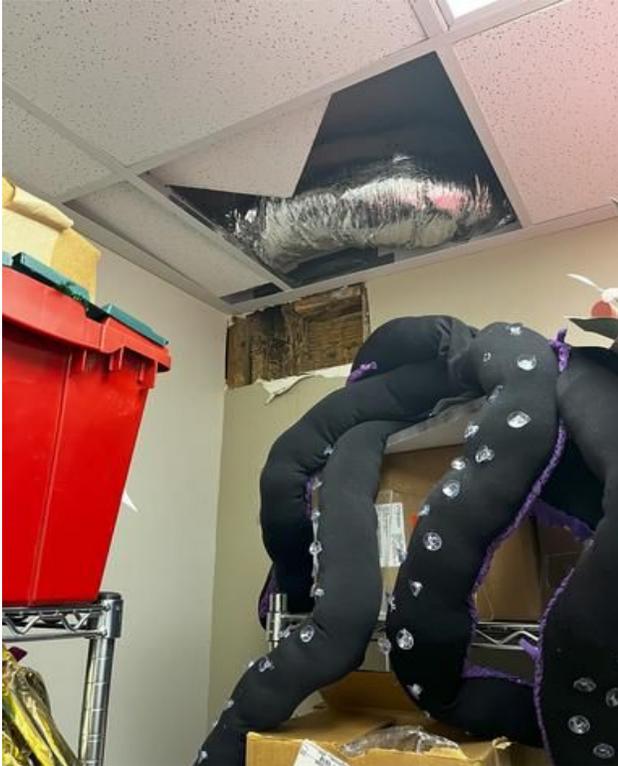
[IMG_0378 - Copy](#)

Description	Termite damage, duct laying on ceiling grid
Assigned to	—
Created by	Jarret Hudson (McMillan Pazdan Smith Architecture)
Created on	Mar 20, 2024
Location	01 CITY HALL > INTERIOR > LEVEL 2 > STORAGE 1 205
Location details	—
Due date	—
Start date	—
Placement	A120 (LEVEL 2 OVERALL PLAN)
Root cause	—
