**2018 Isle of Palms Restoration Project
Year 4 Monitoring Report**

2022
MONITORING REPORT

2018 Isle of Palms Restoration Project
Year 4 (2022) Monitoring Report
Annual Beach and Inshore Surveys

[2492YR4 — Monitoring Year 4]

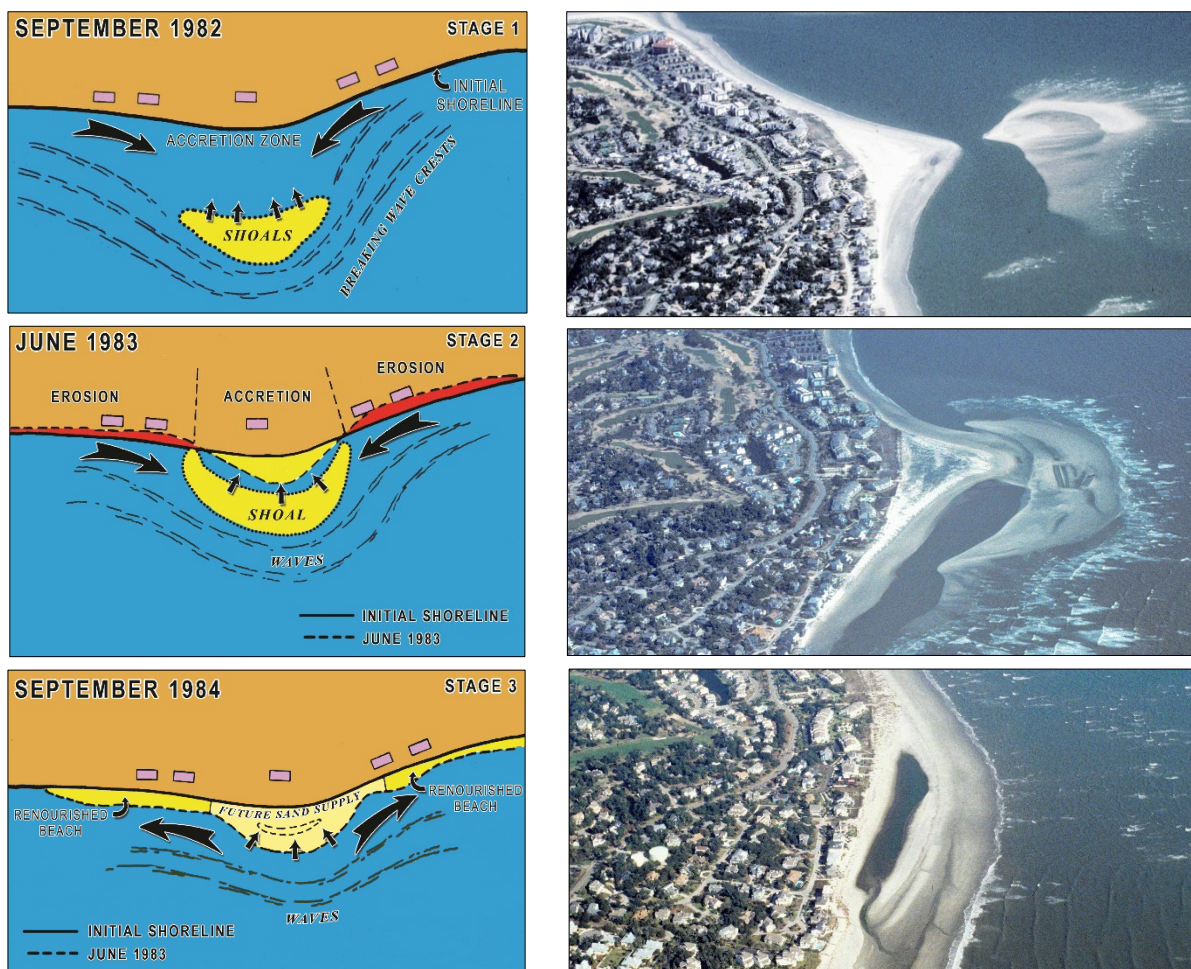
FIGURE 2.3. [LEFT] Schematic of the shoal-bypass cycle originally modeled from a bypass event at Isle of Palms. [RIGHT] A shoal-bypass event at northeastern Isle of Palms corresponding to the schematic. The upper photo shows a shoal in Stage 1 (1996). The middle image illustrates Stage 2 (1997). The bottom photo shows Stage 3 (1998).

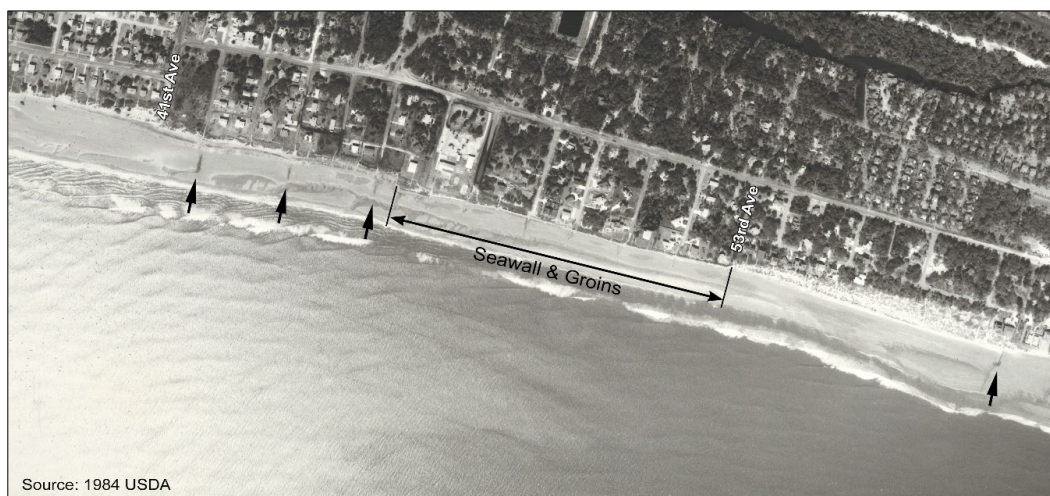
FIGURE 2.4. A seawall and groins were in place in 1984 between 46th Ave to 53rd Ave. Today, due to rapid accretion, these groins and seawalls have been buried.

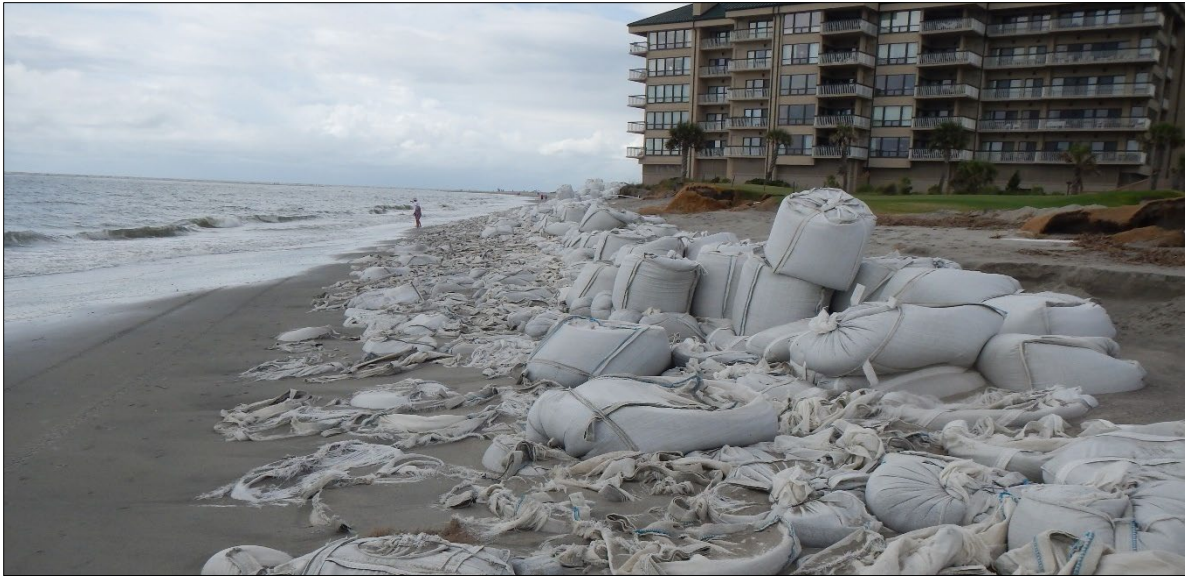
FIGURE 2.5. To prevent additional erosion, sandbags were installed along several structures from Shipwatch to Ocean Club from 2004 to 2007.

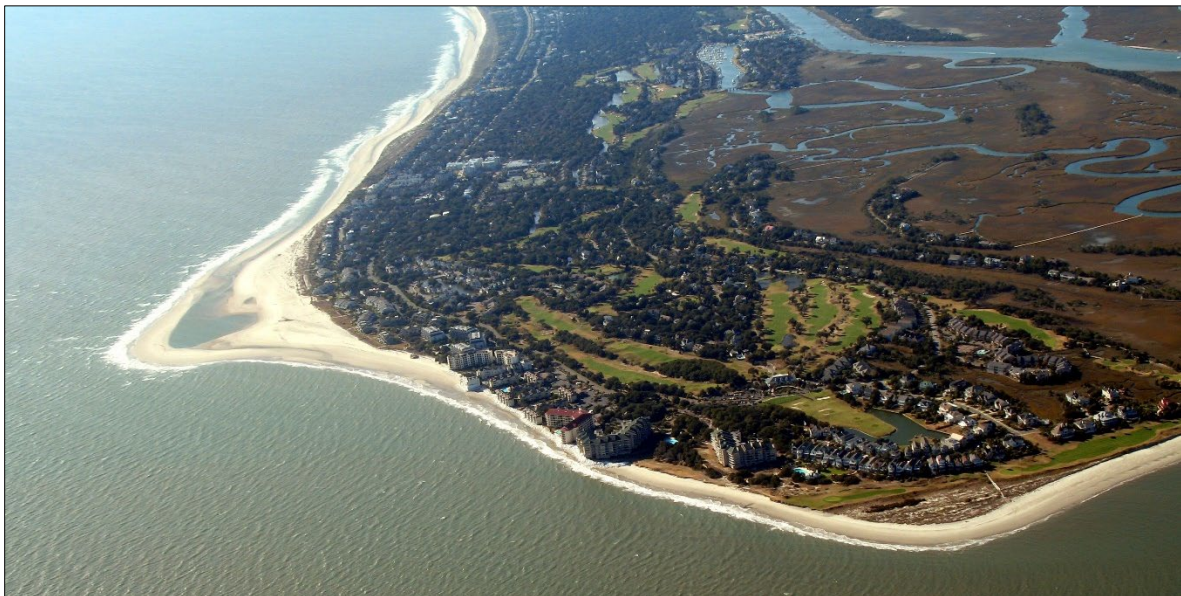
FIGURE 2.6. Isle of Palms in 2007 prior to beach nourishment.

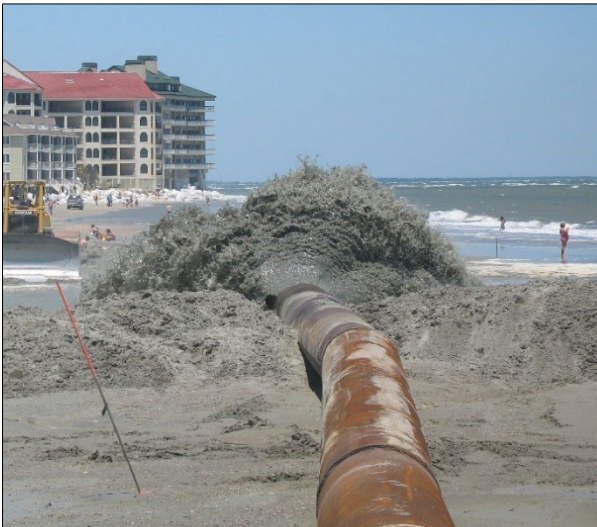
FIGURE 2.7. [ABOVE] 2008 beach nourishment project (completed on 15 July 2008).

The 2008 project was completed between 15 May and 15 July 2008 (Figure 2.7). As part of the project, Weeks Marine removed all sandbags from the project area, which totaled ~9,400 bags. Homeowners removed an additional 4,680 bags from under buildings. Averaging ~25,000 cy of sand per day, the dredge *RS Weeks* pumped sand from three borrow areas 2–3 miles from the beach. The nourishment was placed in three reaches and included ~270,000 cy between 53rd Ave and Dune Crest Ln (Reach A), 552,400 cy from Mariners Walk to the 18th Fairway (Reach B), and 25,000 cy from the 18th tee to the 17th fairway (Reach C). Figure 2.8 shows the layout of the 2008 project. Figure 2.9 shows a post-project aerial photo (2008) that compares to the project area before renourishment (2007).

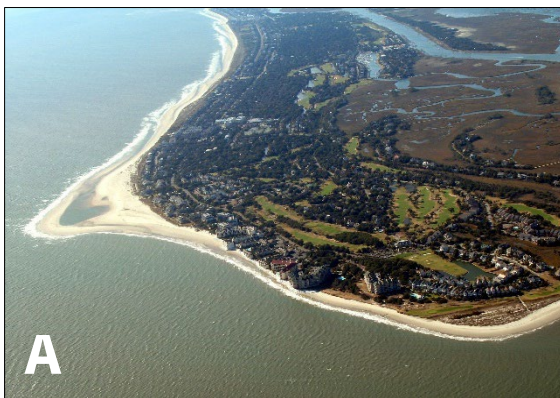
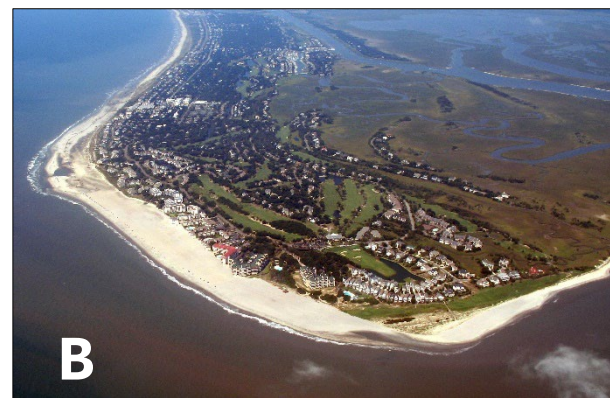
FIGURE 2.9. [LEFT] Isle of Palms in 2007 prior to nourishment. [RIGHT] The project area in 2008 following nourishment.

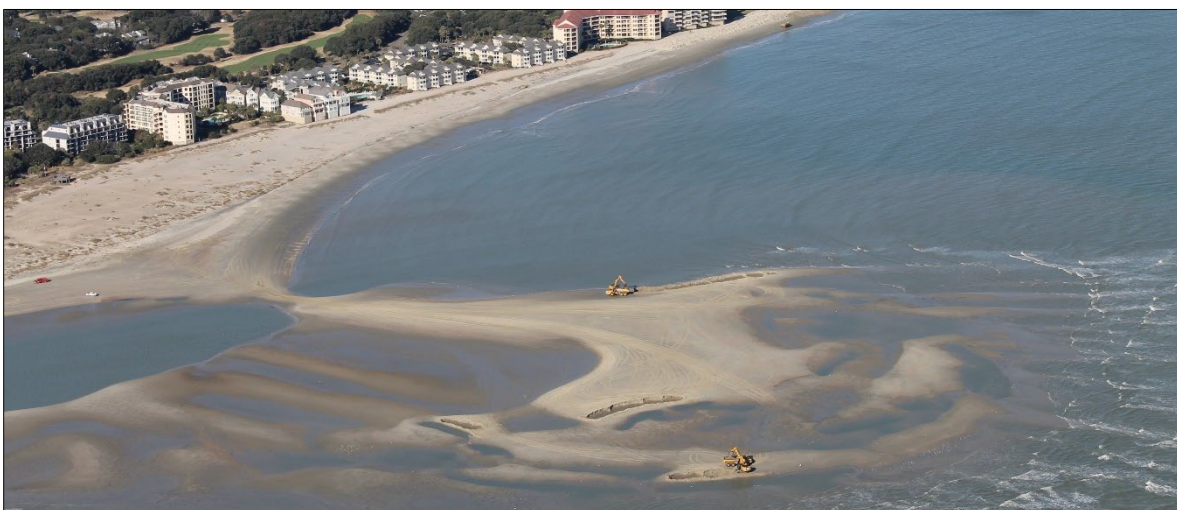
FIGURE 2.10. January 2015 aerial image of the 2014–2015 shoal management project showing equipment transferring sand from an attaching shoal to the eroded beach.

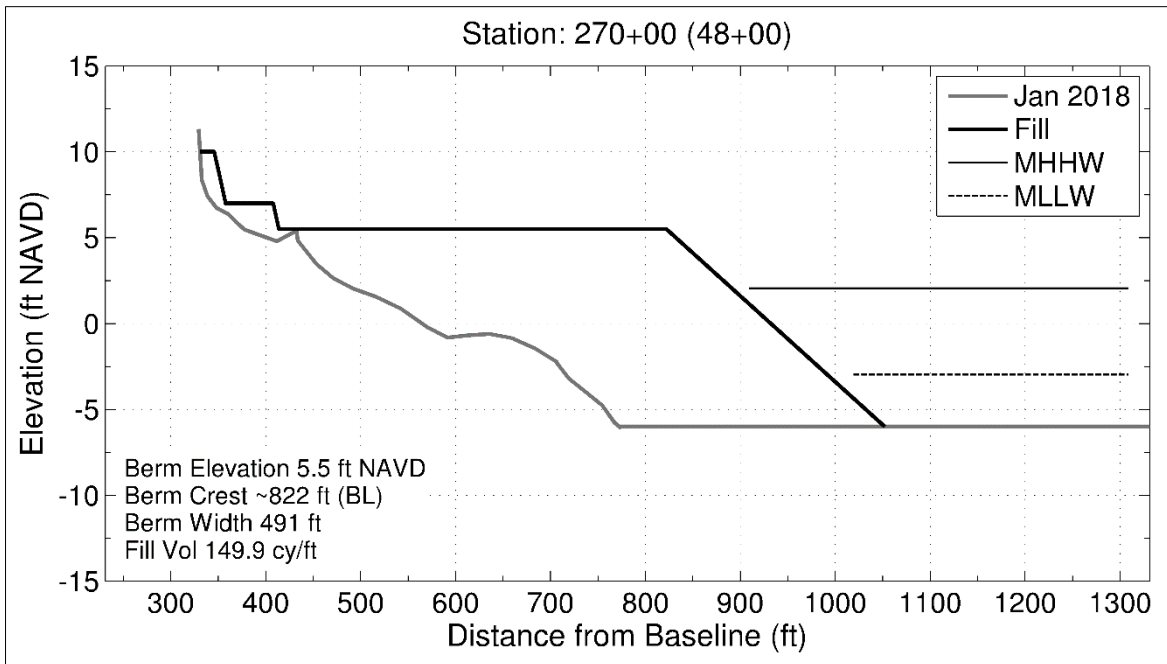
FIGURE 2.12. The 2018 design fill profile incorporated a dune, storm berm, wide fill berm, and sloping section.

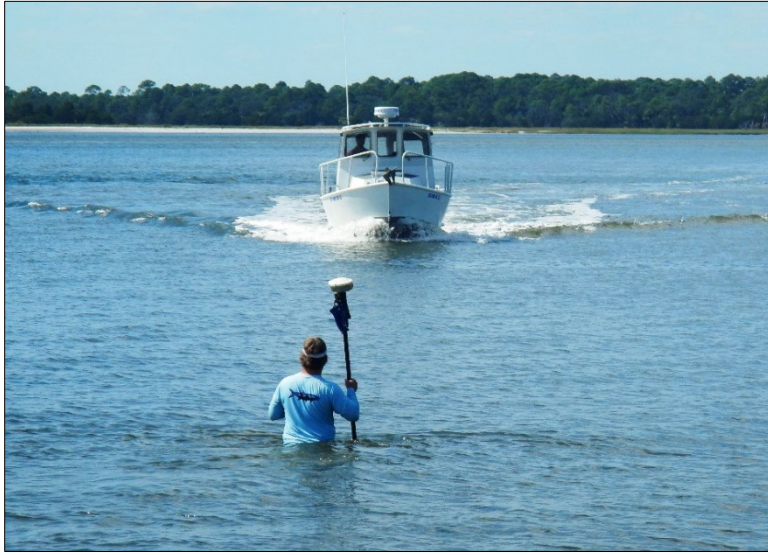
FIGURE 3.2. Surveying beach profiles involves collection of land-based data at low-tide and hydrographic data collection overlapping the land-based work.

Topographic data were collected via RTK-GPS (Trimble™ R10 GNSS), which provides position and elevation measurements at centimeter accuracy. Beach profiles were obtained by collecting data at low tide along the dunes, berm, and active beach to low-tide wading depth. Overwater work was then performed at high tide to overlap the land-based work (Fig 3.2) and was collected with RTK-GPS coupled with an Odom CV100™ precision echosounder mounted on CSE’s survey vessel, the *RV Southern Echo*.

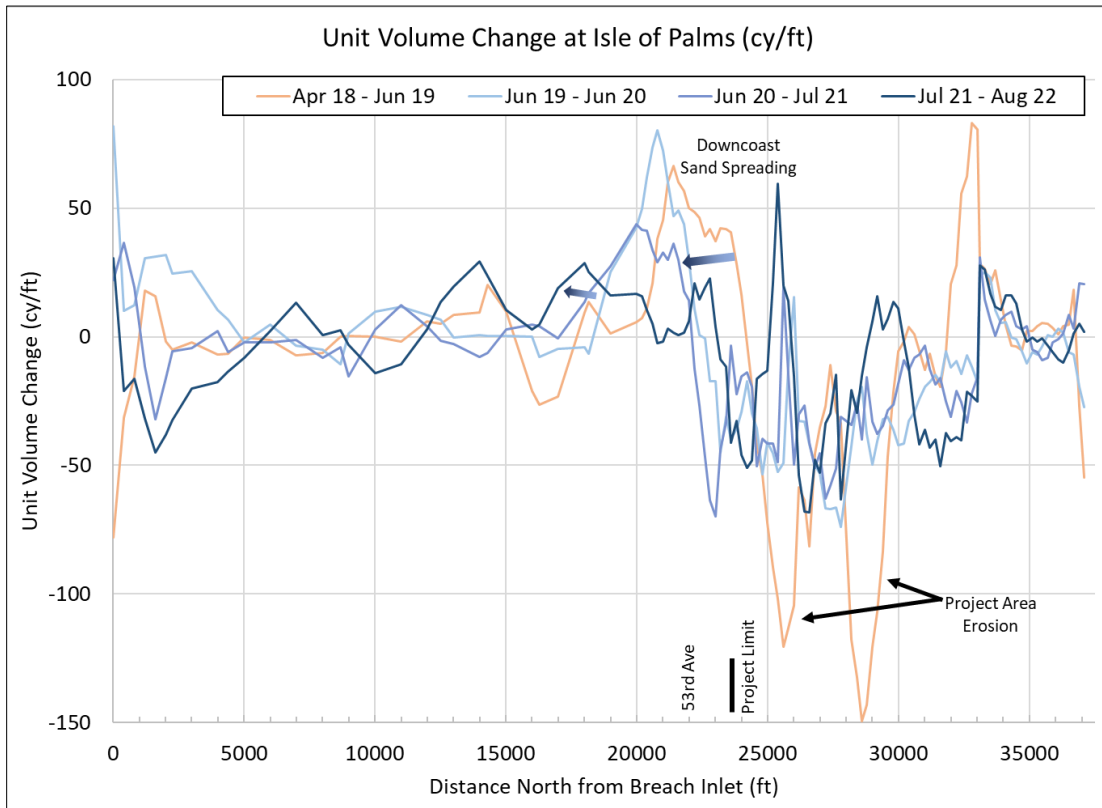
FIGURE 4.2. Beach unit volume change between each monitoring event at Isle of Palms. The X axis represents distance from Breach Inlet. This graph highlights the erosion occurring in the project area and accumulation of spreading sand adjacent to the project area.

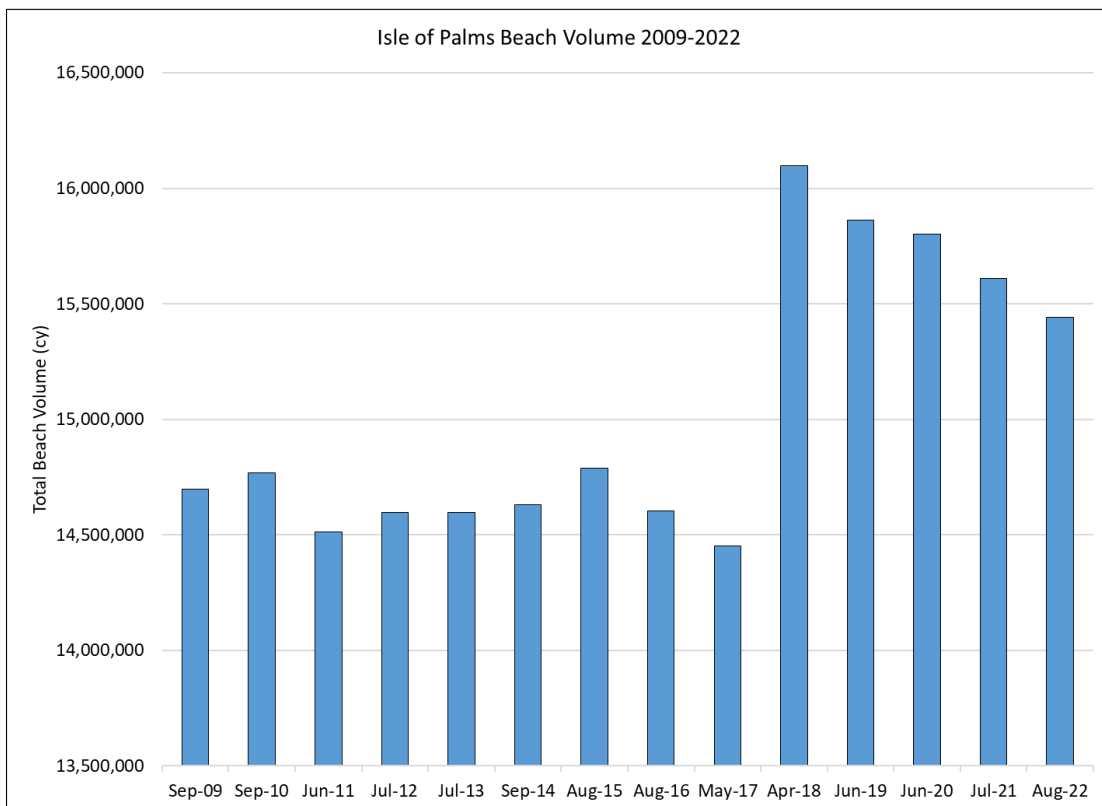
FIGURE 4.3. Total beach volume at Isle of Palms from 2009 to 2022. Effects of the 2018 project are seen in the rapid increase in the April 2018 island-wide beach volume.

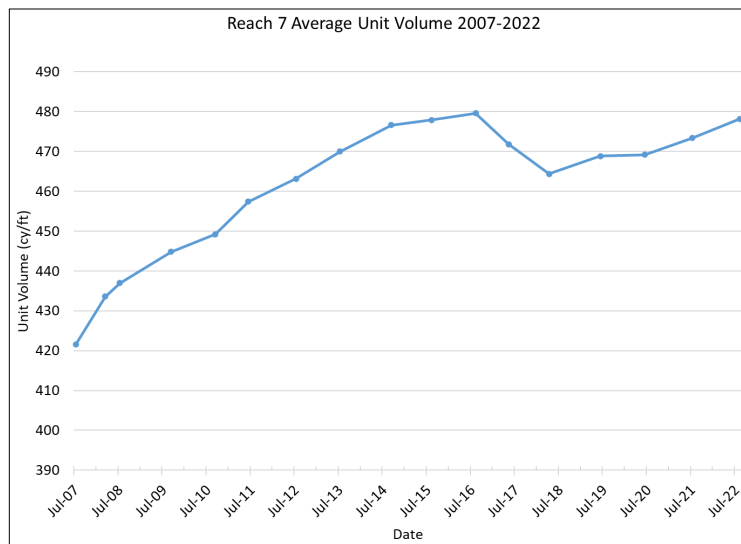
FIGURE 4.5. [UPPER] Average beach volume in Reach 7 since 2007. [LOWER] Profile unit volumes for each monitoring line in Reach 7.

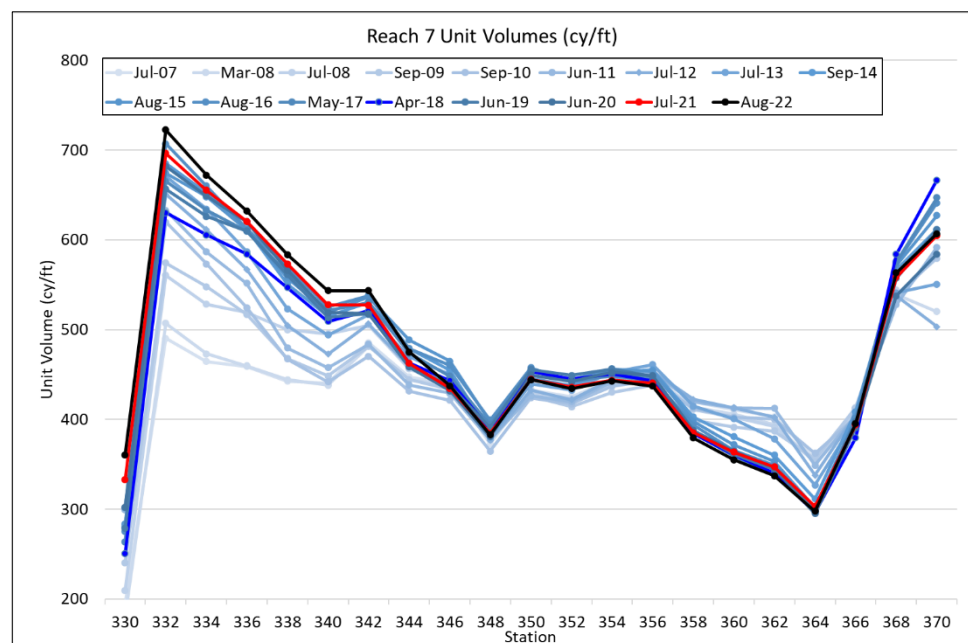
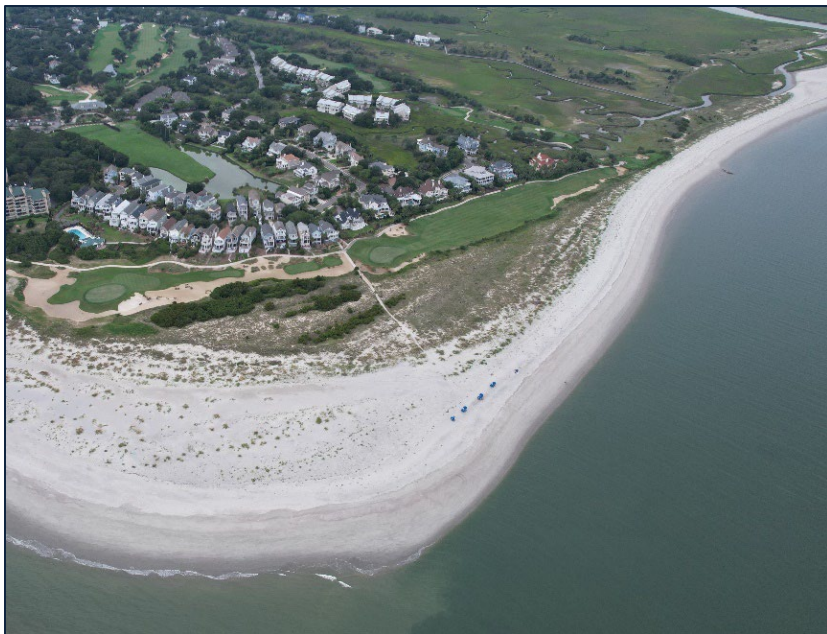
FIGURE 4.6.

the lower figure showing the volume history for each monitoring line. Figure 4.6 provides beach profiles and representative photos of the reach in 2022. Accretion at the seaward end of the reach has led to an increase of over 200 ft of berm width since 2008, including over 100 ft of growth since 2018. All stations seaward of the 17th tee (groin) show at least 10 cy/ft more sand than the most eroded condition since 2008. Ground photos from the reach show that the berm is transitioning into a healthy dune field, with no visible escarpments and reduced areas of dry sand as vegetation cover increases. Photos from further inland also show a very healthy dry sand beach with a vegetated dune well landward of the typical high tide line (Fig 4.6).

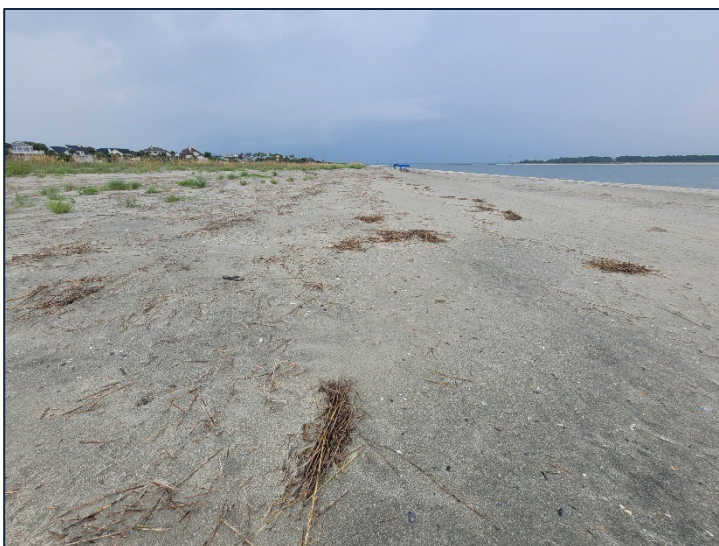
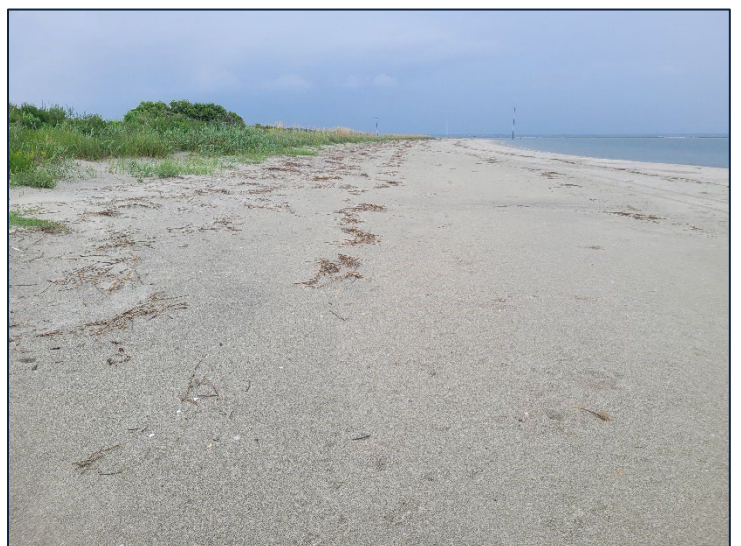
[LOWER] Ground photos from Station 334 **[LEFT]** looking landward and Station 346 looking inland **[RIGHT]** in Aug 2022.

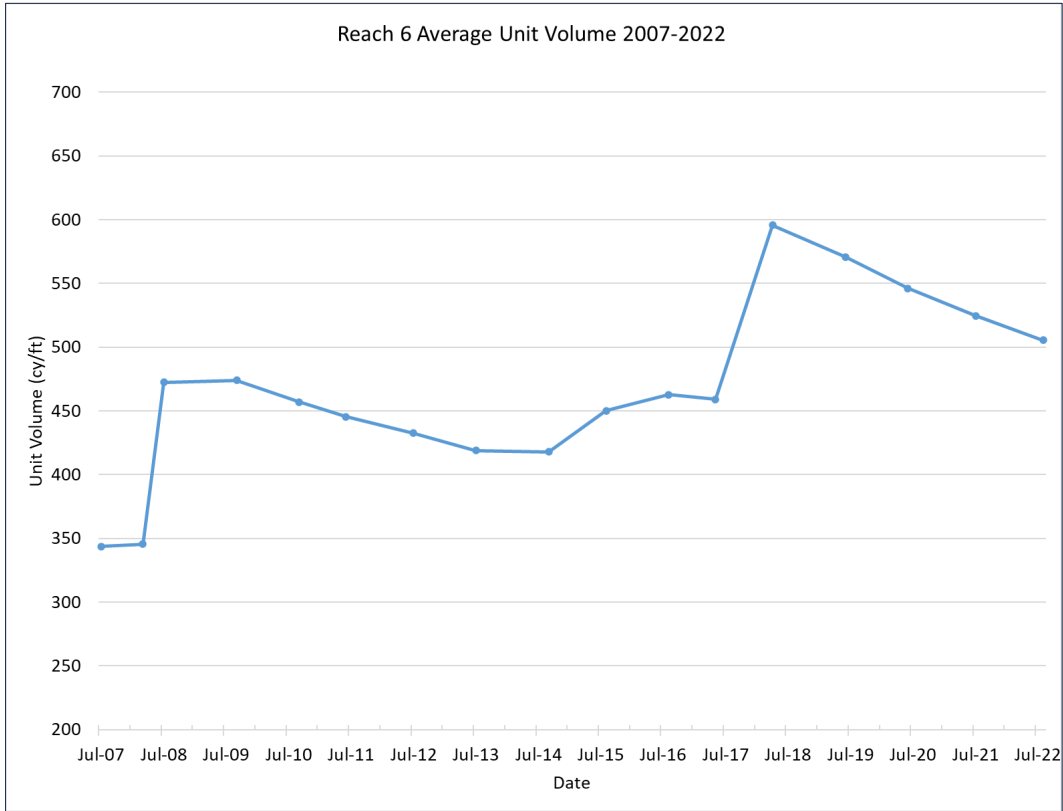
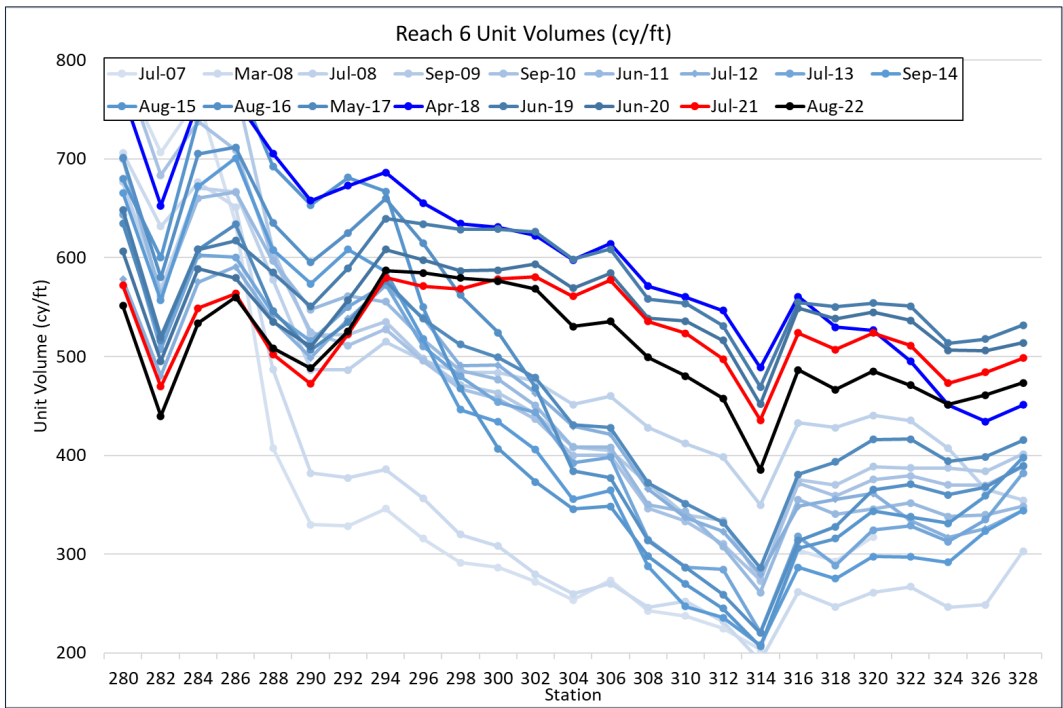
FIGURE 4.8. [UPPER] Average beach volume in Reach 6 since 2007. [LOWER] Profile unit volumes for each monitoring line in Reach 6.

Volume change within the reach ranged from -50 cy/ft to +16 cy/ft. Overall, the reach lost 94,500 cy (19.3 cy/ft) of sand from July 2021 to August 2022. This is a slightly lower value than recent years, as each year from 2018-2021 lost between 105,000 and 122,000 cy. In total, the reach has lost 443,000 cy since 2018. This represents ~66% of the nourishment volume added in 2018; however, the condition highly varies within the reach. Stations 280–292 show an average loss of 53 cy/ft compared to the pre-project condition, whereas stations 294–328 show an average of 81 cy/ft more sand than pre-nourishment. The beach east of Shipwatch still holds more than 60% of the nourishment volume placed in the area. Stations near Beach Club Villas presently hold less sand than the pre-nourishment condition (Figure 4.8).

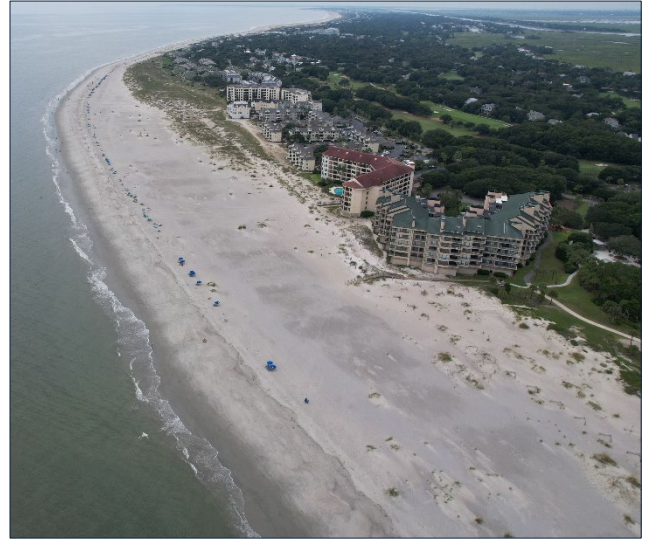
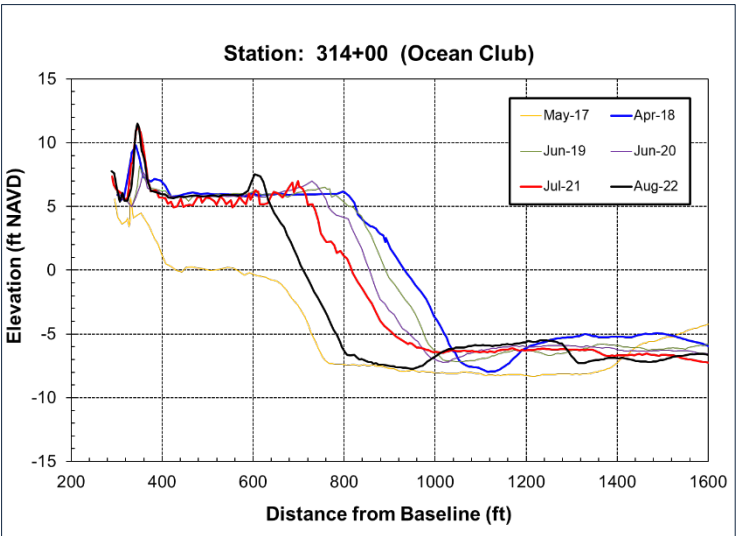
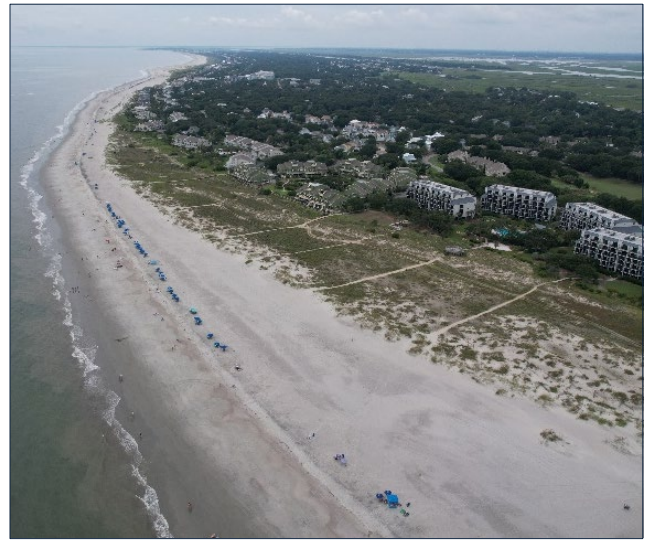
FIGURE 4.9. [LEFT] Reach 6 profiles. The rapid erosion in this area is suspected to be a continuation of the higher erosion trend observed prior to the 2018 project. **[RIGHT]** Aerial photos collected in July 2021.

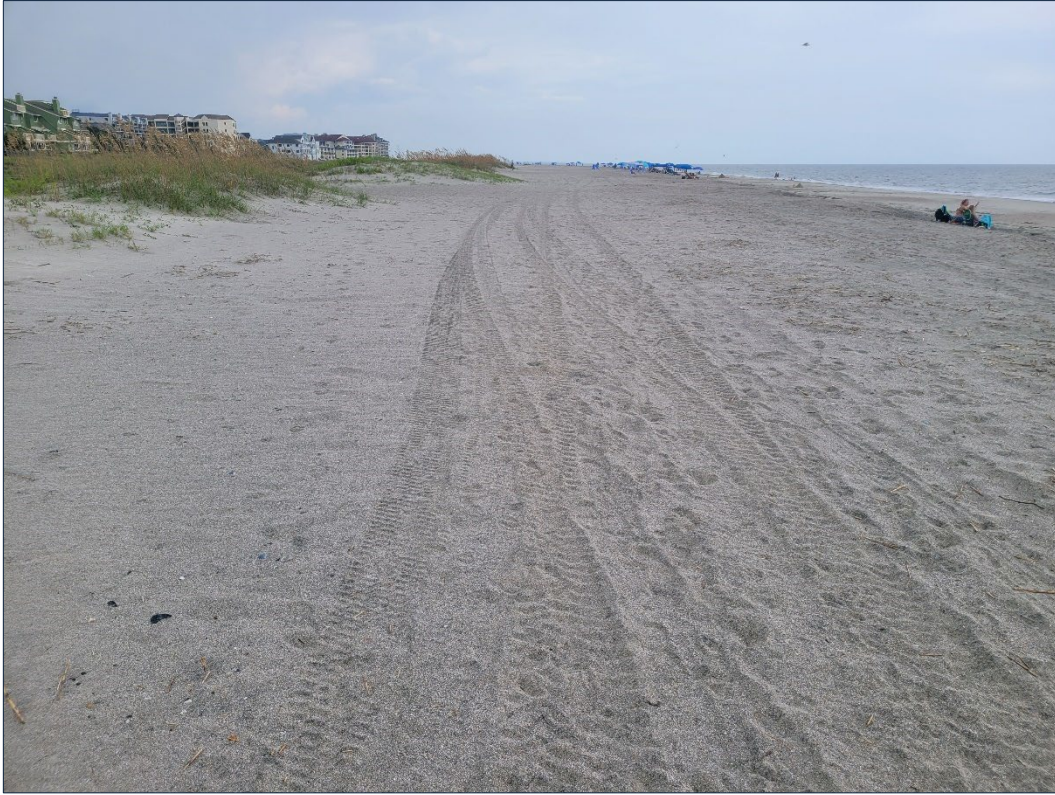
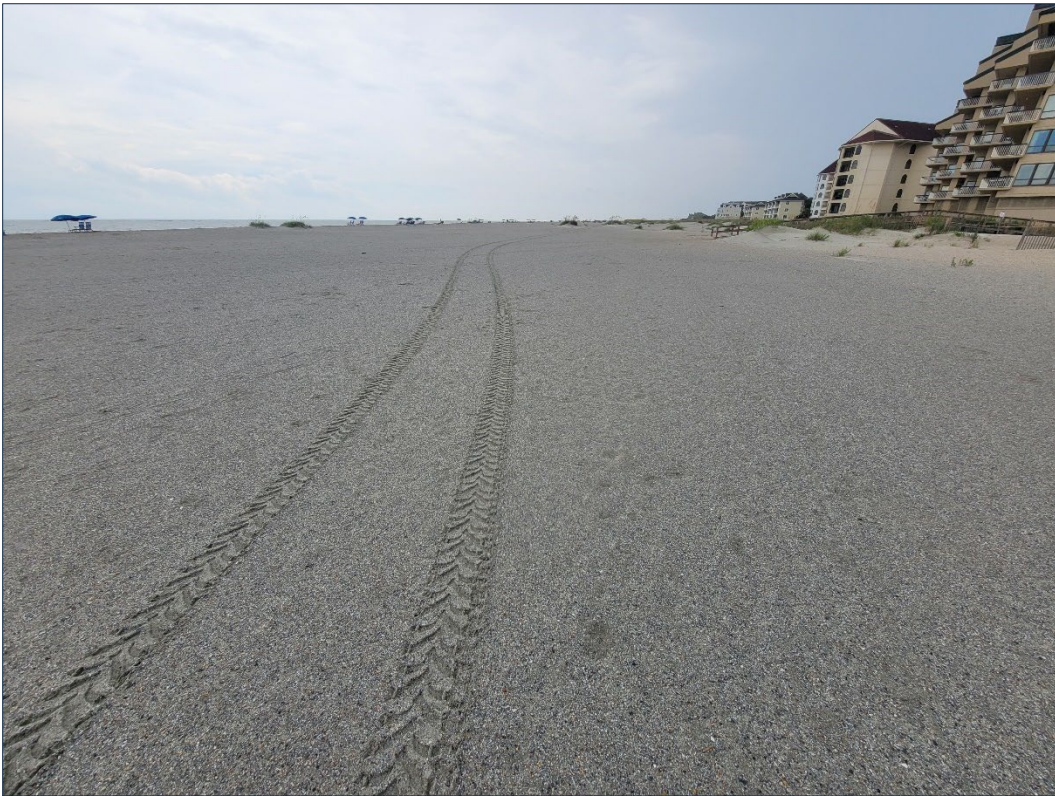
FIGURE 4.10. Ground photos from Station 284 [UPPER] and Station 316 [LOWER] in August 2022.

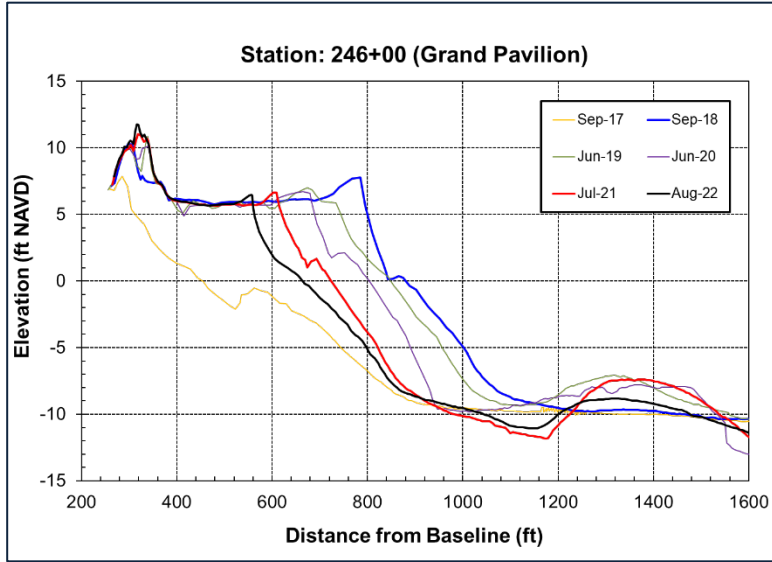
While the magnitude of the erosion is high, the beach condition along the majority of the Wild Dunes area remains in much better condition than in 2017. Erosion has been concentrated in areas along the central portion of Wild Dunes, and most of the shoreline along Reaches 5 and 6 retains at least 100 ft more beach width than the 2017 condition (Fig 4.15). The exception is from stations 270-292, spanning Dunecrest Ln to Mariners Walk (which were generally in better condition in 2017 before the project and received less quantity than adjacent areas). The beach south of the project area has gained over 300 ft of sand due to the downcoast spreading of nourishment fill. The area between Seagrove and Beach Club Villas I is approaching a concerning condition, especially with an anticipated shoal event likely to occur in the next 2-3 years. The shoal may begin to impact the beach over the next year as it approaches stage 2 of the bypass cycle.

FIGURE 4.13. Reach 5 profiles.

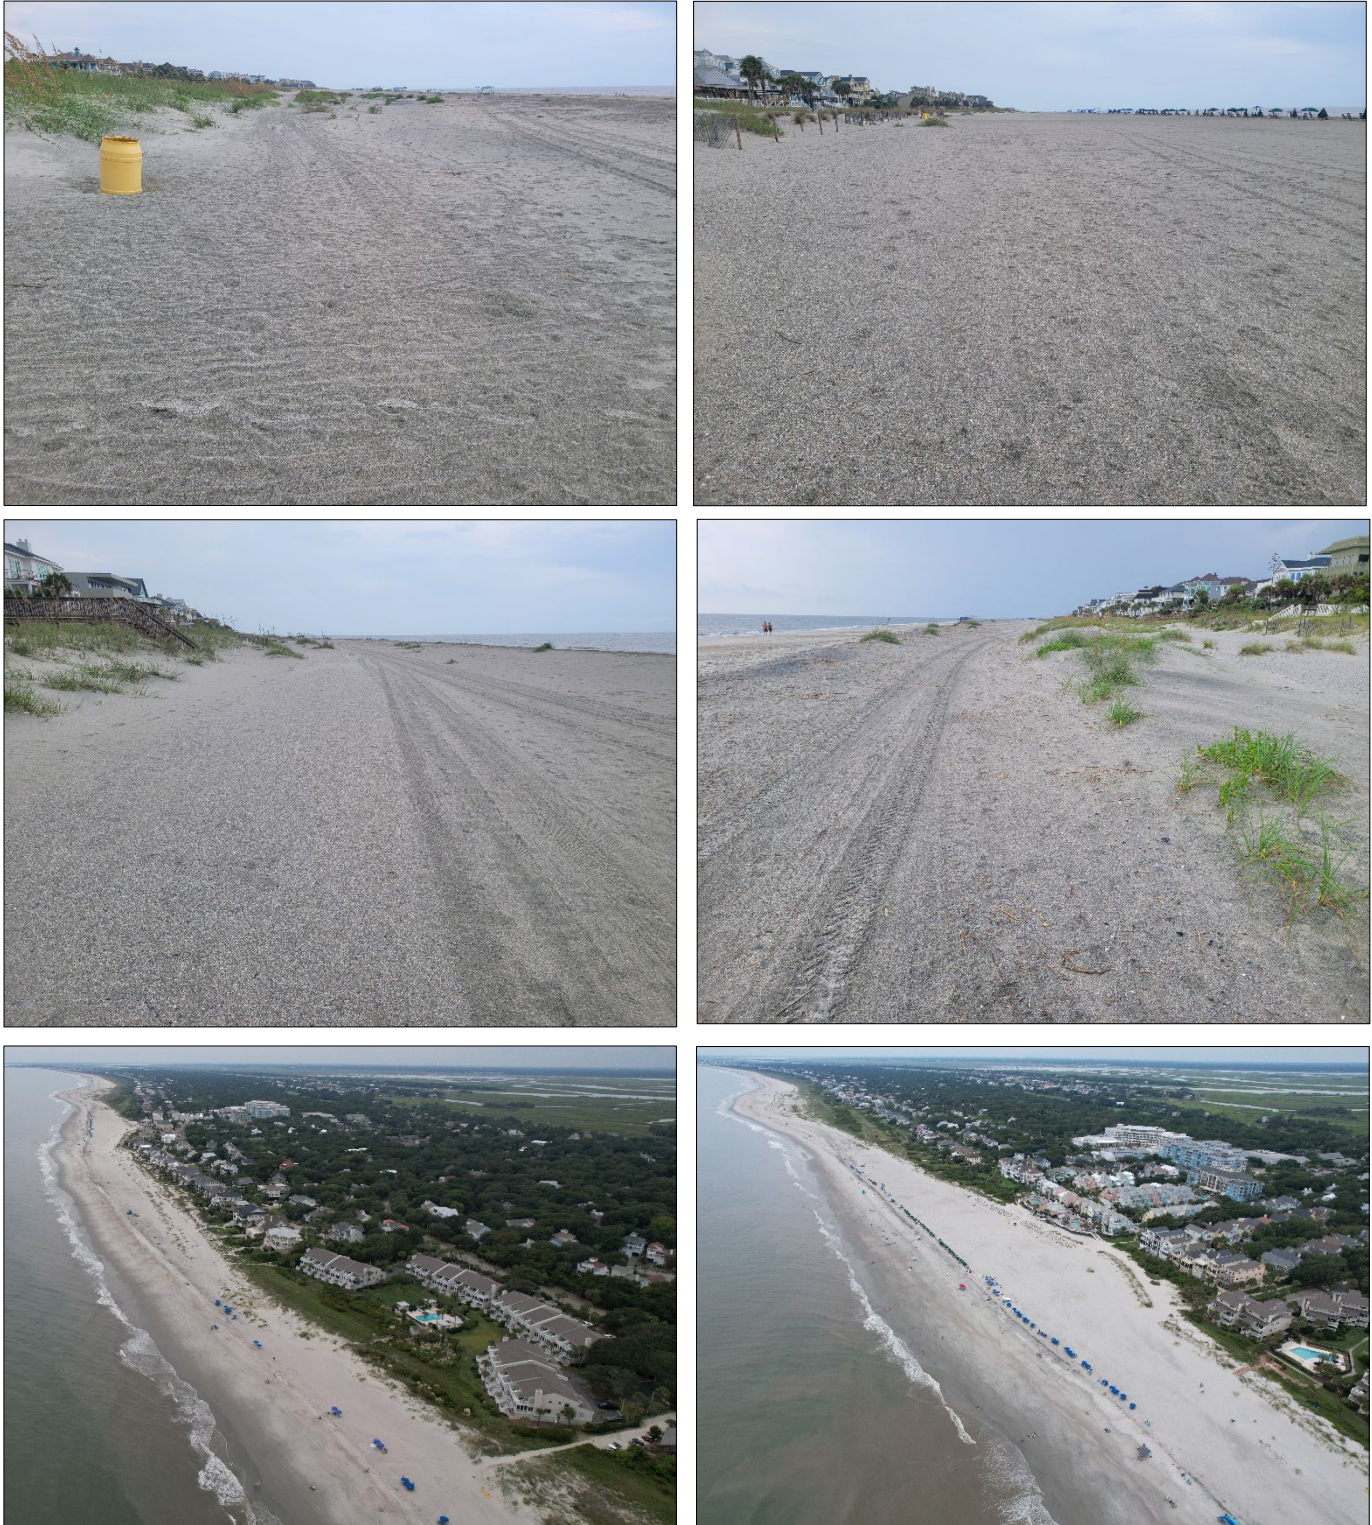
FIGURE 4.14. Ground photos of Reach 6 in July 2021 showing Station 234 [UPPER LEFT], Station 244 [UPPER RIGHT], Station 256 [MIDDLE LEFT], and Station 272 [MIDDLE RIGHT]. Aerial photos from August 2022 are shown in the bottom two photos.

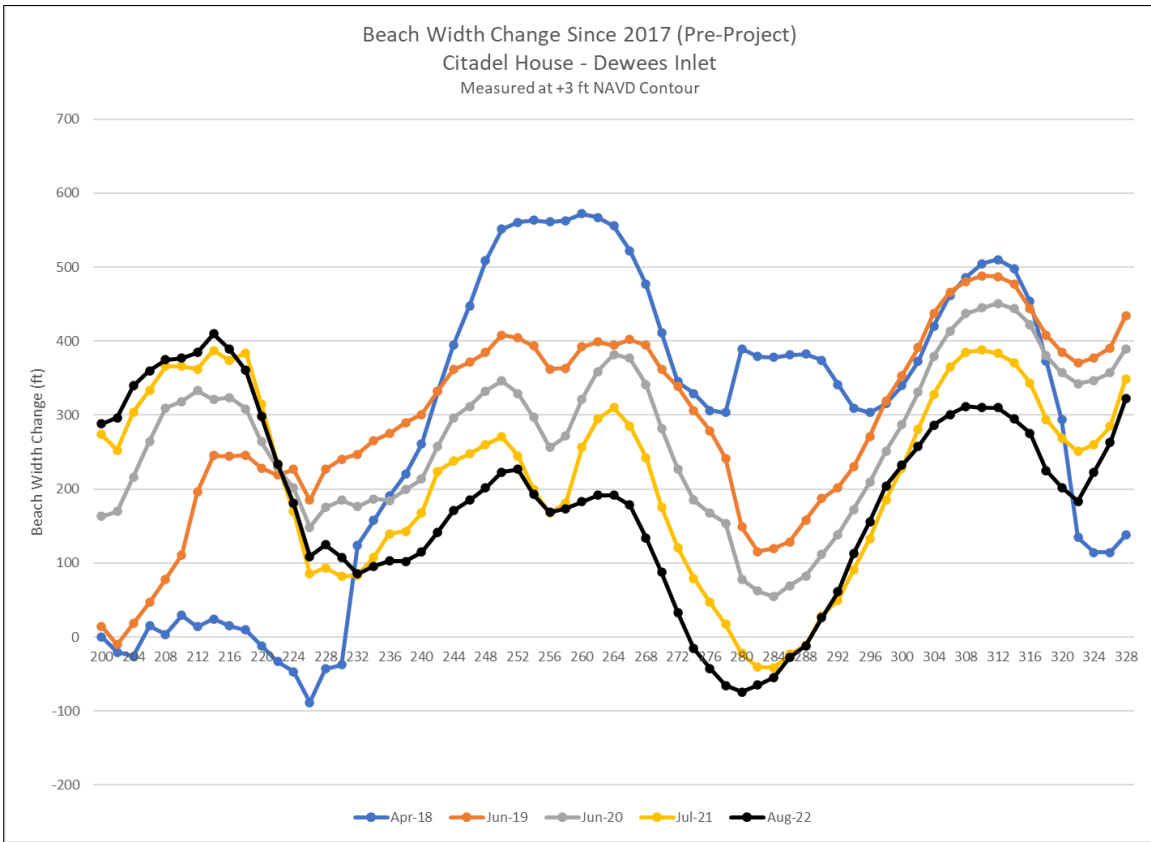
FIGURE 4.15a. Beach width changes along the area spanning the Citadel House to the 18th Hole of the Links Course. Note that the majority of the beach holds at least 100 ft more sand than in 2017; however, the area around Beach Club Villas (~station 280) has lost sand relative to 2017. Also note the extensive accretion present south of the 2018 project area (left side of image from stations 200-230).

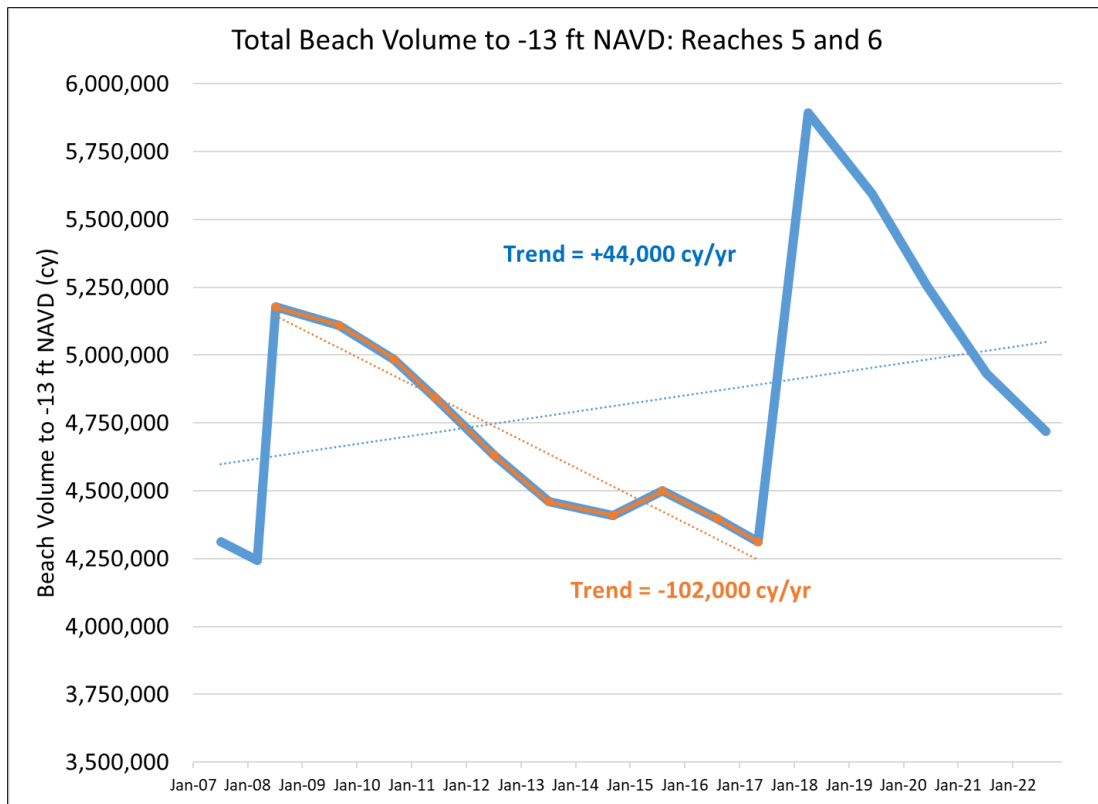
FIGURE 4.16. Total beach volume history of the eastern end of the island since 2007. The graph illustrates the overall erosional trend along reaches 5 and 6 between nourishment projects.

Figure 4.16 provides the beach volume history of the eastern end of the island since 2007, with dates following nourishment indicated. The overall erosional trend is evident along reaches 5 and 6 between nourishment projects, each of which restores sand volumes to maintain a dry beach and protective dune. Sand lost from reaches 5 and 6 either moves south to provide sediment to the rest of Isle of Palms, or recycles to Dewees Inlet, which will eventually form a shoal and recycle back to the beach. The volume increases observed along Reach 7 in recent years and the buildup of sand within the delta at the northeast corner of the island document the transfers of sand from reaches 5 and 6 into the inlet system (see Fig 4.16).

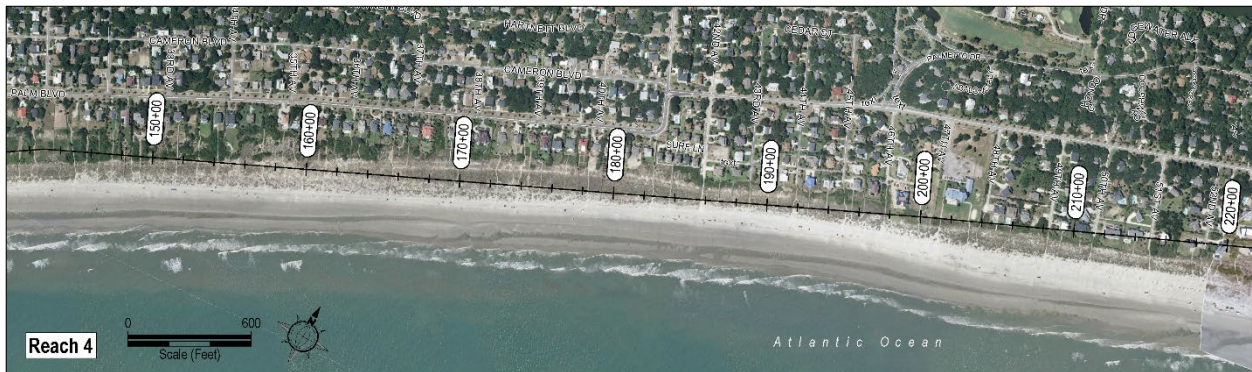
FIGURE 4.17. Baseline stationing along Reach 4 spanning the length of beach between 31st Ave and 53rd Ave.

Reach 4 includes the length of beach between 31st and 53rd Avenues (stations OCRM 3140 to CSE 222+00 – Fig 4.17 and Fig 4.18). This reach is ~7,910 ft long and immediately downdrift of the 2008 and 2018 project area. It is also outside Dewees Inlet's direct influence and maintains a more typical and consistent beach profile shape. By being positioned downdrift of the nourishment area, it receives nourishment sand spreading from the placement area as well as spreading shoal sand. The reach has gained sand every year since 2009 except for 2016, the year after Hurricane *Matthew* impacted the Isle of Palms.

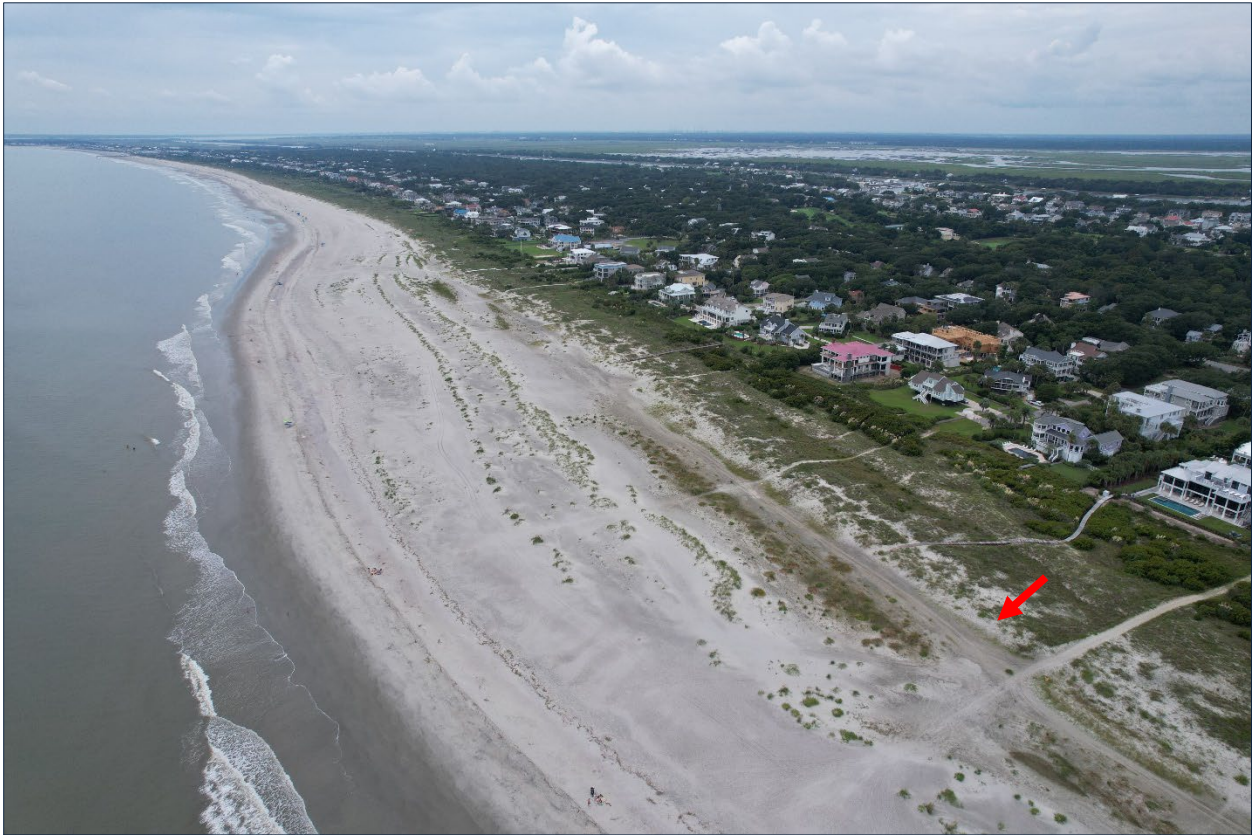
FIGURE 4.18. August 2022 aerial photo of Reach 4 (53rd Avenue is at the right of the image). By being positioned downdrift of the nourishment area, Reach 4 receives nourishment sand spreading from the placement area as well as spreading shoal sand. This reach has gained sand every year since 2009 except 2016. As the vegetated dunes expand, sheltered locations (such as low-lying areas behind protective dune ridges) will gradually transform into a shrub habitat with larger areas of wax myrtle replacing dune grasses. The 2008 dune line is shown by the red arrow.
