**2018 Isle of Palms Restoration Project
Year 4 Monitoring Report**

2022
MONITORING REPORT

2018 Isle of Palms Restoration Project
Year 4 (2022) Monitoring Report
Annual Beach and Inshore Surveys

[2492YR4 — Monitoring Year 4]

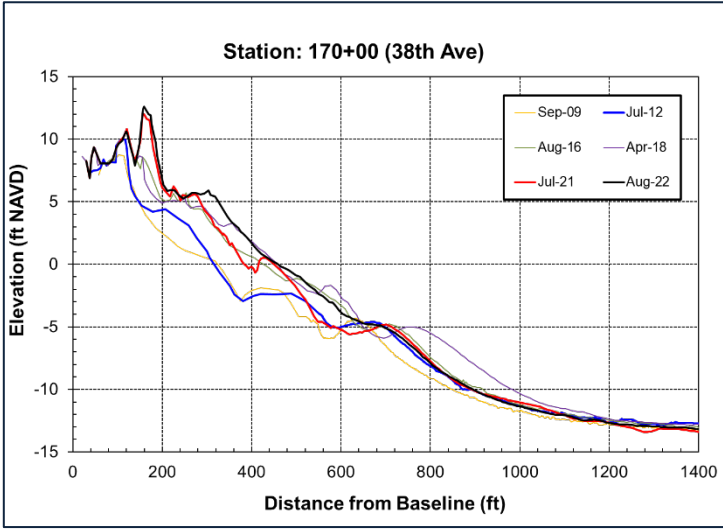
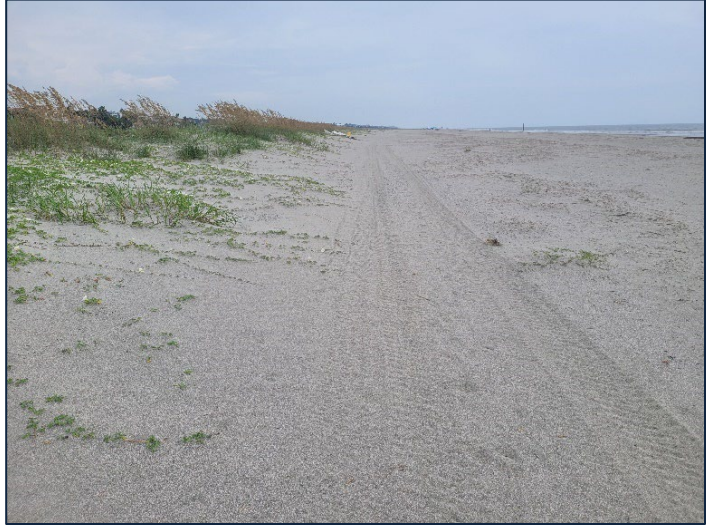
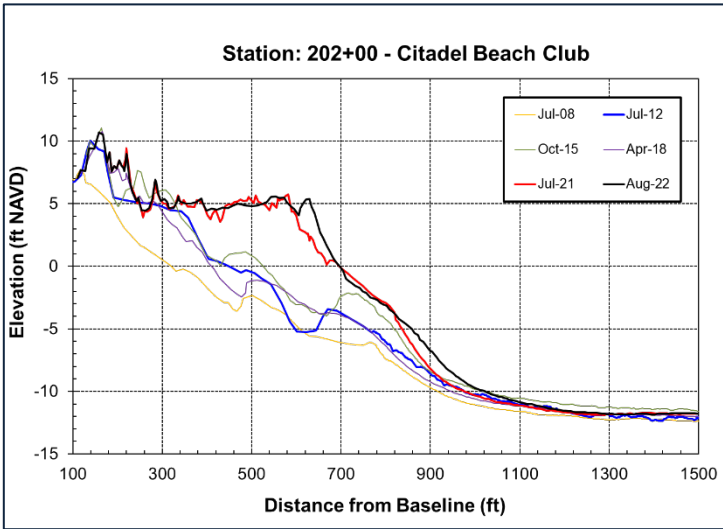
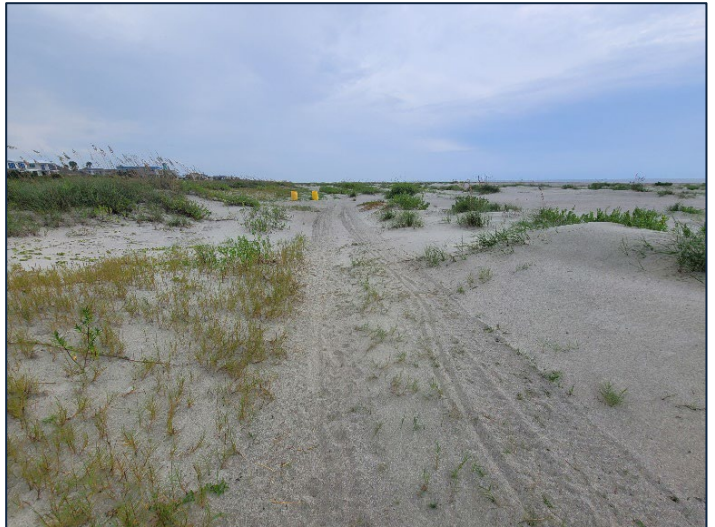
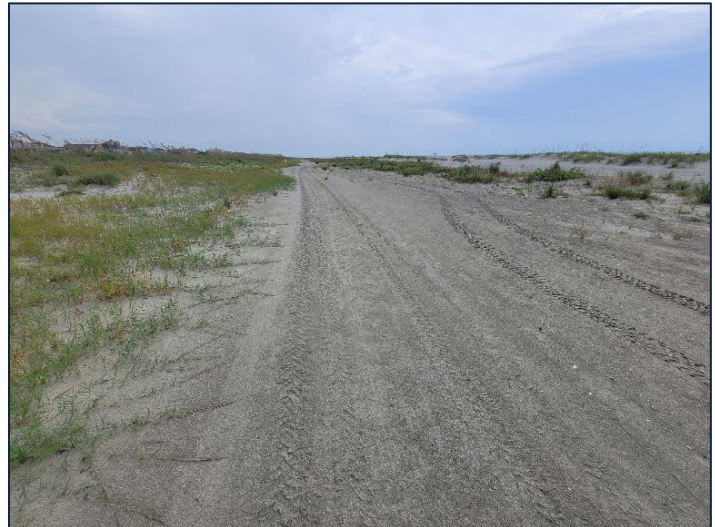
FIGURE 4.19. [LEFT] Profiles along Reach 4 show accretion has led to gains of over 300 ft of dry sand width and formation of new dune ridges. [RIGHT] Ground photos from Station 170 [UPPER], Station 200 [MIDDLE], and Station 216 [LOWER] in August 2022.

The reach receives sand eroded from the island's east end, particularly reaches 5 and 6, with that sand originating from shoal bypass events or nourishment. A significant influx of sand has been observed along the reach since the 2018 project, with an accretional wave propagating south. The leading edge of the spreading sand is visible as a span of high accretion relative to adjacent areas. Over time, the magnitude of the accretion wave decreases as sand spreads at uneven rates. Initially, the peak accretion reached up to 66–80 cy/ft, but by 2022, the highest accretion rates were 29 cy/ft. Accretion has led to the creation of a new dune ridge and wide dry sand beach along the reach. (Figure 4.19).

The beach volume in Reach 4 has increased at an average annual accretion rate of 9.5 cy/ft per year since 2009. Profiles show the dune width has increased by at least 50 ft along the reach, and the dry sand beach by at least another 50 ft. Along the northern end of the reach, the beach is over 300 ft wider than the 2009 condition, with unit volume gains of over 160 cy/ft. This level of accretion is of similar magnitude to many large beach nourishment projects conducted along coastal communities in South Carolina and is equivalent to a \$10–15-million-dollar nourishment investment. The dune has grown ~3–5 ft in elevation and offers substantially more storm protection than the 2009 condition. CSE anticipates continued accretion over the next few years as more sand spreads from the 2018 project area, with the rate of accretion slowly decreasing as sand is lost to the dune system and offshore. **Combined with Reach 3, there is a net gain of 1,172,600 cy of sand along the downcoast areas of Isle of Palms (Sea Cabins Pier to 53rd Ave), which is a direct benefit of the 2008 and 2018 nourishment projects.**

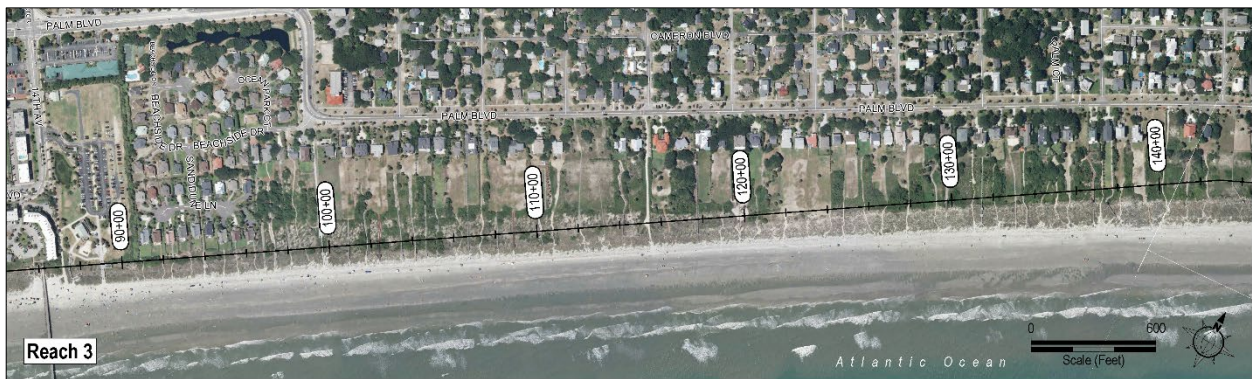
FIGURE 4.20. Baseline stationing along Reach 3 spanning the length of beach from the Sea Cabins Pier to 31st Ave.

Reach 3 extends from the Sea Cabins Pier to 31st Avenue (OCRM monuments 3125 to 3140 – Fig 4.20 and Fig 4.21). Like Reach 4, the long-term trend in this area is stable to accretional. Dwellings in the reach are well set back from the beach, generally between 400 ft and 500 ft, except at the western end where Sand Dune Lane and the county park are set back ~150 ft. The reach has shown periods of erosion and accretion since CSE began island-wide monitoring in 2009. This is typical for stable to moderately accretional beaches as variations in wave conditions from year to year and temporary changes in sediment supply lead to minor fluctuations in yearly volume change. Over the long term, the trend is accretion.

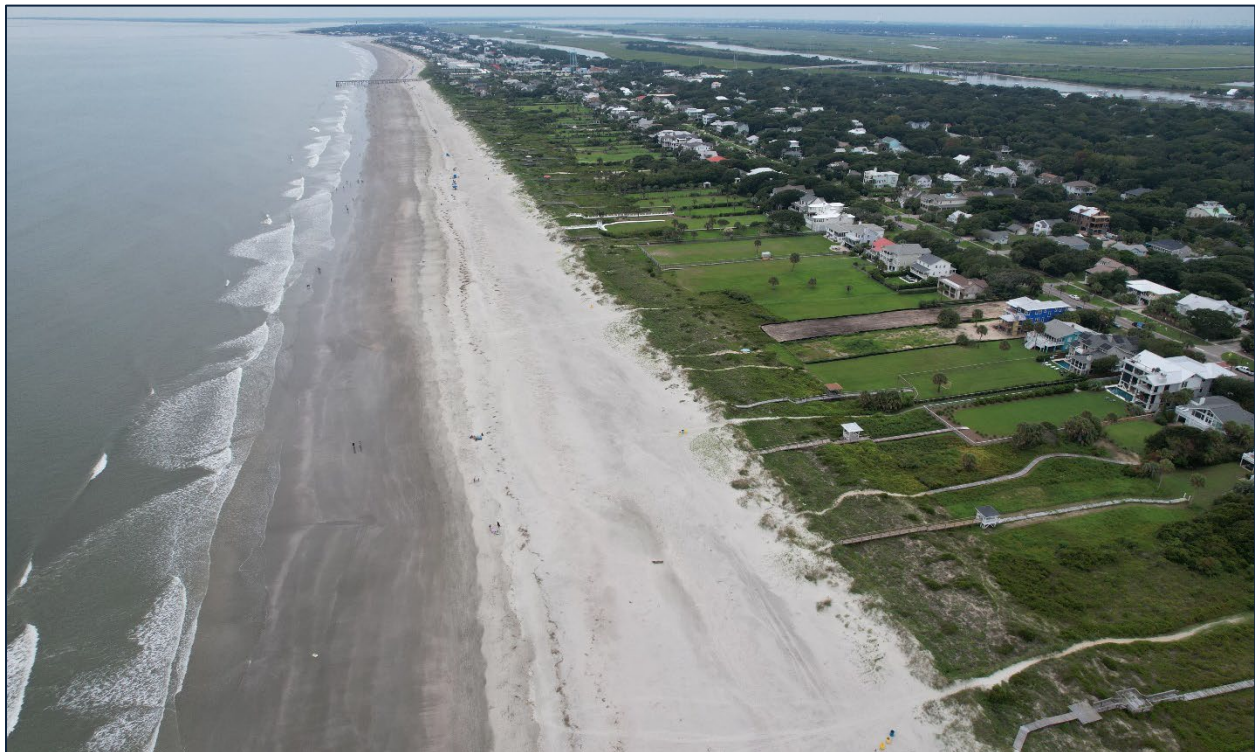
FIGURE 4.21. Aerial photo of Reach 3 in August 2022 (29th Ave in the foreground). The long-term trend for Reach 3 is stable to accretional. Dwellings in the reach are generally set back from the beach between 400 ft and 500 ft.

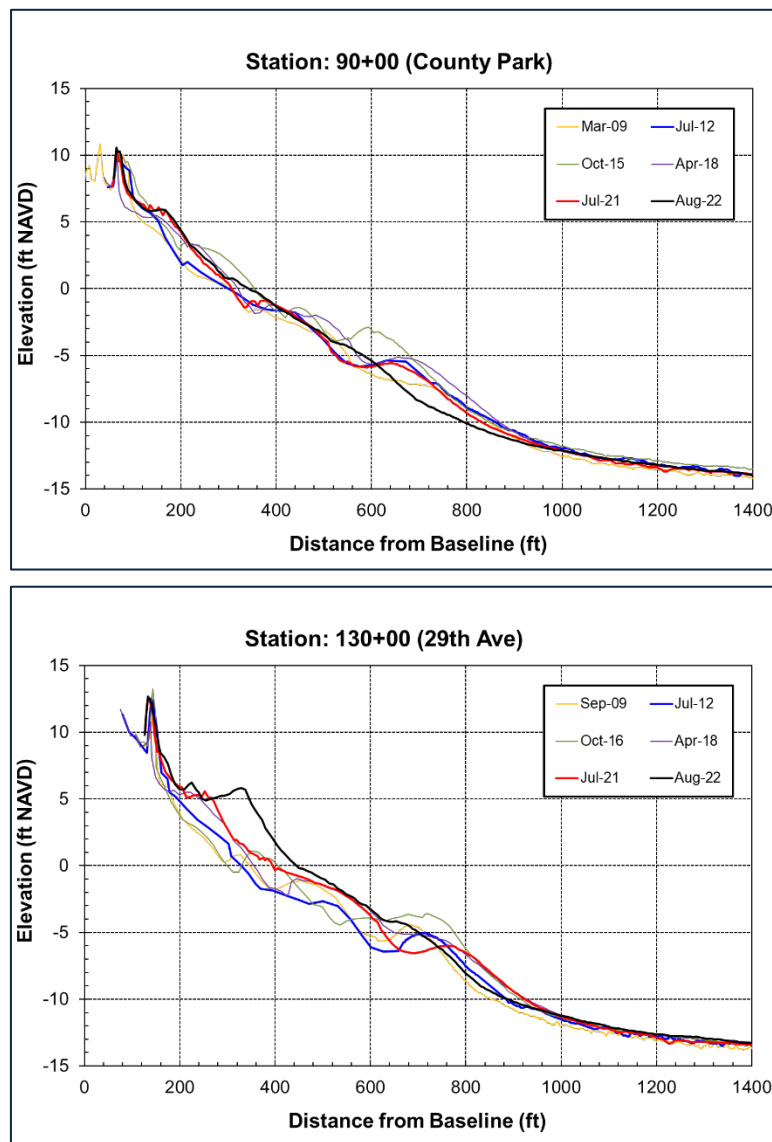
FIGURE 4.22. Example profiles from Reach 3. At station 90+00, there was a net loss of volume due to movement of the underwater sandbar. The dry beach remained stable over the past year.

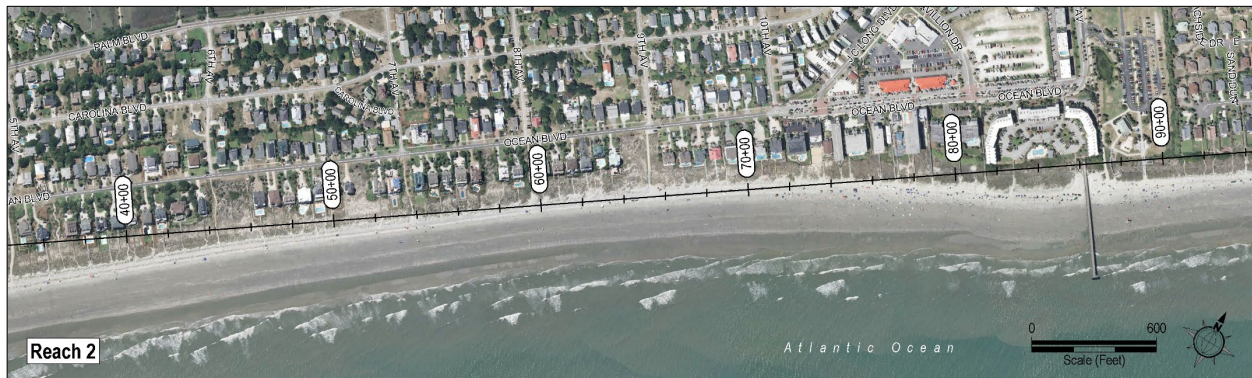
FIGURE 4.24. Baseline stationing along Reach 2 spanning between 6th Avenue and the Sea Cabins Pier.

Reach 2 spans 4,280 ft between 6th Avenue and the Sea Cabins Pier (OCRM monuments 3115–2125 – Fig 4.24 and Fig 4.25). It includes the oceanfront commercial area at the eastern end of the reach. Reach 2 shows an erosion/accretion pattern similar to Reach 3, with intermittent periods of accretion and erosion and a long-term accretion trend. Since monitoring began in 2009, Reach 2 has been the most stable reach, typically showing a lower magnitude of volume change than the other reaches.

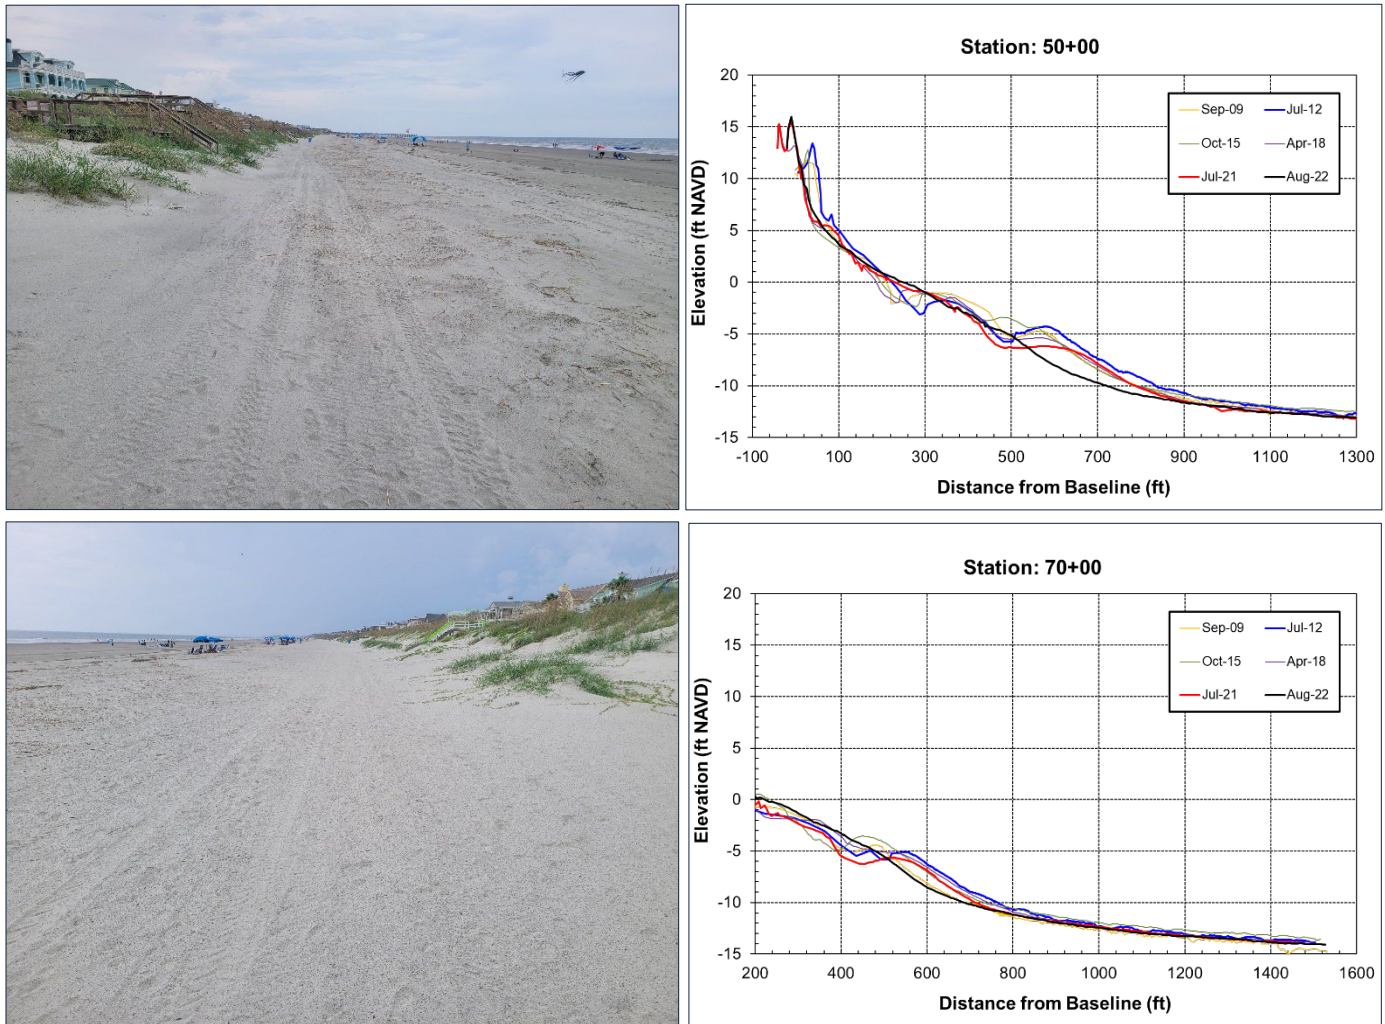
Photos and profiles show the healthier condition of the eastern end of the reach (south of the pier) compared to the western end (Fig 4.25). The dune constructed in 2017 following Hurricane *Irma* remains mostly in place three years after construction. This dune was scraped from the intertidal beach following the storm to accelerate the natural beach recovery cycle.

FIGURE 4.25. Aug 2022 photos of Reach 2. [UPPER LEFT] View north from Station 50. [LOWER LEFT] View west from Station 70. The photos show a healthy beach with dry sand seaward of the dune. Profiles show that the dune remains more landward than the 2012 condition; however, it has been fairly stable since 2017.

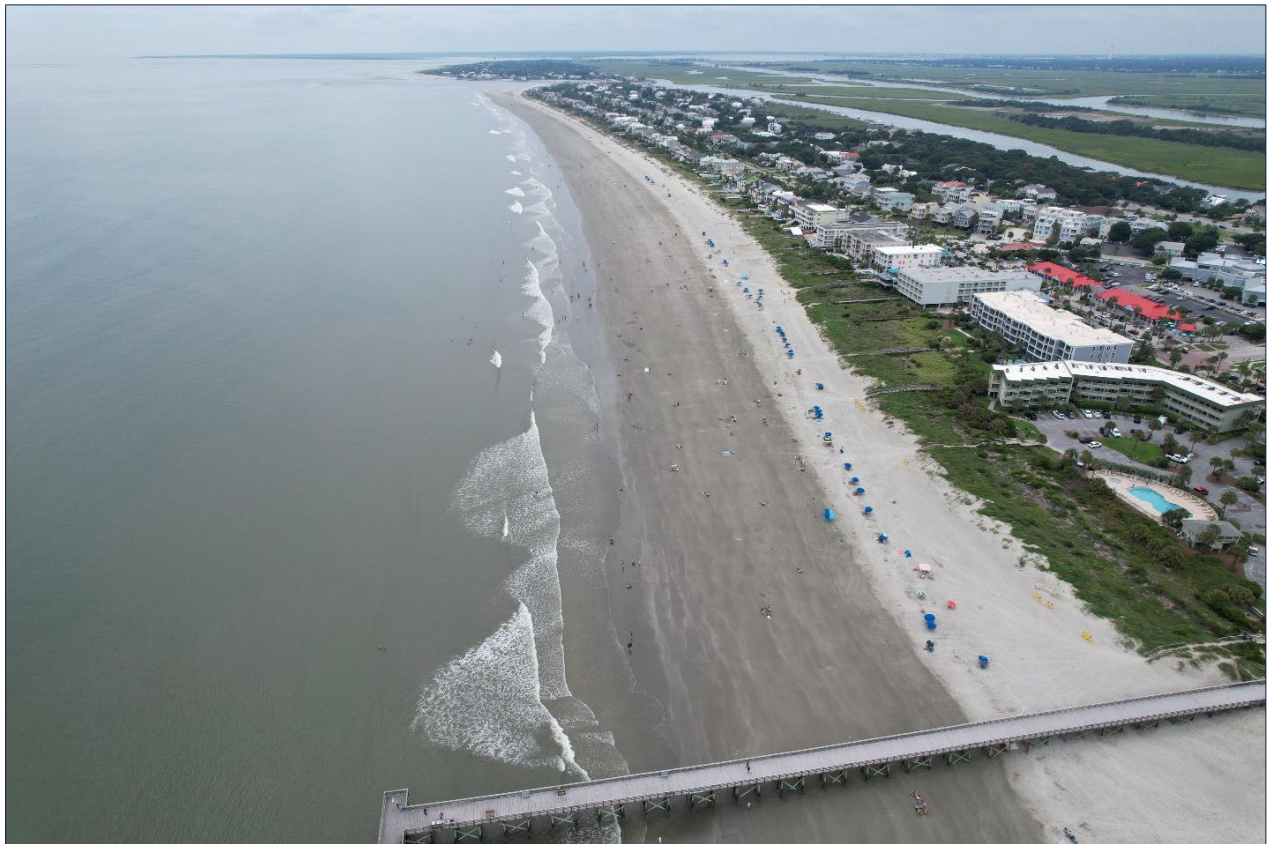
Aerial photos (Fig 4.26) of the reach show a crescent-shaped beach extending south of the pier. The shoreline morphology and the variable erosion patterns observed in this area should be closely monitored, as building setbacks are generally less than reaches 3–4. Should an erosional period persist, or a major storm impacts the area, structures along Front Beach or the southern end of the Isle of Palms could become threatened. At a minimum, additional erosion along the south end of the reach will reduce the dry beach width, limiting recreational area. CSE recommends that this area continue to be included in future permit applications for nourishment, though additional sand is not presently needed.

FIGURE 4.26. Aerial views of Reach 2 in Aug 2022. Since monitoring began in 2009, Reach 2 has been the most stable reach, typically showing lower magnitudes of volume change compared to the other reaches along Isle of Palms. The arc in the shoreline west of the pier indicates that the pier may act to trap sand, which may impact Reach 2 in certain wave conditions.

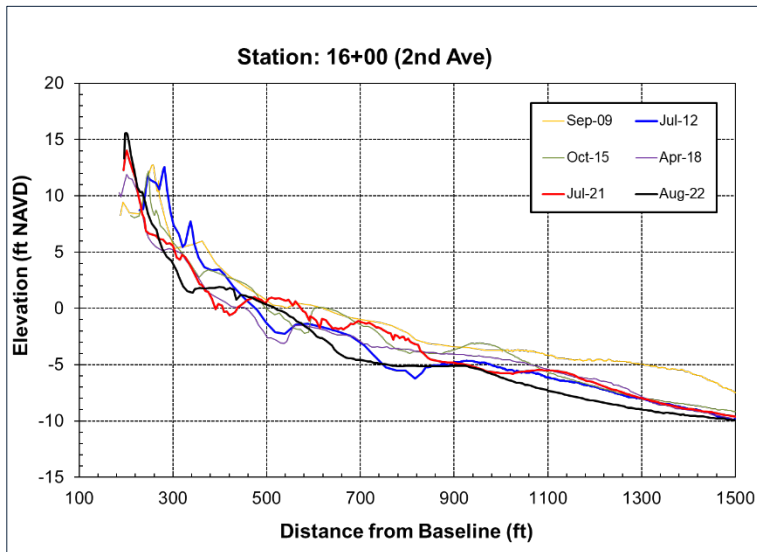
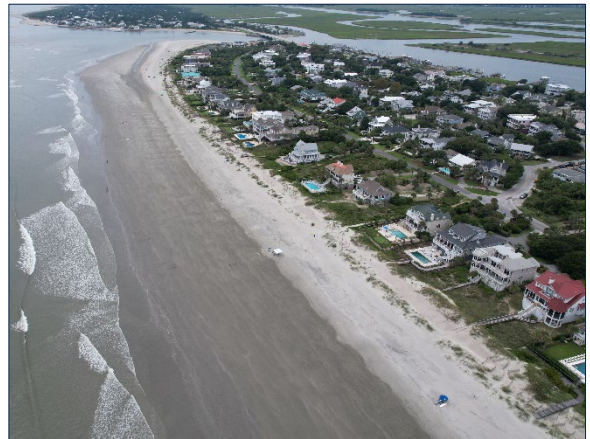
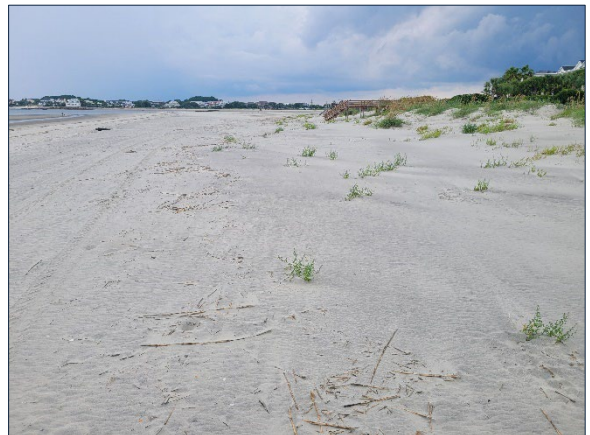
Profiles from this area show that despite the volume loss, the beach remained in good condition, with visible dune growth at all profiles except at station 20+00 (Fig 4.28). The large sandbar present in 2021 was no longer evident in the profiles, leading to the measured volume loss. The dune line along the reach is still ~80 ft landward of the 2012 position, which was the healthiest observed condition (prior to Hurricane *Sandy*). The dune placed after Hurricane *Irma* in 2017 has performed well north of 2nd Ave. West of there, the dune eroded through 2020 but has since rebuilt naturally.

FIGURE 4.28. [LEFT] Profile plots for Reach 1 indicate that while recent erosion rates are higher than historical trends, the majority of volume loss has been restricted to the portion of the profile below the high tide line. This means that the dunes have been more stable than the erosion rate would suggest. [RIGHT] August 2022 photos from Reach 1 [MIDDLE] Station 12 looking south [BOTTOM] Station 30 looking south.

The Breach Inlet reach has been dynamic since 2009 and needs to be closely monitored moving forward. CSE recommends the City pursue discussions with the US Army Corps of Engineers (USACE) to place material along this area as a beneficial use of dredged material when the Intracoastal Waterway is dredged in the future.

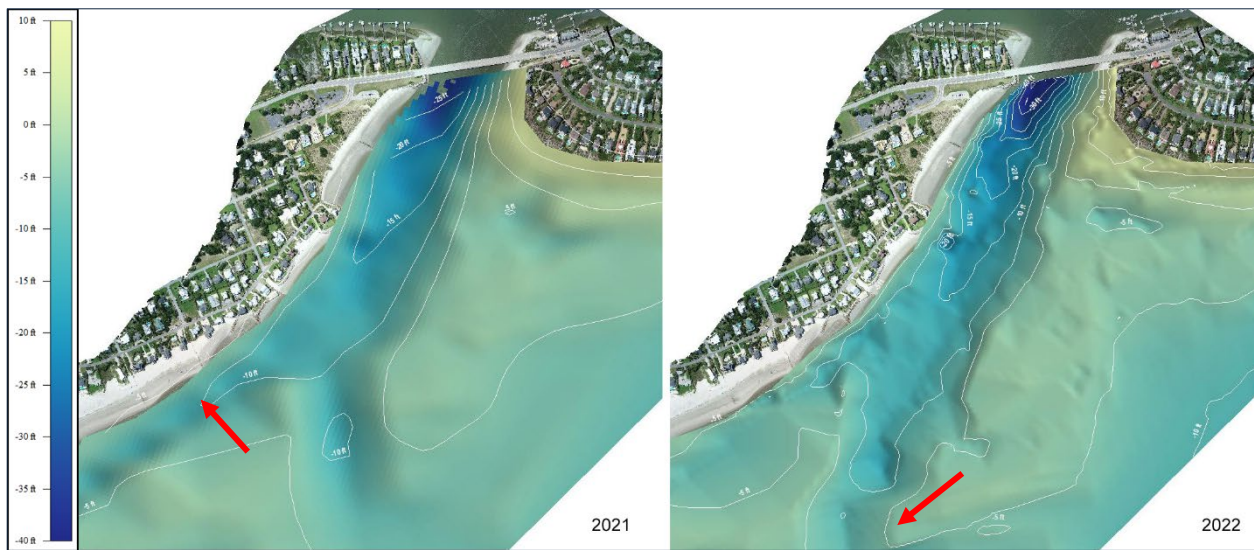
FIGURE 4.29. A pair of digital terrain models spanning the majority of the Breach Inlet channel collected in 2021 (left) and 2022 (right). The model shows the old main channel present in 2021 has infilled and the secondary channel has become the new main channel. No significant changes were observed along the northern shoal; however, it is elongating, which may draw sand off of Isle of Palms.

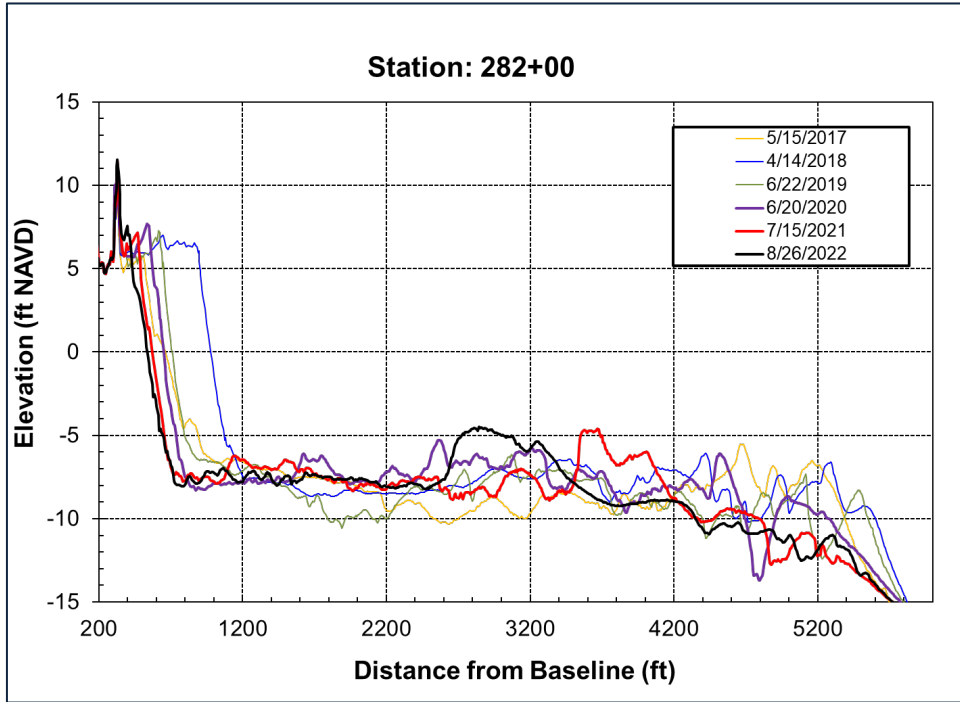
FIGURE 6.2. Profiles from stations 282 [UPPER] and 298 [LOWER] showing growth and onshore migration of a large shoal in Dewees Inlet. At both locations, the shoal moved ~750 landward over the past year. The shoal is exposed at low tide off of Summer House.

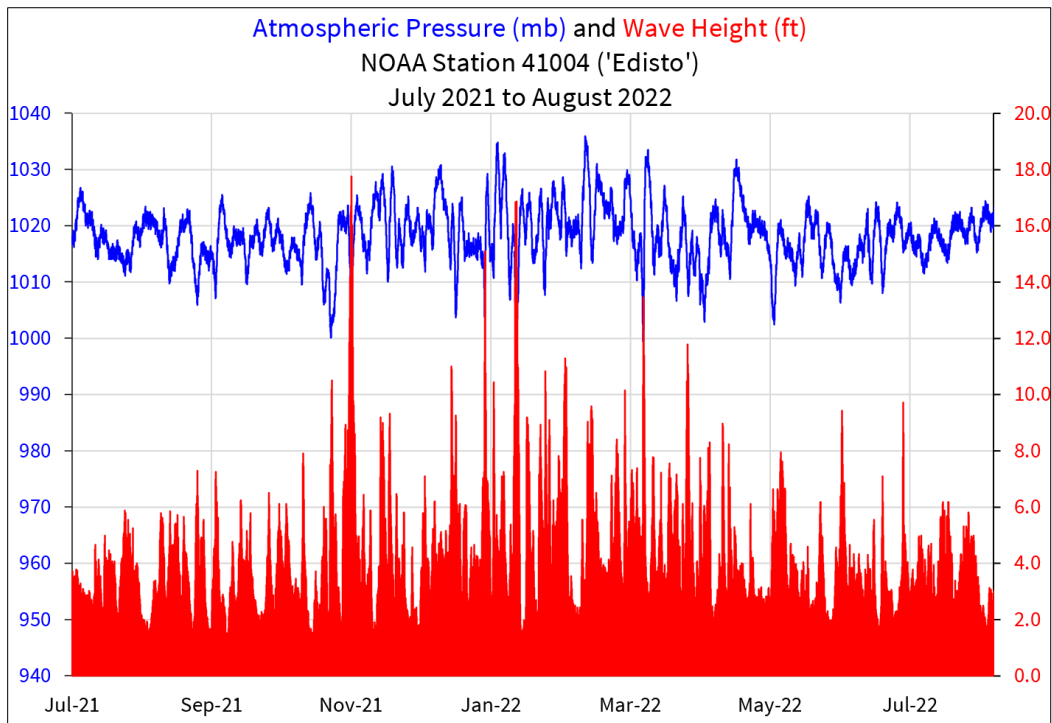
FIGURE 7.2. Atmospheric pressure and wave height at NDBC 41004 from July 2021 to August 2022. Wave heights exceeded 10 ft only once during the study period – far below the annual average since 2010 – and atmospheric pressure did not go below 1000 mb. These two parameters indicate conditions have been relatively calm over the past year.

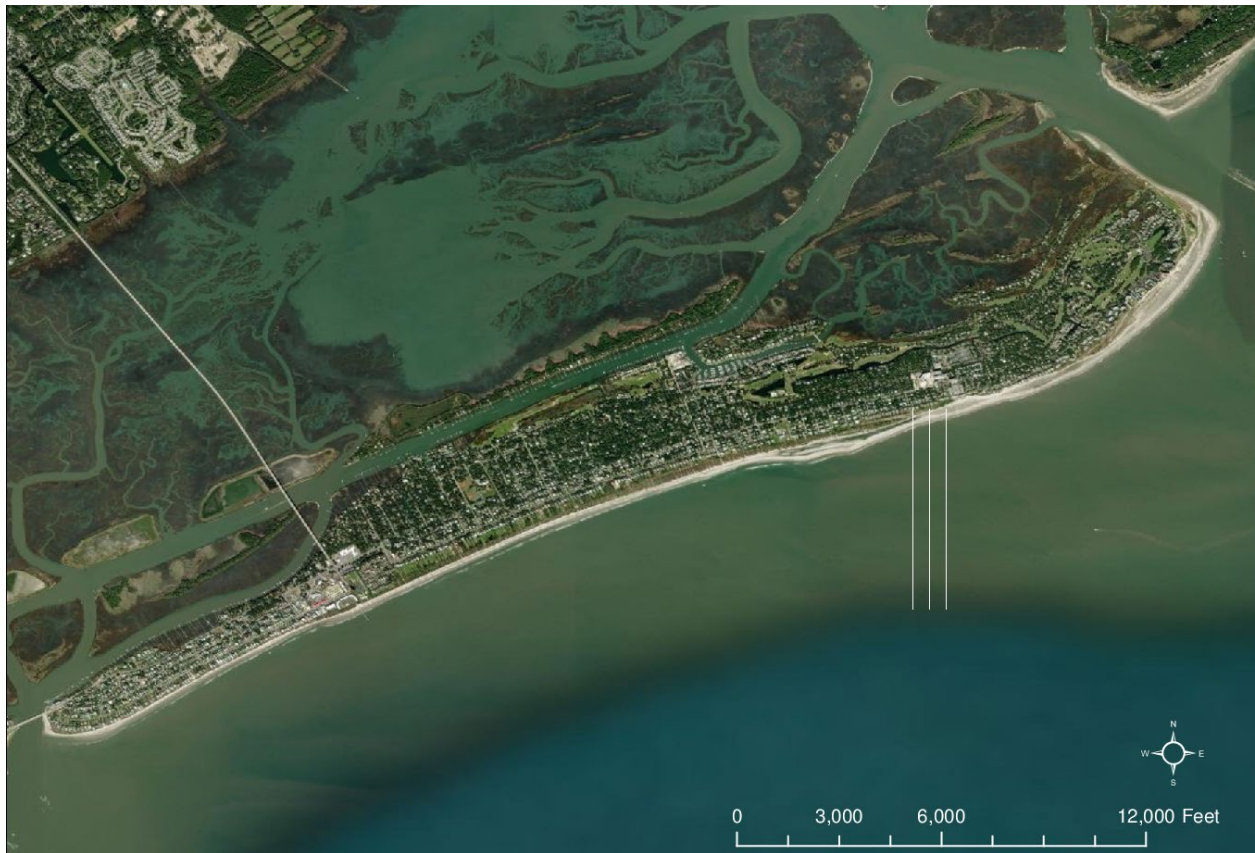
FIGURE 7.5a,b. Sea level inundation models around the Isle of Palms generated using data from NOAA (<https://coast.noaa.gov/digitalcoast/tools/slr.html>). Shades of yellow, orange, red, and maroon are used to signify SLR of 1, 2, 3, and 4 ft above present-day MHHW.
