February 24, 2014

RE: Breach Inlet Quarterly Survey — January 2014 (Amendment 2 – Task 8) [CSE 2386]

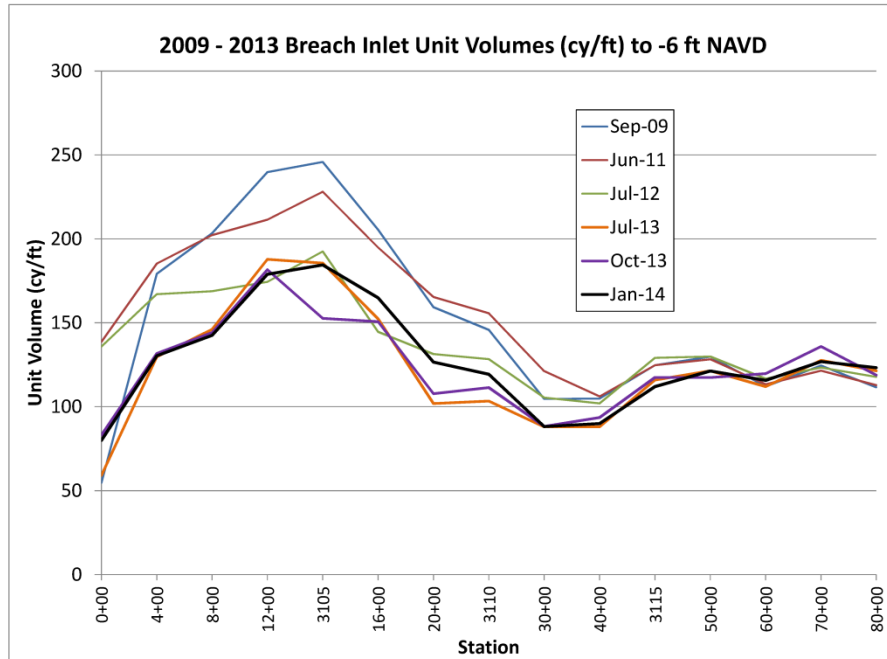
FIGURE 2. Beach unit volumes (in cy/ft to -6 ft NAVD) for monitoring stations in the Breach Inlet area.

Beach profiles are provided in Attachment 1 and volume changes are shown in Table 1. The Breach Inlet area (Reaches 1 and 2) gained ~24,000 cubic yards (cy) of sand between July and October 2013. This led to moderate recovery of the dry beach following the erosion occurring between 2011 and July 2013 (details are provided in the letter report submitted in November 2013). Between October 2013 and January 2014, the area as a whole was stable, gaining only 116 cy (measured to –6 ft NAVD). Reach 1 (west of 6th Avenue) gained ~9,500 cy, while Reach 2 lost a similar volume.

There was not a distinct erosional trend within either reach. The tip of the spit (stations 0+00 thru 12+00) showed minor erosion (1.4 to 3.1 cy/ft) and stations 0+00 and 4+00 showed ~10 ft of dune recession. Stations OCRM 3105 thru OCRM 3110 (2nd and 3rd Ave) all gained sand and were responsible for the net accretion observed over the reach. Figure 2 shows unit volumes for monitoring stations useful for visualizing how beach volume has changed over the past 4.5 years. Profiles show that sand from a low-tide ridge (higher part of the beach seaward of a runnel) present in October 2013 migrated higher up the beach by January 2014. Erosion/accretion was more variable north of station 30+00, ranging from 9.0 cy/ft erosion to 4.4 cy/ft accretion. Station 30+00, 40+00, and OCRM 3115 all showed minor erosion of the frontal dune toe, though no significant loss of dune width or elevation was evident. Comparative ground photos are provided at the end of this letter.

In Reach 1, the October–January time period showed a similar accretion **rate** as the July–October time period (~45,000 cy/yr). The volume change rate for Reach 2 changed from +47,500 cy/yr (accretion) between July and October to –43,800 cy/yr (erosion) between October and January. For comparison, Reach 1 lost an average of ~85,000 cy/yr between July 2011 and July 2013 and Reach 2 was essentially stable.

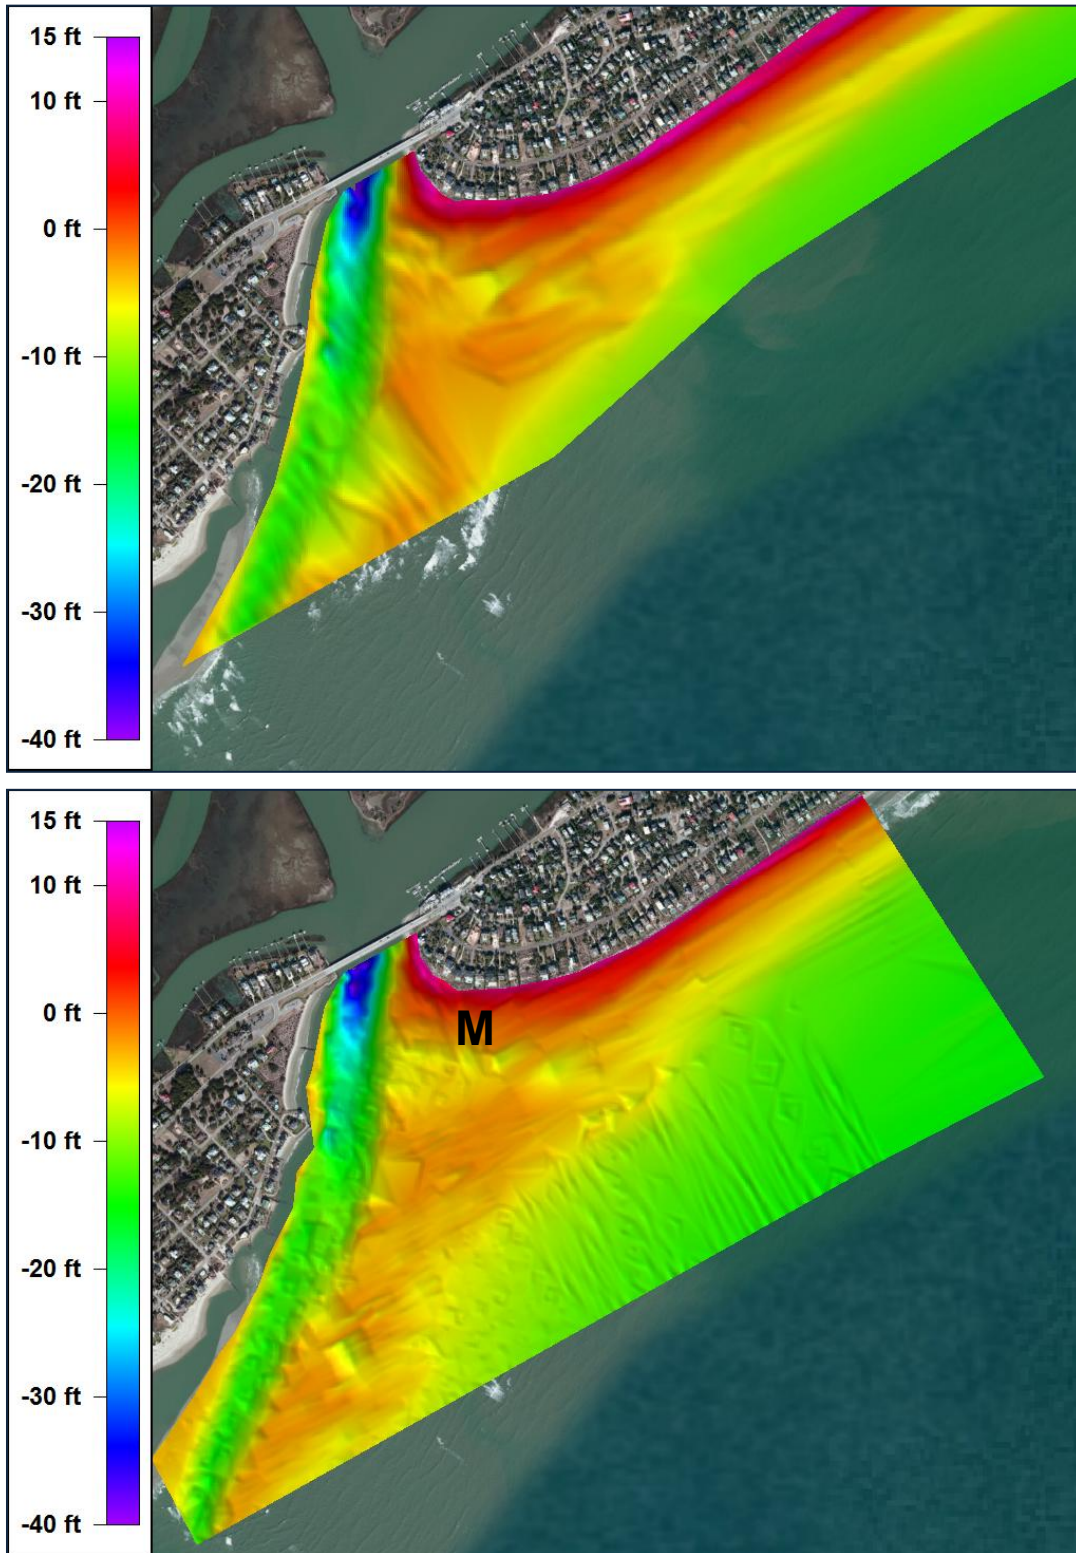
The most recent assessment included a comprehensive survey of the Breach Inlet delta to evaluate potential changes in channel positions, channel depths, and shoal positions. Figure 4 shows digital terrain models (DTMs) of the inlet delta in July 2013 and January 2014. Note that the data coverage is variable between the two, so the limits of the colored area are not the same. Overall, the main channel of the inlet (green hues) has been fairly stable, although it continues to slowly migrate toward Sullivan’s Island. As the channel shifts west, the linear shoal on the eastern side of the channel also migrates west, drawing sand away from Isle of Palms.

Of particular importance to the Isle of Palms shoreline directly adjacent to Breach Inlet is the position and extent of the marginal flood channel. The channel is marked by “M” (Fig4) and was generally stable between October and January. The only location showing any notable change was at station 8+00, where the channel edge moved closer to the beach, although this was likely in response to a low-tide bar merging with the wet beach (sand moved higher up in the profile, allowing the channel boundary to migrate closer to the shore). Other than the minor changes in the marginal flood channel, no significant changes were observed in the DTMs that directly impacted the beach condition between October and January. The next quarterly monitoring event (scheduled for April 2014) is planned to survey only the beach to low-tide wading depth (excluding the channels and shoals of the inlet). The next comprehensive survey is scheduled for summer of 2014.

FIGURE 4. Digital terrain models (DTMs) of the Breach Inlet area in July 2013 (upper) and January 2014 (lower). The marginal flood channel is denoted by “M” and was mostly stable between October and January.

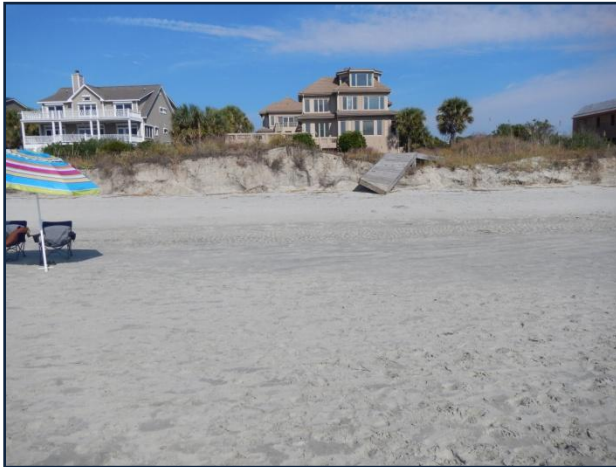
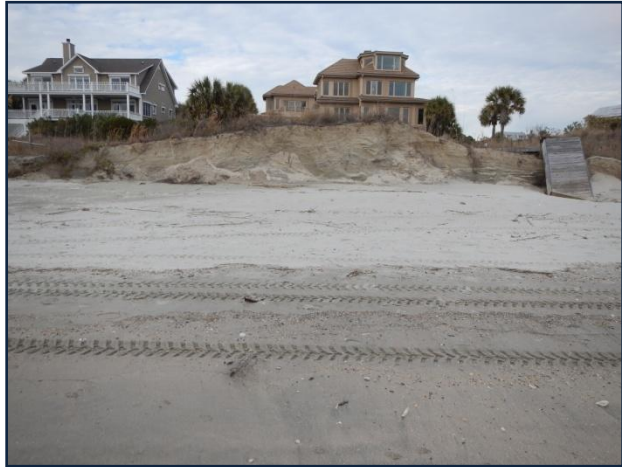
October 2013 (left) and January 2014 (right) images from station 8+00, looking toward the dune. The escarpment in this area moved a few feet landward between the image dates.

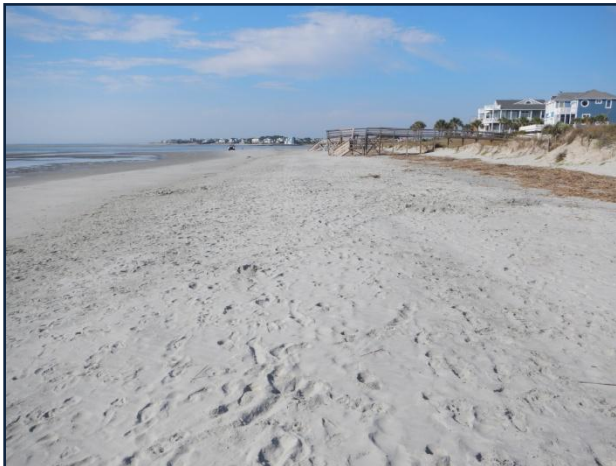
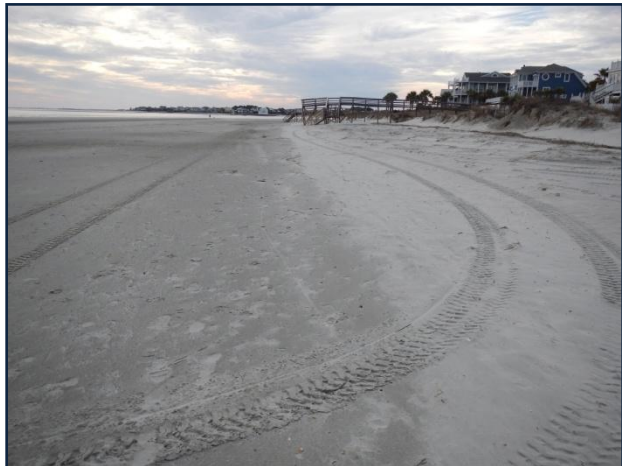
October 2013 (left) and January 2014 (right) images from station 16+00, looking west. This area gained sand between the image dates.

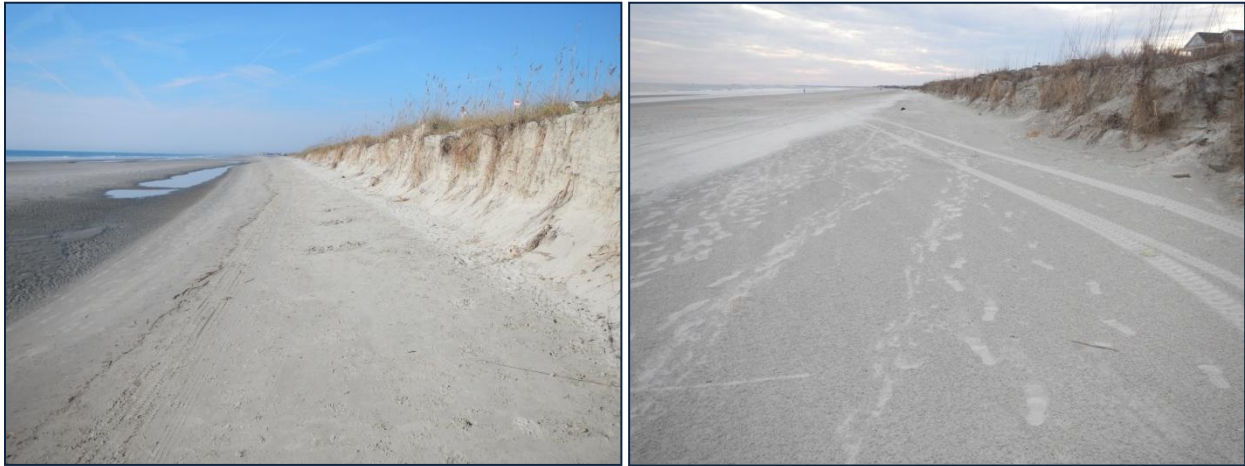
October 2013 (left) and January 2014 (right) images of station 50+00, looking west. This station gained 4.0 cy/ft between October and January, and the escarpment appears to be healing (note small buildup of sand at the base of the escarpment in the right image).

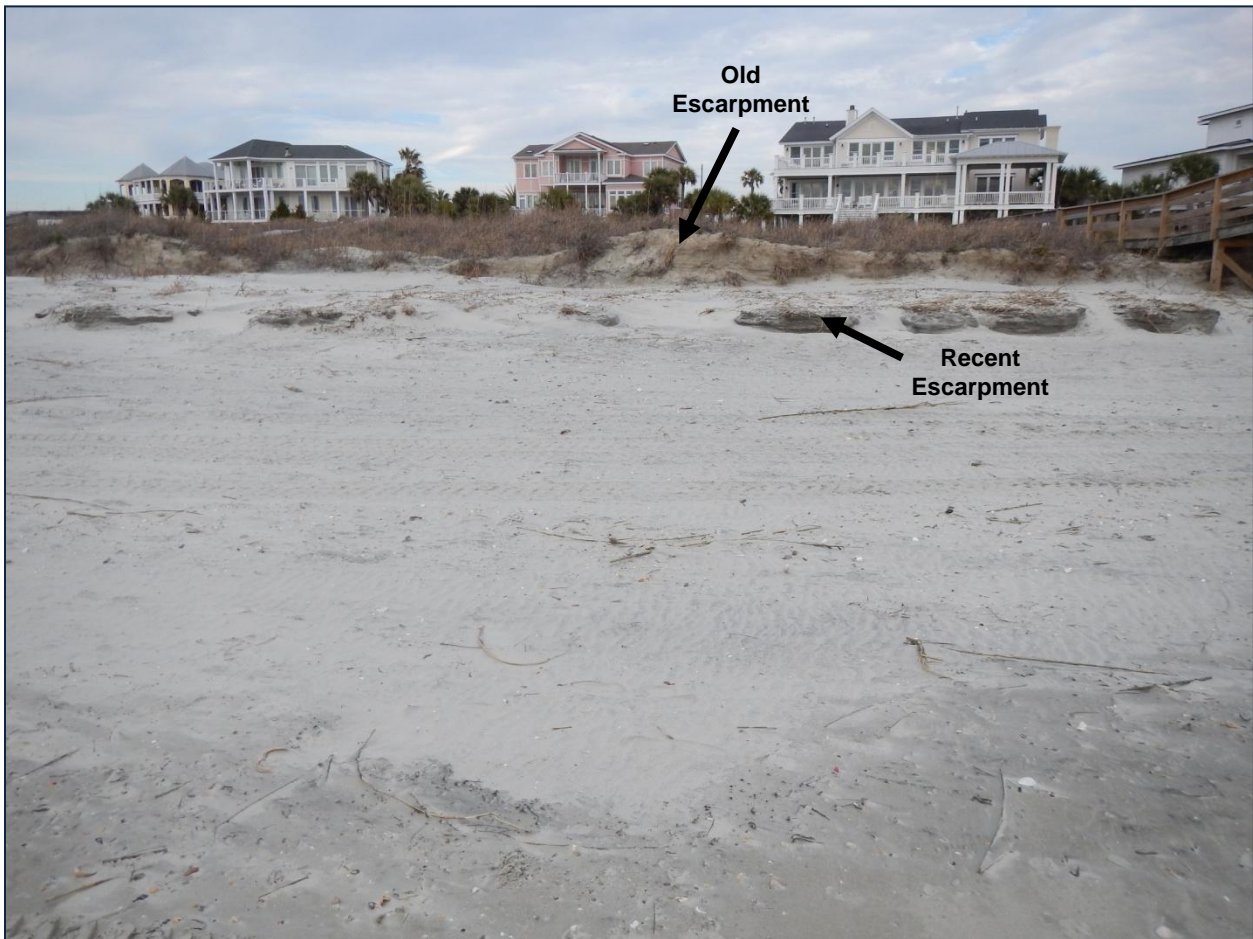
January 2014 image from station 4+00, looking landward. This area continues to rebuild following extensive erosion between 2011 and 2013. Note the older escarpment behind a more recent one, all fronted by a dry beach.
