Final Report

Shoal Management Project

ISLE OF PALMS (SC)

[CSE-2384-FR]

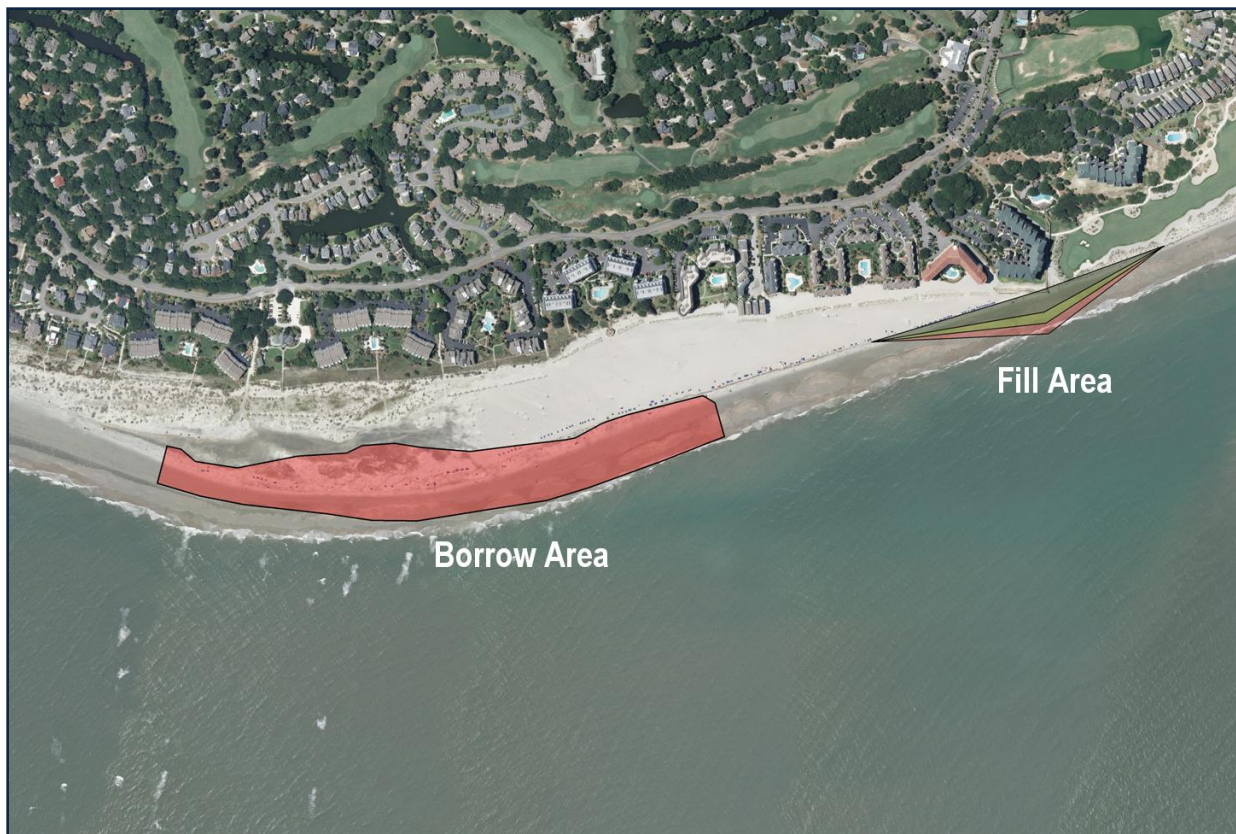
FIGURE 1. General project plan showing the borrow and fill areas. Aerial image (July 2011) courtesy IMC Inc (Charlotte NC).

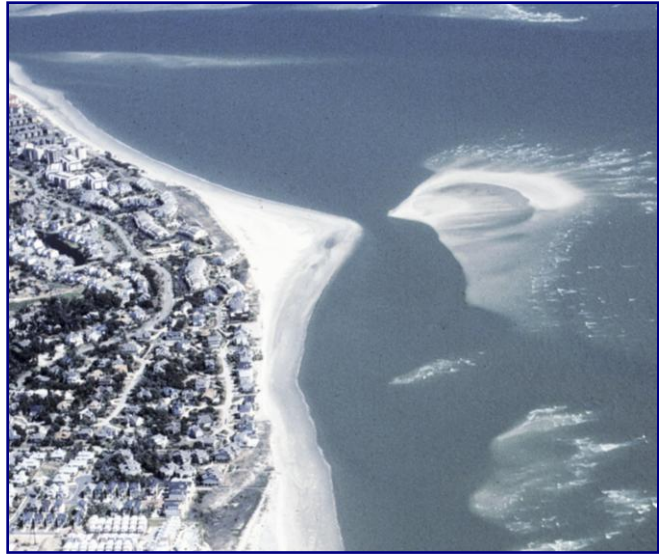
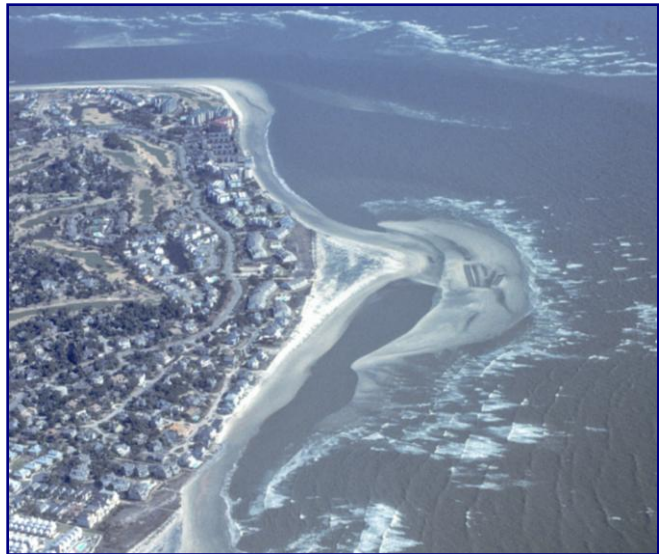
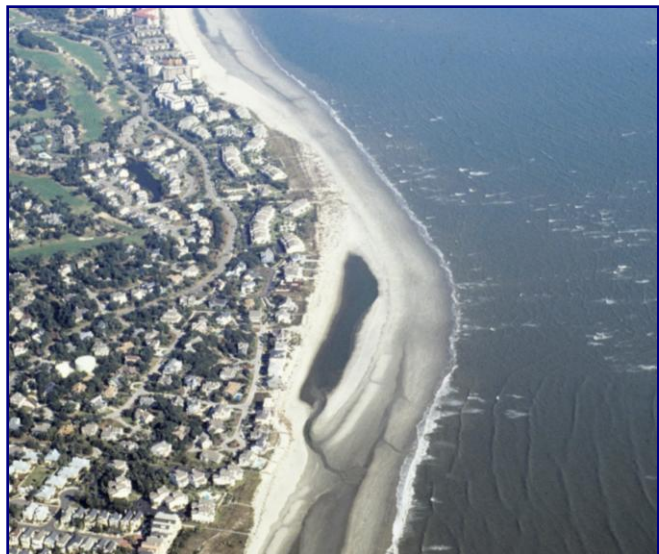
FIGURE 2.

Schematic of the shoal-bypass cycle originally modeled from a bypass event at IOP. During Stages 1 and 2 of the cycle, accretion in the lee of the shoal is accompanied by erosion on either side of the attachment site. (After Kana et al 1985)

Shoal-bypass event at the northeastern end of IOP. The upper photo shows a shoal in Stage 1 of the bypass cycle in March 1996. The middle image, taken in 1997, shows that the shoal is beginning to attach to the beach and is in Stage 2 of the bypass cycle. The lower image (from December 1998) shows the shoal completely attached (Stage 3), and sand has spread to previously eroded areas.

The morphology and shoreline evolution of the eastern end of Isle of Palms has been studied in detail since the 1980s (Kana & Dinnel 1980, ATM 2006). This area is heavily influenced by Dewees Inlet and the process of shoal bypassing (Fig 2)—which is when volumes of sand are released from the offshore shoals (ebb-tidal delta) of the inlet, then migrate and attach to the beach. Periodic shoal bypassing accounts for the historical accretion along Isle of Palms; however, it is also a cause of localized erosion in the vicinity of each bypassing event. The bypass cycle consists of three stages:

- Stage 1 is the emergence of an offshore shoal and its release from the ebb-tidal delta.
- Stage 2 is onshore migration and initial attachment of the shoal and accompanying response of the beach.
- Stage 3 is the merging of the shoal with the shoreline and spreading of the shoal sand to adjacent areas.

Stage 2 is generally the period of maximum erosion along the shoreline flanking the shoal. The cycle moves to Stage 3 when the shoal fully merges with the beach. Waves then drive sand away from the bulge and spread it alongshore. Gaudio and Kana (2001) found that bypassing events occur at the northeast end of Isle of Palms every ~6.6 years, on average (though the interval may be as short as two years or greater than ten years). Individual events can vary in size, adding from less than 100,000 cubic yards (cy) to well over 500,000 cy. The additions of sand near the downcoast limit of the ebb-tidal delta produce salients (ie – seaward bulges) at the attachment point. Accumulations of sand create the characteristic “drumstick” barrier-island shape with a wider upcoast end and a narrow spit at the downcoast end (Fig 3) (Hayes 1979).

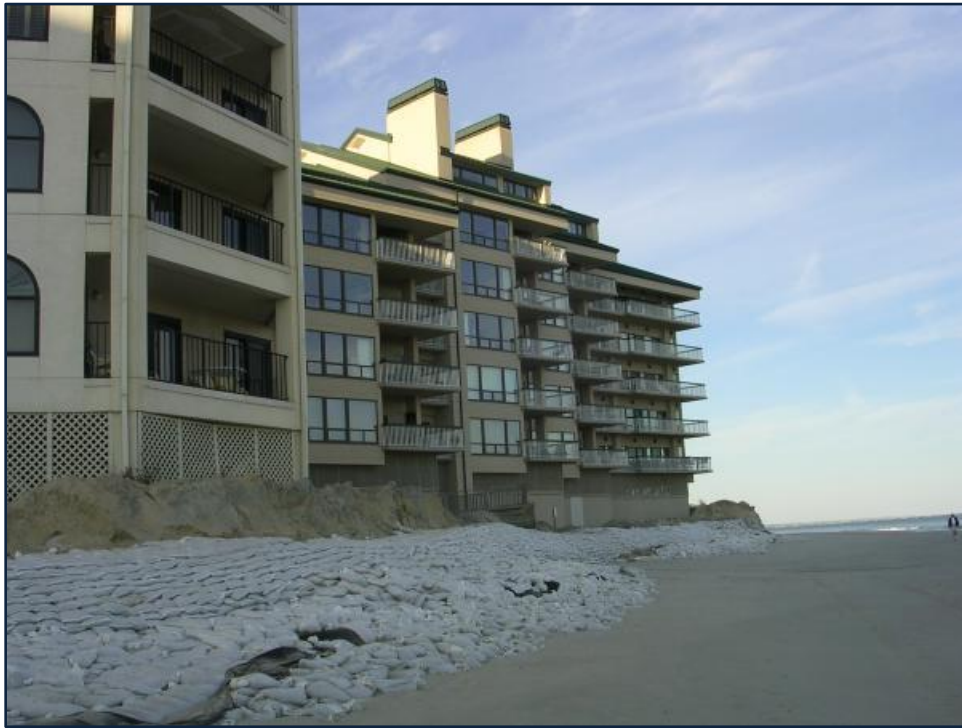
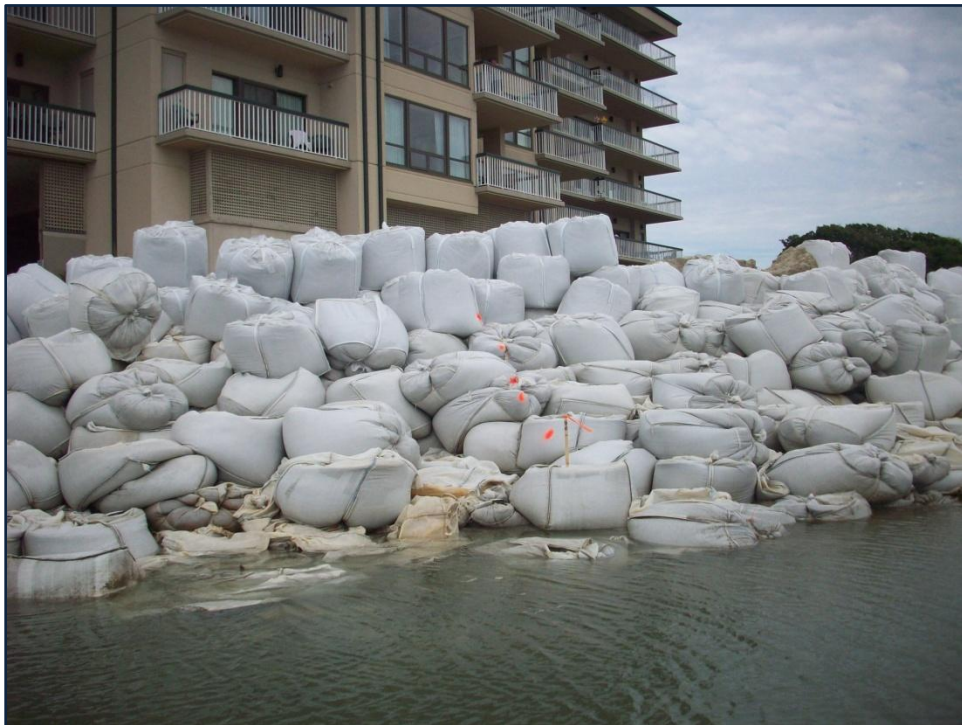
FIGURE 4. Small sandbags were placed in front of structures (upper); however, these quickly washed away, and large sandbags were placed on top of the remaining sandbags (lower).
[Upper photo from Coastal Carolina University BERM Program]

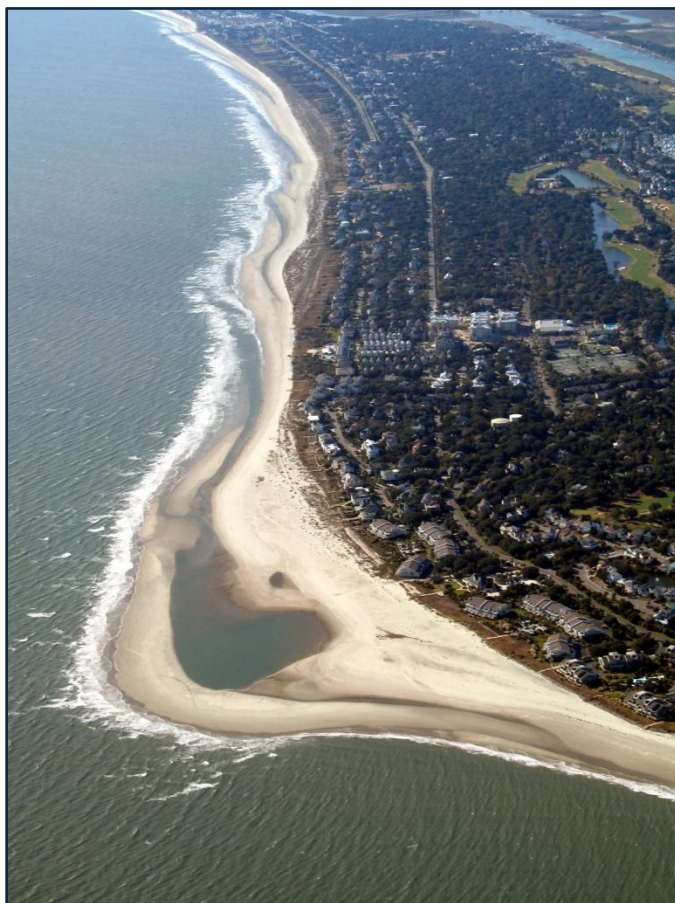
[LOWER] December 2007 image of Project Reach. Note how the shoal sand has merged with the beach, creating a temporary lagoon feature.

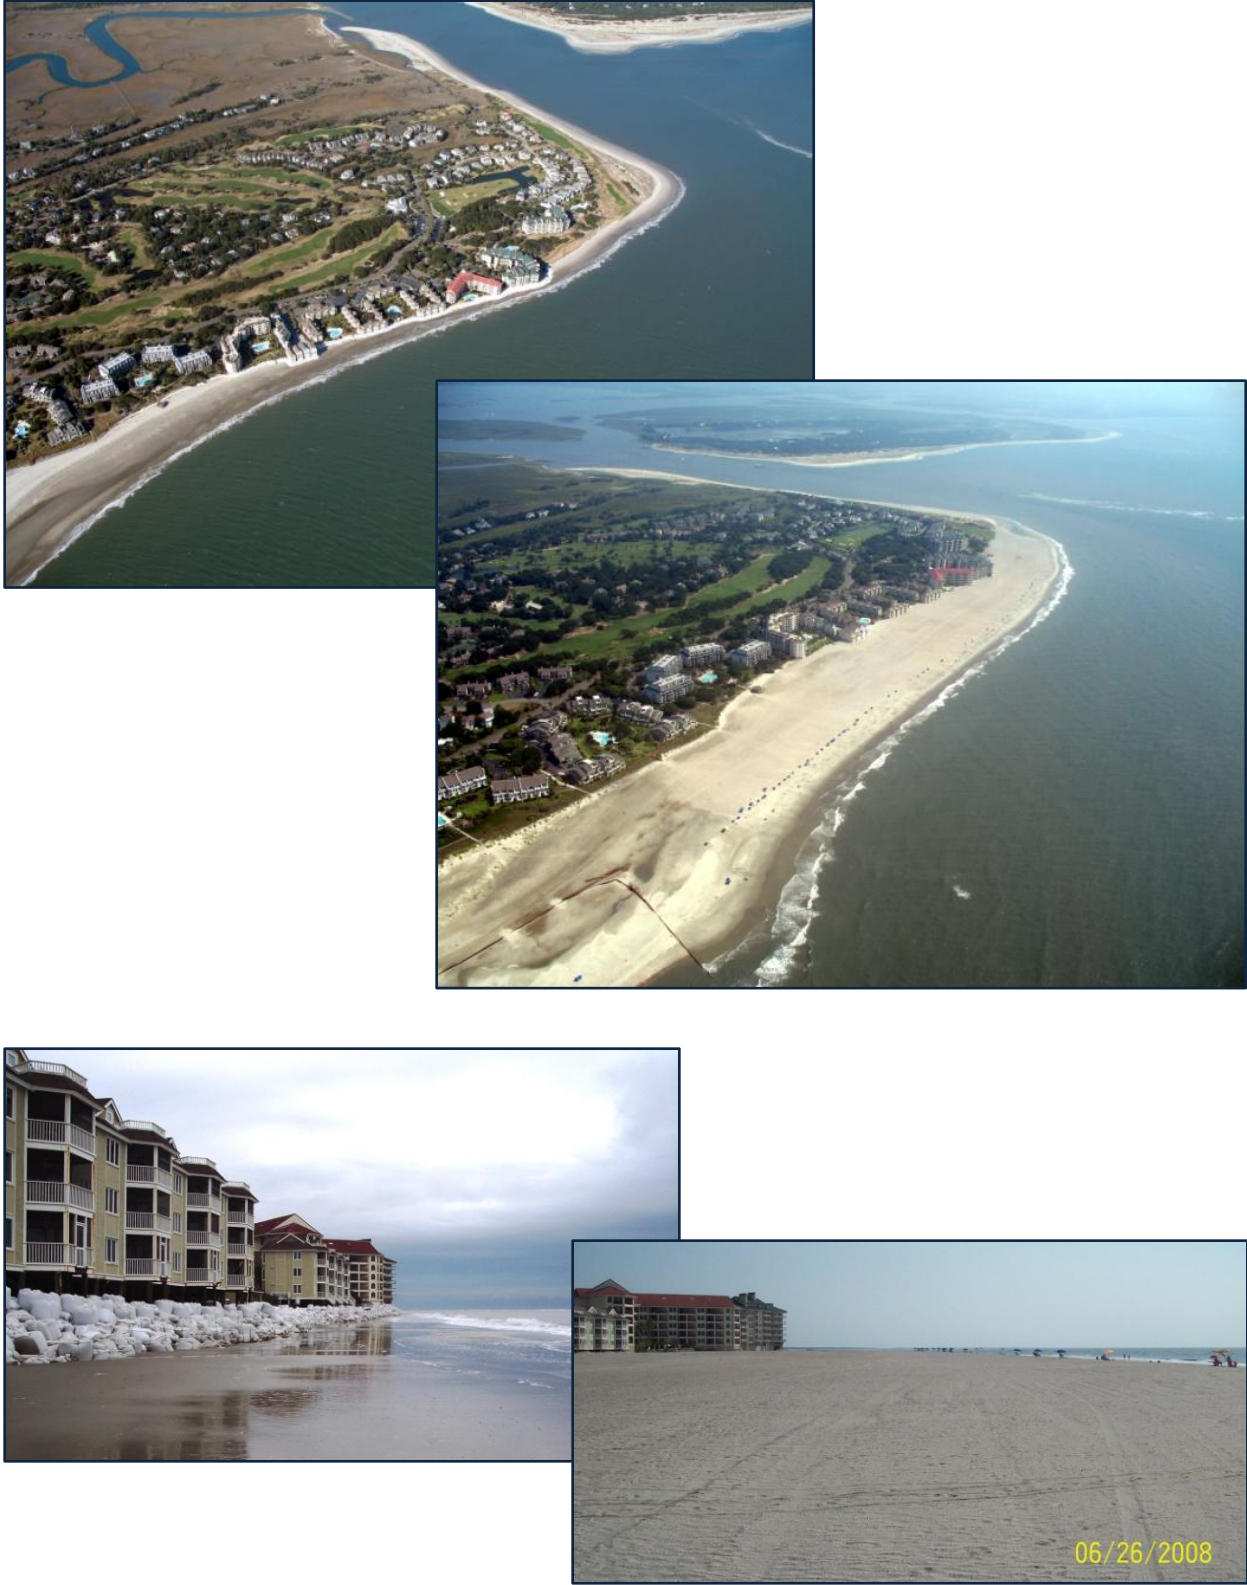
FIGURE 7. Aerial and ground photos of Reach B of the project area before (left images) and after (right images) nourishment. Over 550,000 cy of sand were added to the area, widening the beach by over 300 ft. The northern end of this reach has been an erosional hot spot since the project and is the general location of the current shoal-management project.

The City took the lead in implementing a restoration project which placed ~847,400 cy via hydraulic dredge in three reaches between 53rd Avenue and the 17th hole of the Links Course. The sources of borrow sand were several areas 2–3 miles from the beach (Fig 6). The project was completed over a period of 33 working days from 24 May 2008 through 25 June 2008 (CSE 2008). As part of the project, accessible sandbags were removed and discarded. The measured placed volume was 933,985 cy, a difference of ~10 percent from the design quantity. The difference was not a pay quantity. Average fill volumes were ~75 cubic yards per foot (cy/ft) in Reach A, ~104–180 cy/ft in Reach B, and ~27 cy/ft in Reach C. Nourishment increased the beach width by over 300 feet (ft) in some places (Fig 7).

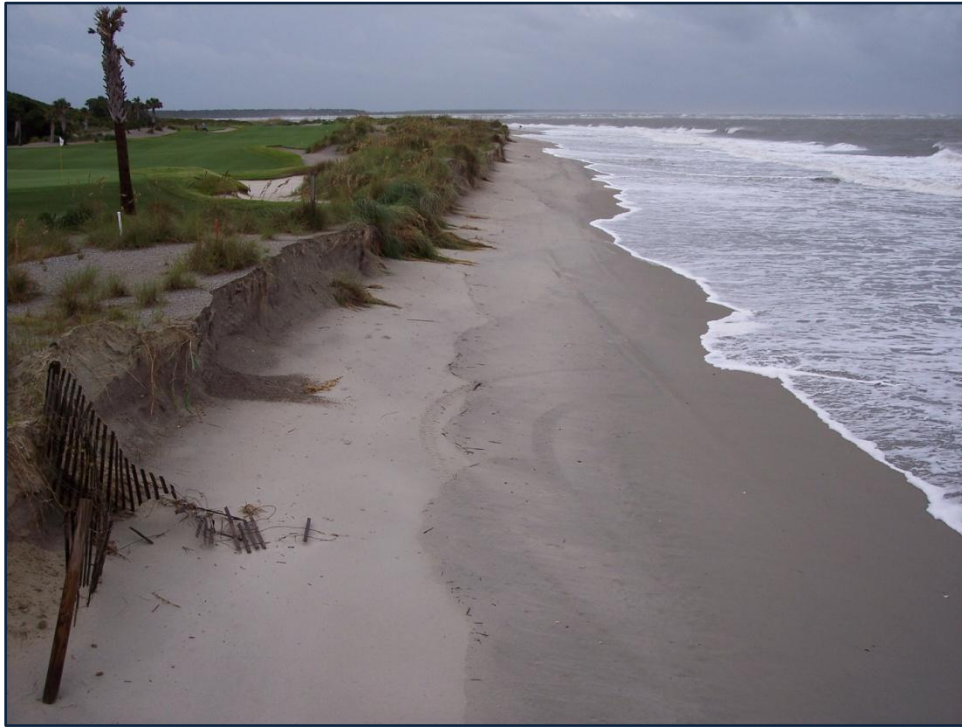
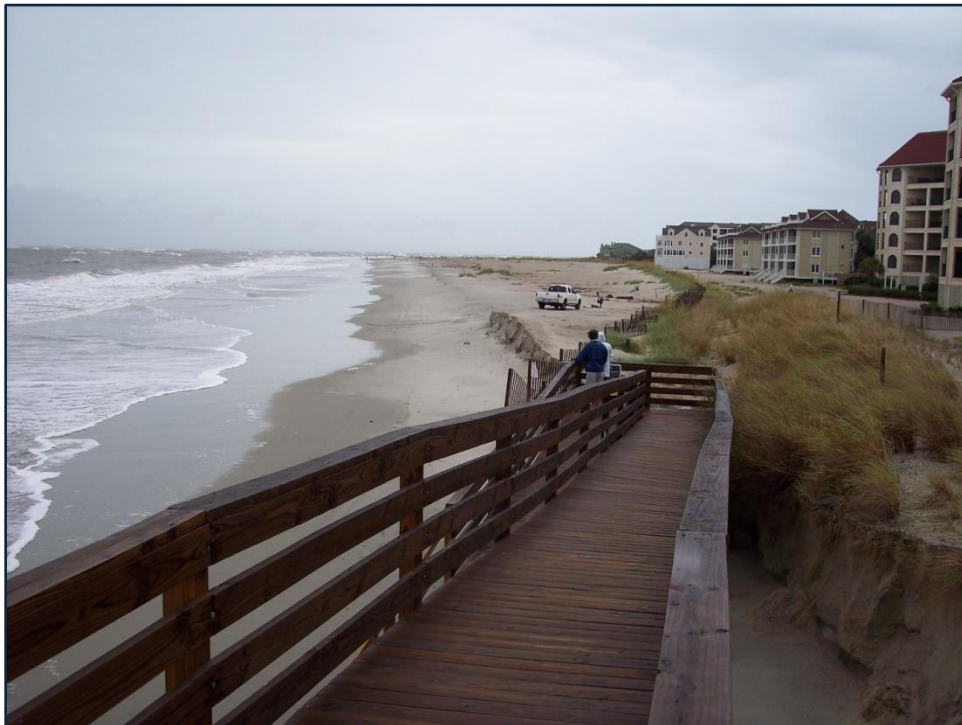
FIGURE 9. Condition of the shoal-management project fill area in August 2011 during Hurricane *Irene*, which passed offshore of South Carolina but produced significant wind and waves at Isle of Palms.

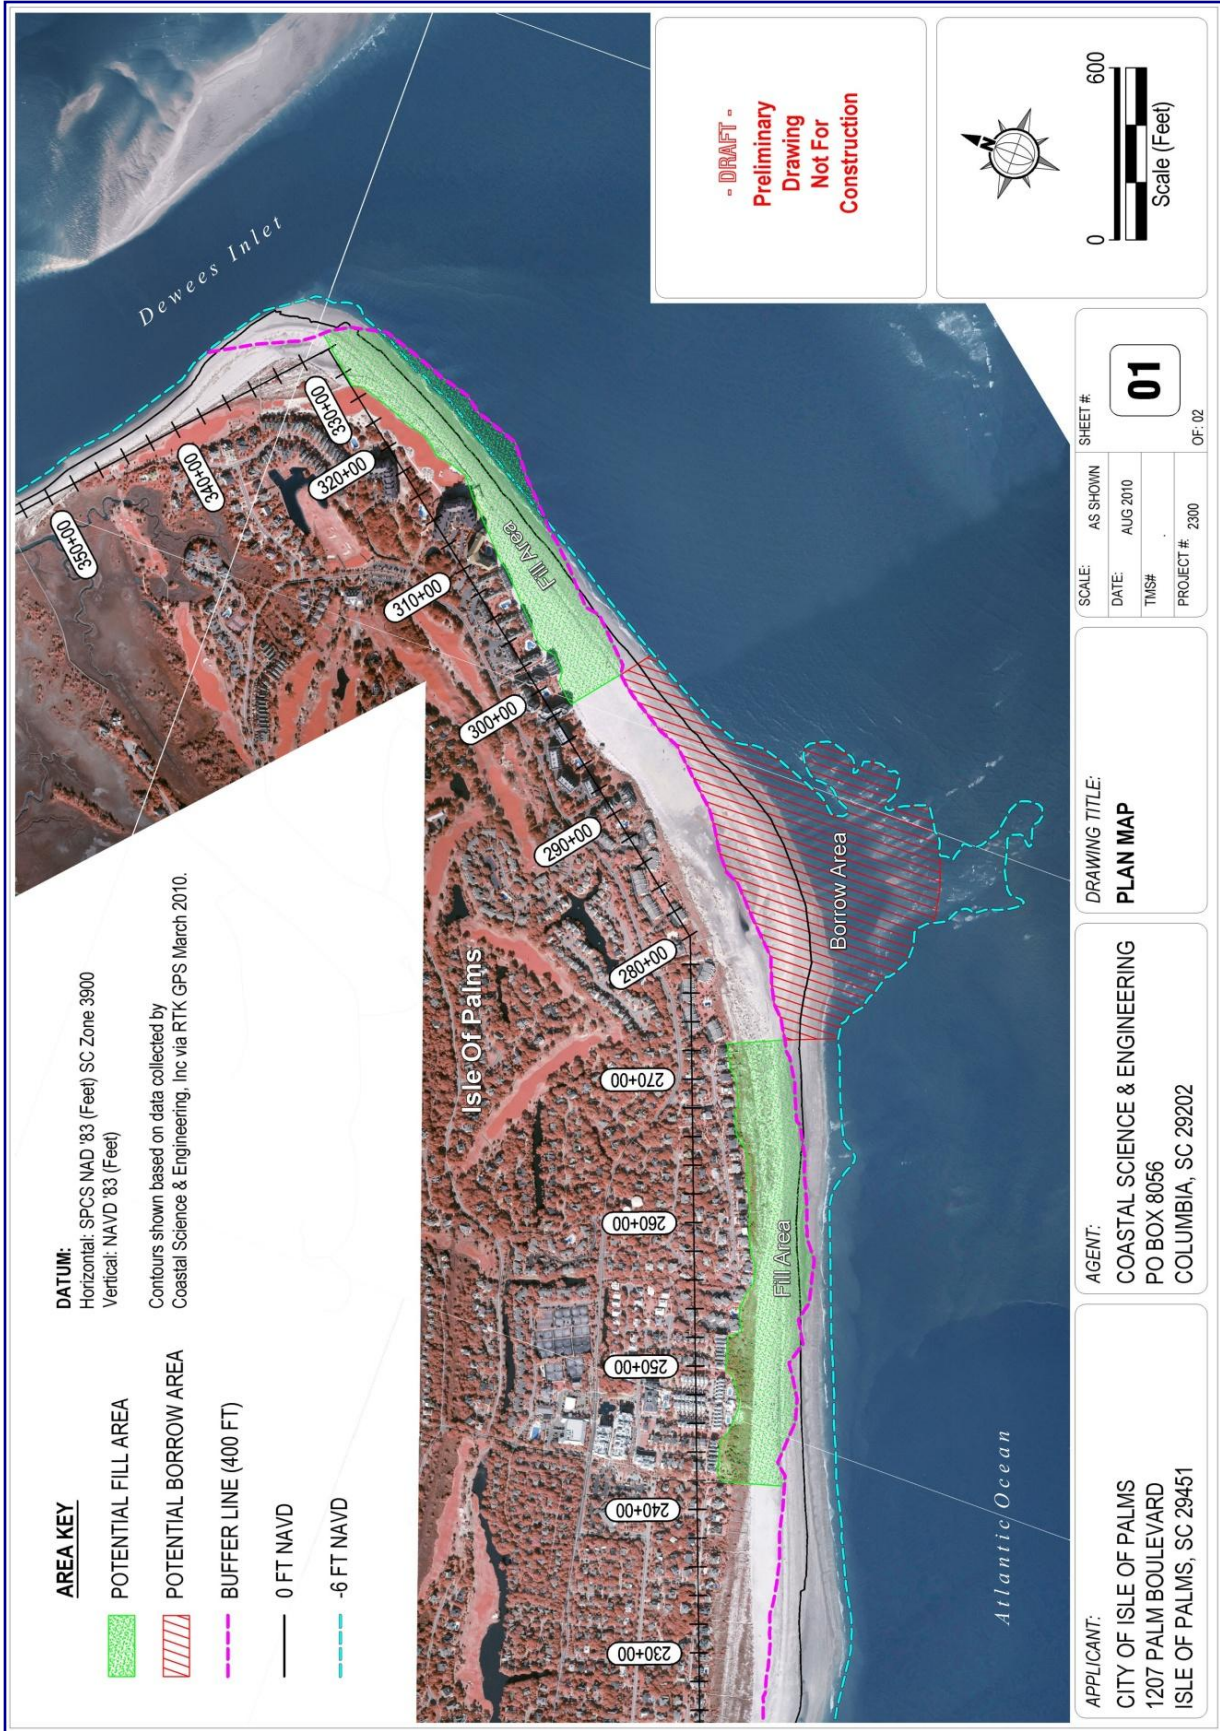
FIGURE 11. Permit drawing showing a potential scenario for a shoal-management project. Sand would be taken from an accreting area and placed in an eroded area. Under the permit, sand may be excavated or placed anywhere between 53rd Avenue and the groin along Dewees Inlet. [Note: This was not the final design for the project.]

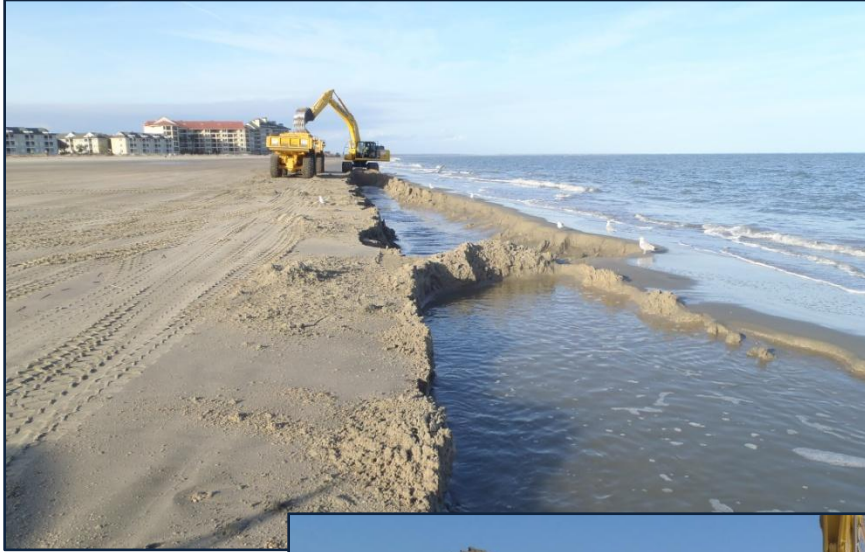
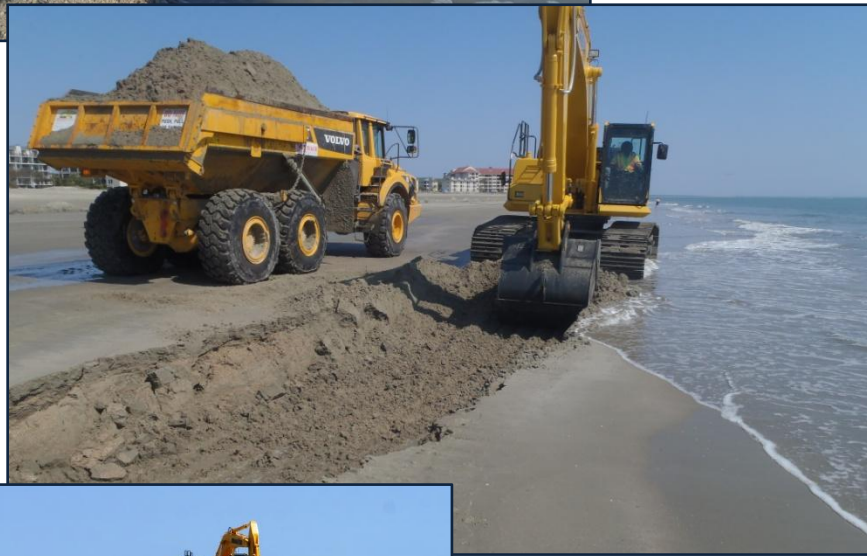
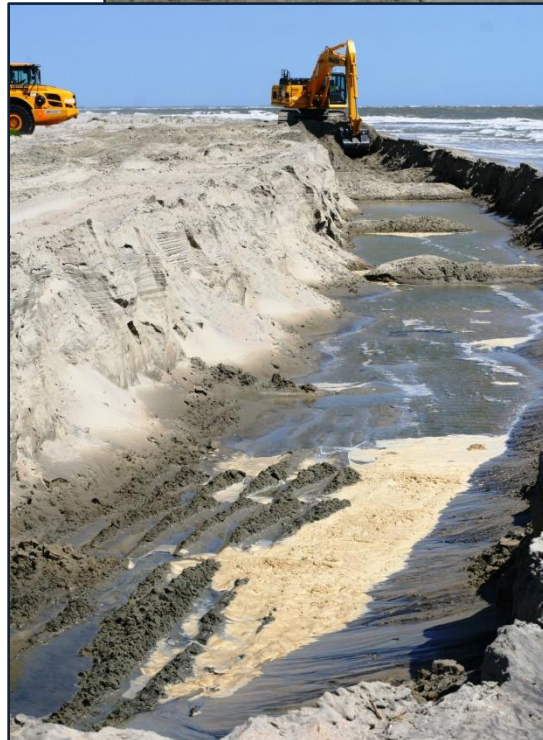
FIGURE 13.

Construction photos of the project in March 2012.

Excavated holes would infill during the ensuing high tide. Once the excavator moved out of an area, beachgoers were able to re-occupy the site.

Figures 13–15 show construction activities. The contractor mobilized two Volvo A25 and one Volvo A30 off-road dump trucks, one Komatsu 360 excavator, and one Komatsu 61px dozer to the site. Excavations began the morning of 12 March 2012. The work was accomplished by excavating rows of beach ~10 ft wide by ~150 ft long and ~3 ft deep. Excavations occurred near the waterline, following it out during falling tide and back in during a rising tide. Work ceased during high tide so all holes would infill. The excavator moved parallel to the beach from the south end of the borrow site to the north end, then moved back to the south end. This method allowed room for the trucks to maneuver between the excavated holes.

Loaded trucks drove along the wet-sand beach to the fill area, where they dumped piles in a line along the length of the fill area (sometimes placing more sand in a given area to meet the design template). The contractor chose to leave the piles overnight, allowing the high tides to erode and redistribute the sand in a natural profile. Occasionally, accumulated sand piles would be bulldozed to the design elevation (+6 ft NAVD) according to the plans. This strategy allowed the contractor to minimize equipment time and still produce a natural beach slope. Work progressed in this manner for the duration of the project.

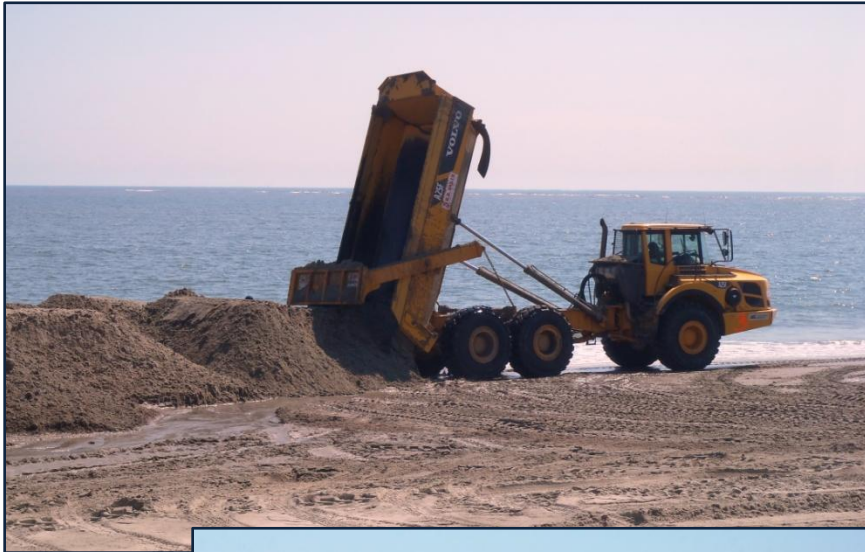
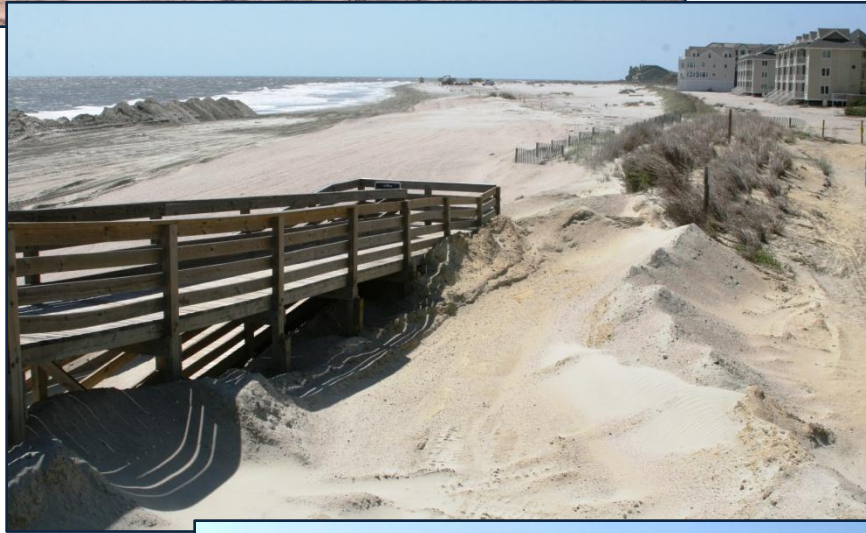
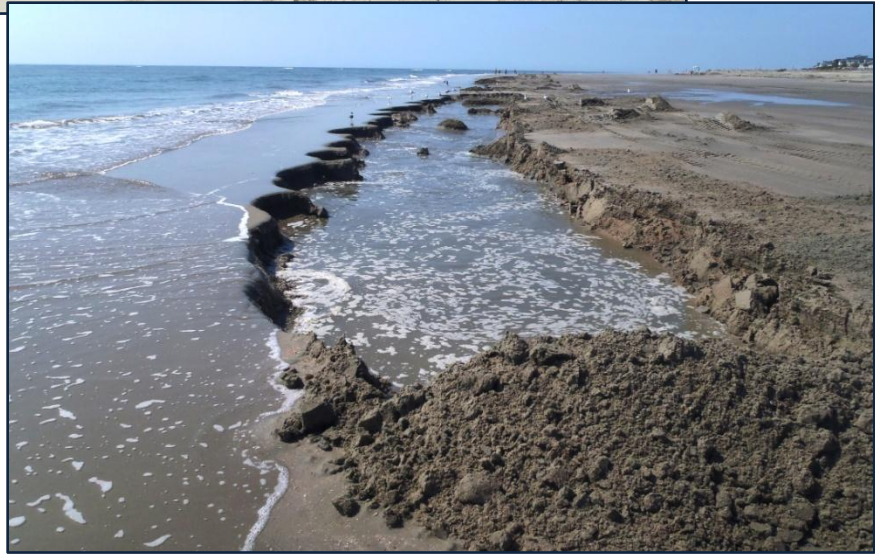
FIGURE 14. Construction photos of the project in March 2012.

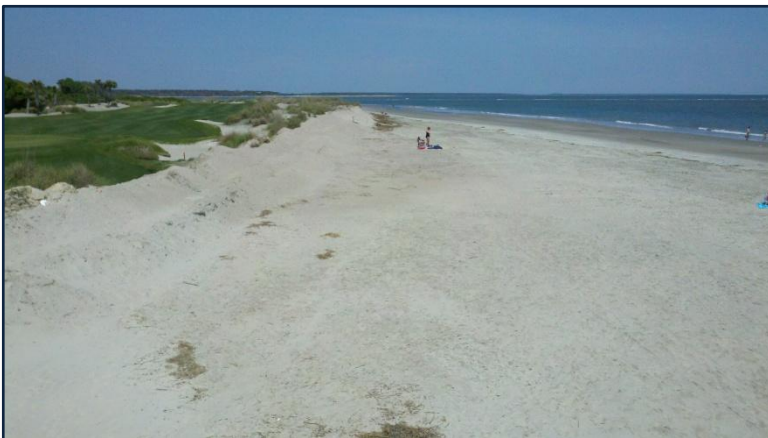
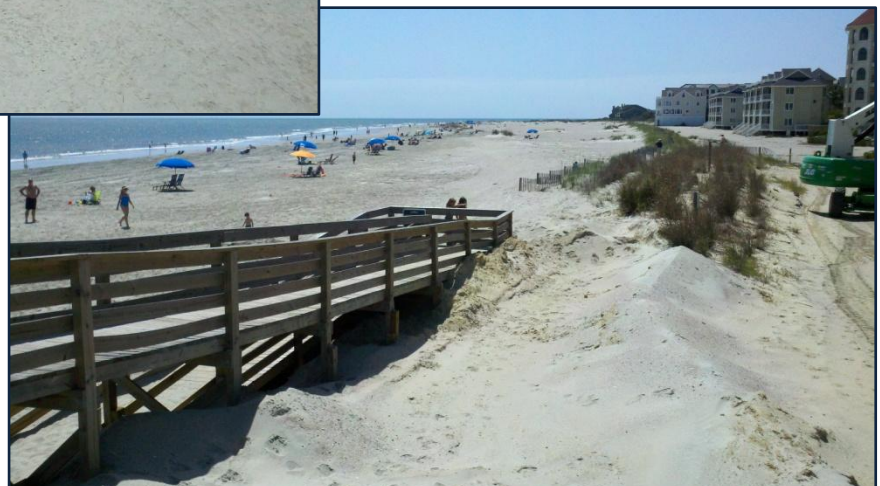
FIGURE 16.

Images of the completed fill area on 10 April 2012.

Payment quantity was determined by multiplying the total number of loads for each truck by that truck’s haul volume. Work was completed over 21 working days between 12 March and 10 April 2012. **The volume moved was 87,763 cy for a total price of \$245,019.35** (60,000 cy at the base price of \$2.95/cy and 27,763 at the alternate price of \$2.45/cy). On average, 4,179 cy were transported per day by the contractor. Table 3 summarizes daily loads/volumes for the project. Figure 16 shows photos of the completed fill area.

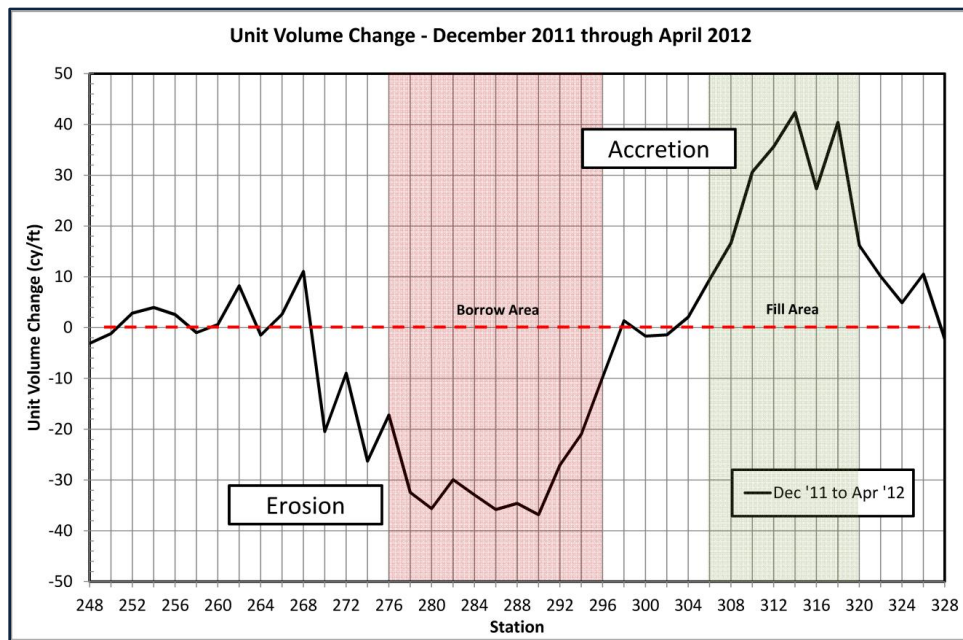
FIGURE 18. Unit volume change between December 2011 (pre-nourishment) and April 2012 (post-nourishment). The borrow area is highlighted in red and the fill in green. These values include background erosion and accretion between the two surveys.

Between December 2011 and April 2012, the fill area showed a net gain of 41,171 cy within the fill limits and a gain of 48,883 including nearby stations (which likely received sand that spread from the fill area). The difference between this gain and the payment quantity (a difference of 38,880 cy) is the background erosion between December 2011 and April 2012 and volume loss due to compaction of hauled sand. This area lost ~17,000 cy between June and December 2011; and is assumed to have a greater background erosion rate between December 2011 and April 2012 based on limited profile data collected and visual observations at the beginning of the project (for example, station 304 was stable from June to December 2011, but lost ~2,660 cy from December 2011 to March 2012, calculated to -6 ft NAVD). Unit volumes in the fill area increased by up to 40 cy/ft (Fig 18).

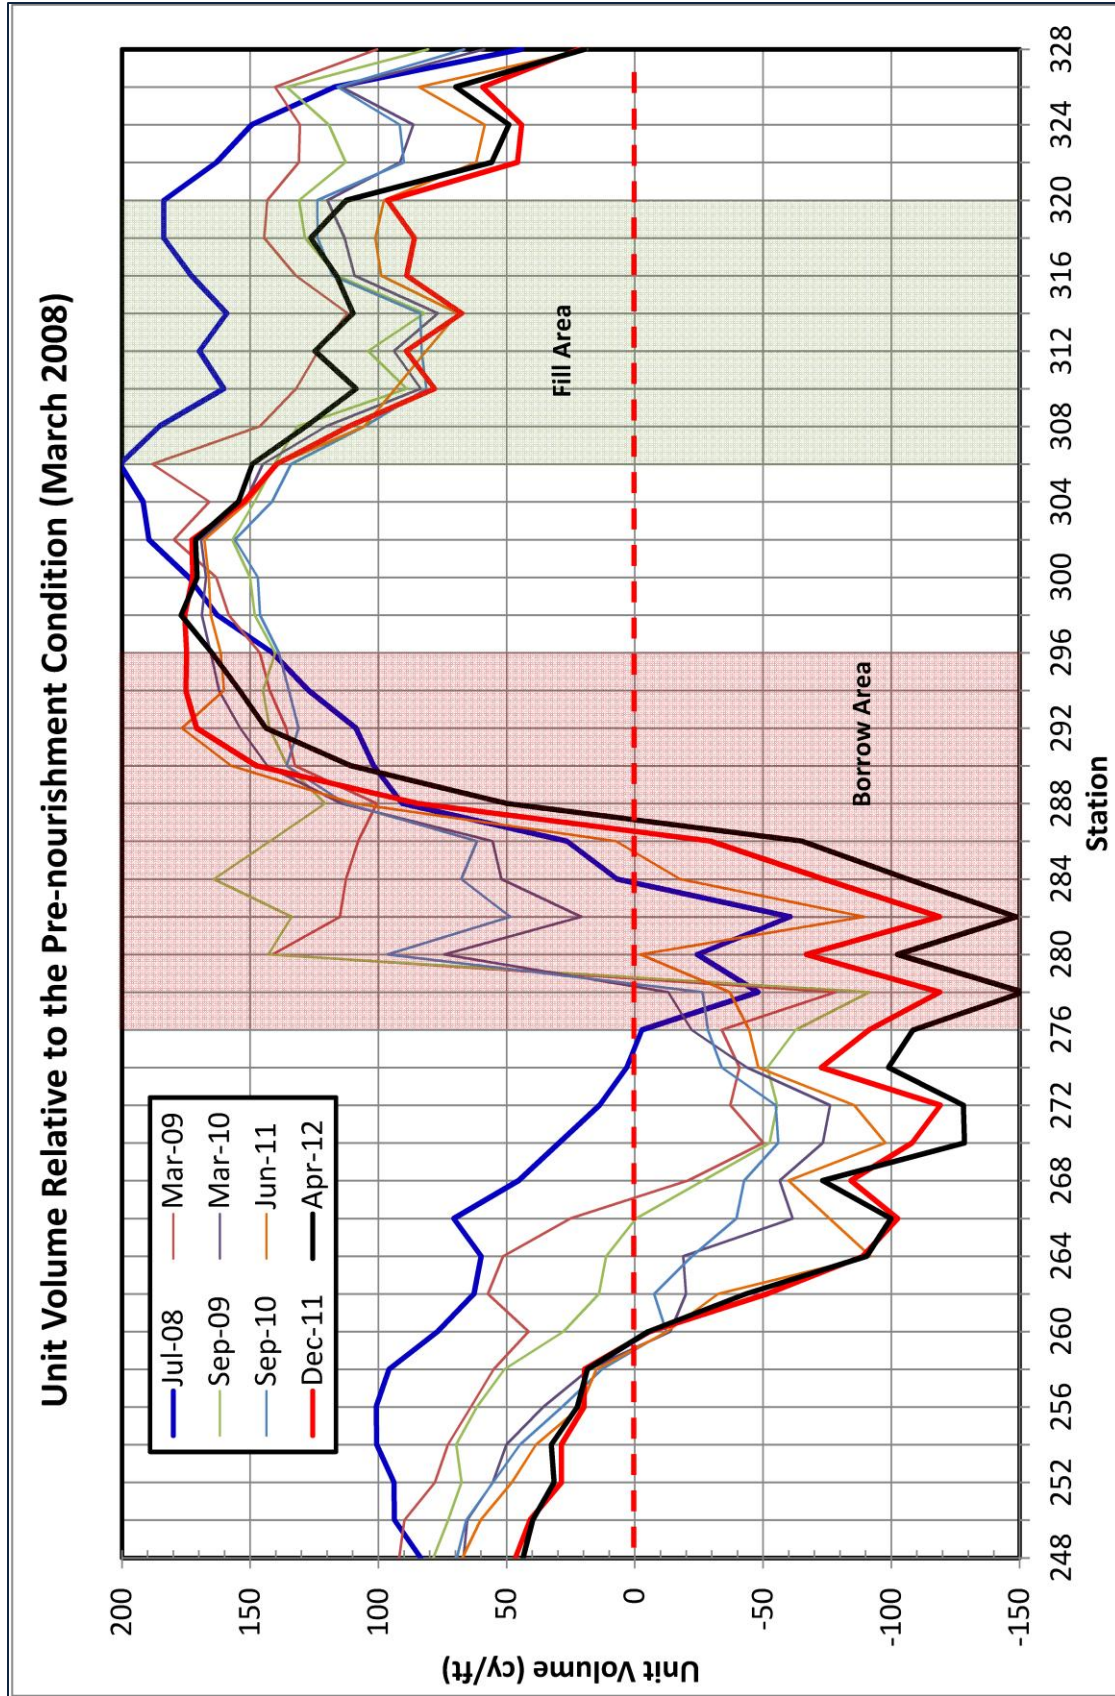
FIGURE 19. Unit volume (to -10 ft MAVD) relative to the beach condition prior to the 2008 project. Positive values represent a healthier beach than the March 2008 condition. The difference between the red and black lines represents the project change (and background change). The difference between the blue and black lines represents the current condition compared to the post-nourishment condition.

Compared to the March 2008 condition (pre-nourishment), the southern half of the borrow area shows significant erosion while the northern half has an equal amount of accretion (Fig 19). Despite the shoal management project, which produced a volume loss up to ~35 cy/ft in the borrow area, the northern half shows a net accretion of 50-150 cy/ft compared to March 2008. The southern half has been steadily eroding following the shoal attachment in 2007, though there still is a wide protective berm/dune area between the water and structures. Currently, the beach between station 260+00 and station 286+00 (2,600 linear ft from Beachwood East to Beach Club Villas II) shows less volume than the pre-nourishment condition (red dotted line in Fig 19). The beach between stations 290+00 and 320+00 (Mariners Walk to the 18th fairway) retains at least 100 cy/ft more sand than the pre-nourishment (March 2008) condition (measured to the -10-ft NAVD contour).

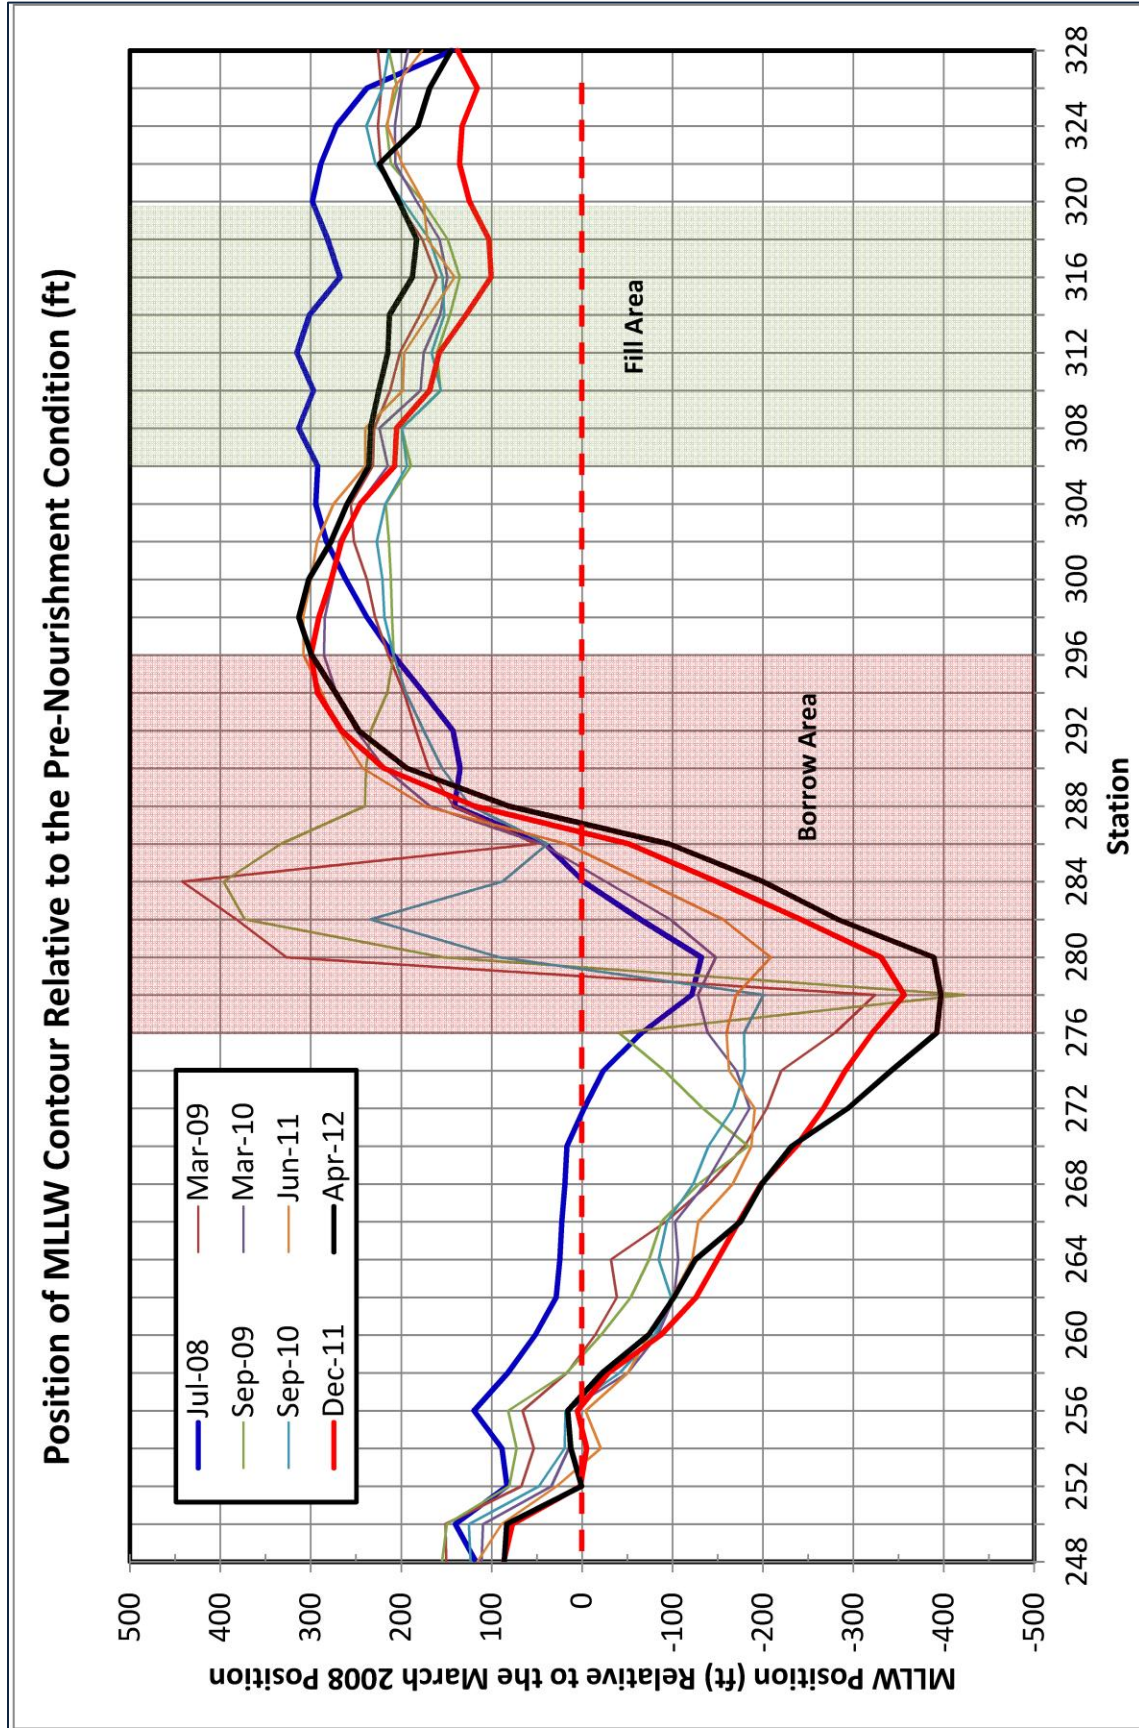
FIGURE 20. Position of the -3.1-ft NAVD contour (mean lower low water line) compared to the March 2008 (pre-nourishment) condition. Positive values indicate seaward movement of the contour.

For a simple beach condition assessment tool, the position of the mean lower low water (MLLW) contour (-3.1 ft NAVD) is plotted in Figure 20 compared to the March 2008 (pre-nourishment) condition. When the lines fall above zero (red dotted line), the shoreline is further seaward than it was in March 2008. When the line is below zero, erosion has occurred. Generally, stations south of 288+00 (Mariners Walk) show landward retreat of the MLLW contour up to 400 ft near the Wild Dunes Property Owners Beach House. Between December 2011 (red line) and April 2012 (black line), the MLLW contour receded up to 70 ft, averaging 37 ft. In the fill area, the MLLW contour was 100 ft seaward of the pre-nourishment position as of December 2011. After the shoal management project, the contour moved up to 90 ft seaward, returning it to near the March 2009 position.

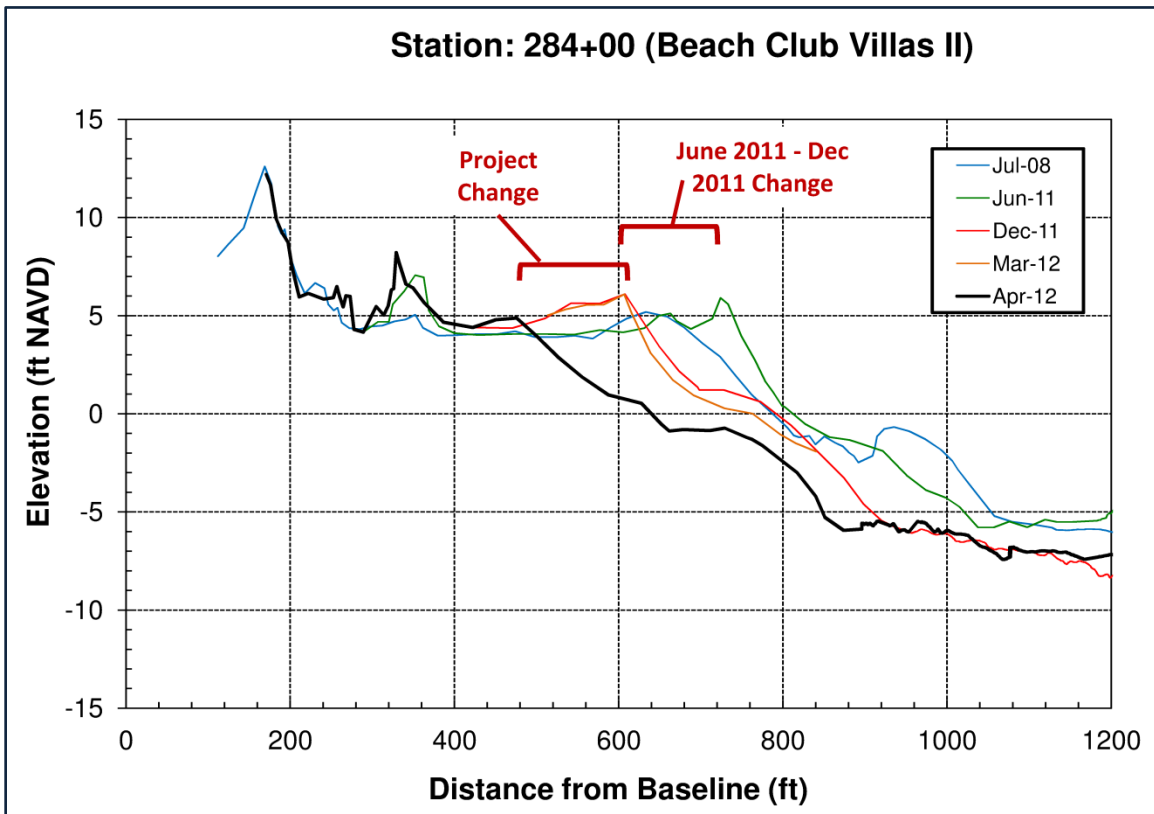
FIGURE 21. Profiles from station 284 near Beach Club Villas II. The upper plot shows the active beach area and recession of the berm crest ~130 ft from December 2011 to April 2012. The lower plot shows the offshore shoal migrating toward the beach at a rate of over 500 ft per year.

Profiles from station 284+00 (Beach Club Villas II) in the borrow area are shown in Figure 21 (upper). On the upper plot, the beach area is shown to have eroded ~115 ft between June and December 2011. During the project, the beach eroded ~130 ft. While the shoreline change was slightly greater during the project window (December–April), the net volume loss was actually greater during the earlier window (June–December). The June–December 2011 period showed a unit volume loss of ~56 cy/ft, while the December 2011 to April 2012 period only lost ~33 cy/ft of sand. CSE believes the beach between Beach Club Villas II and Summer House is beginning to respond to the offshore shoal, which is approaching Stage 2 of the bypass cycle (see Fig 2). This portion of the beach is in the lee of the oncoming shoal, and should show higher rates of accretion as the shoal gets closer to shore over the next year or two. The shoal migrated ~250 ft landward from December 2011 to April 2012 and is currently ~1,500 ft from the beach at this profile (Fig 21, lower).
