**2008 BEACH RESTORATION PROJECT  
ISLE OF PALMS SOUTH CAROLINA**

**Monitoring Report No 4  
November 2012**

## YEAR 4 MONITORING REPORT

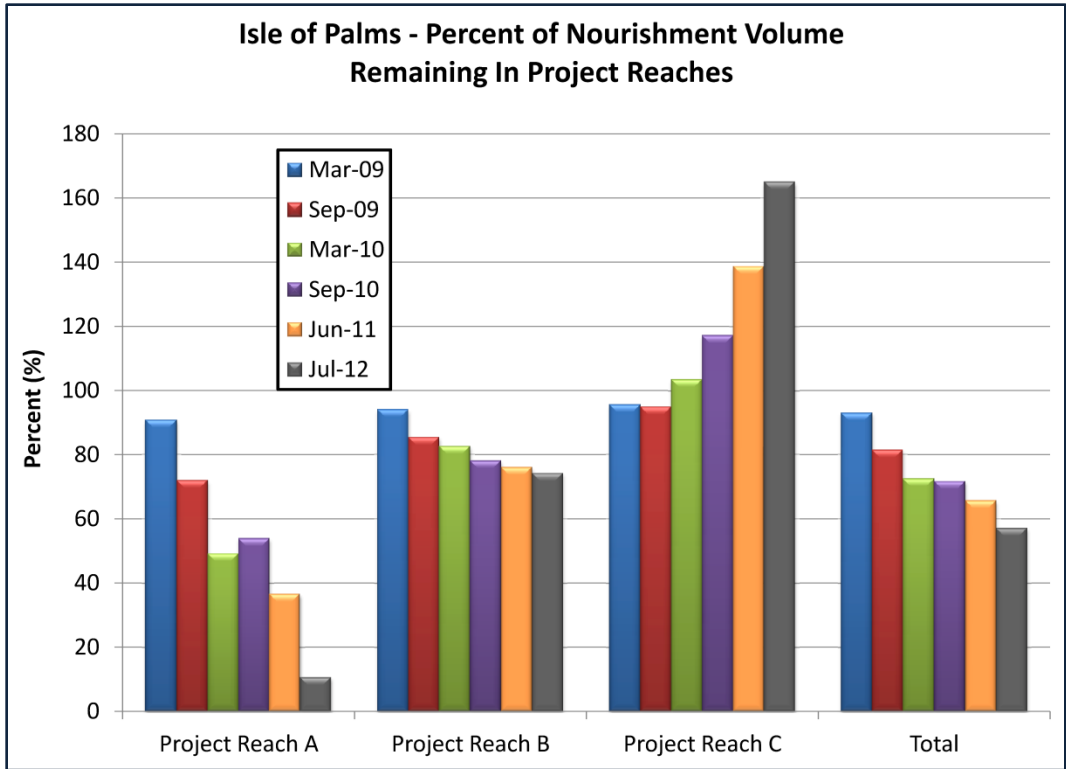
FIGURE A. Percent of nourishment volume remaining in project areas as of July 2012.

- Reach A (53<sup>rd</sup> Avenue to Beach Club Villas) retained ~10.7 percent of the nourishment volume. Erosion has been mostly restricted to the eastern third of the reach, which presently has less sand than the post-nourishment condition. The western two-thirds of the reach from 53<sup>rd</sup> Ave to Beachwood East retain 71.3 percent of the nourishment volume.
- Reach B (Mariners Walk Villas to the 18<sup>th</sup> fairway of Wild Dunes Links Course) retained ~74.3 percent of the nourishment volume.
- Reach C (a 1,000-foot length of Dewees Inlet shoreline adjacent to the 17<sup>th</sup> hole and 18<sup>th</sup> tee of the Wild Dunes Links Course) retained ~165.0 percent of the nourishment volume (Fig A).

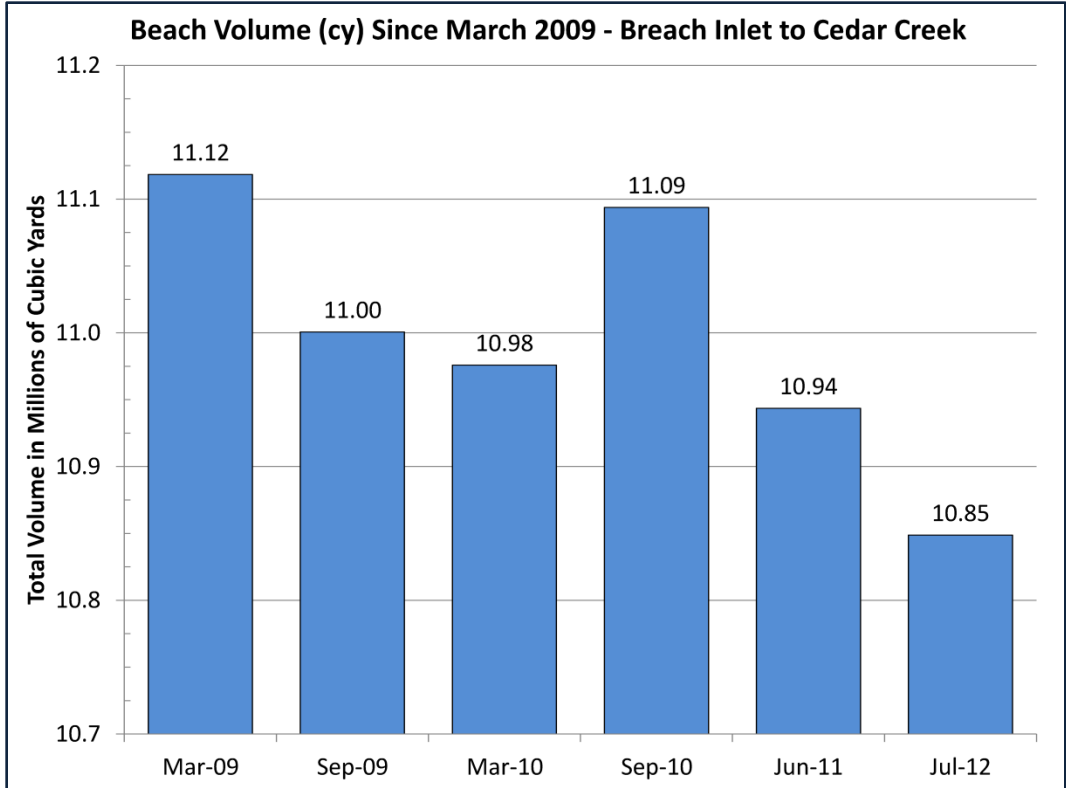
FIGURE B. Total beach volume at Isle of Palms from March 2009 to July 2012. Volume is measured to local closure depth (between -10 ft and -18 ft NAVD).

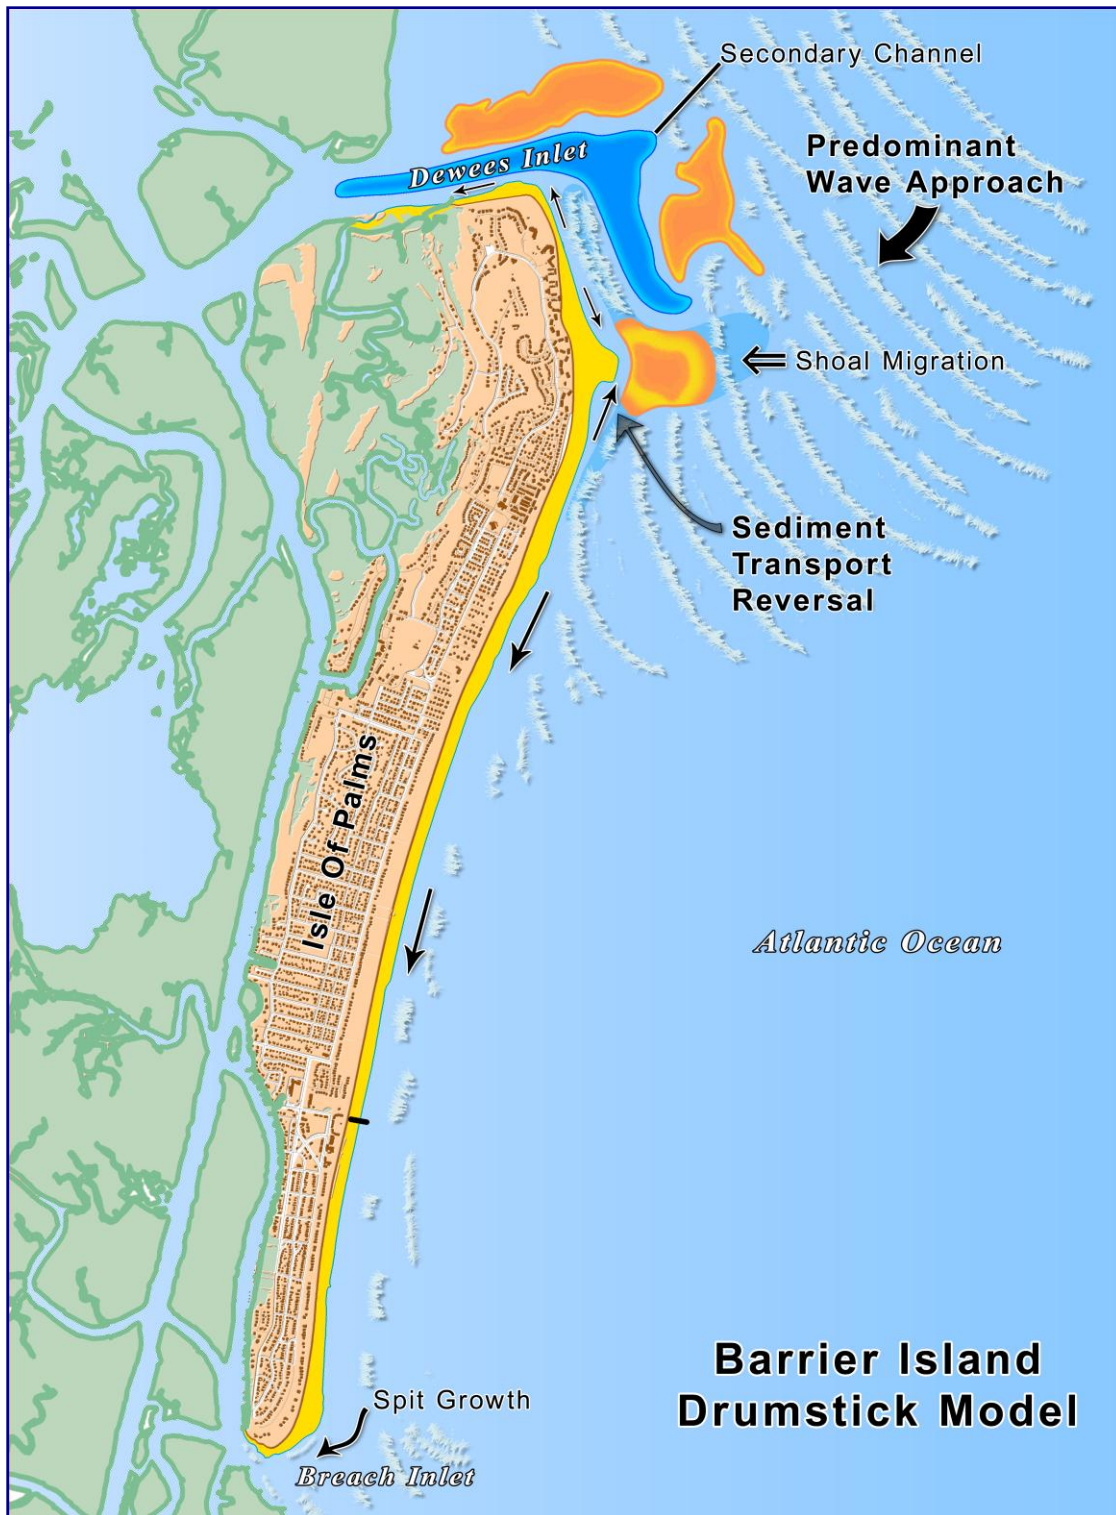
**FIGURE 1.1.** Isle of Palms is a typical “drumstick” barrier island (after Hayes 1979), where the upcoast end is wider due to sediment accumulation through shoal-bypass events, and the downcoast end usually forms a growing recurve spit. Other examples of drumstick barrier islands along South Carolina are Bull Island, Kiawah Island, and Fripp Island. Zones of sediment transport reversal generally occur in the lee of delta shoals which are situated offshore. Upon shoal attachment to the beach, transport directions in the vicinity of the shoal switch, spreading sand away from the attachment point (see for example — Fig 1.2).

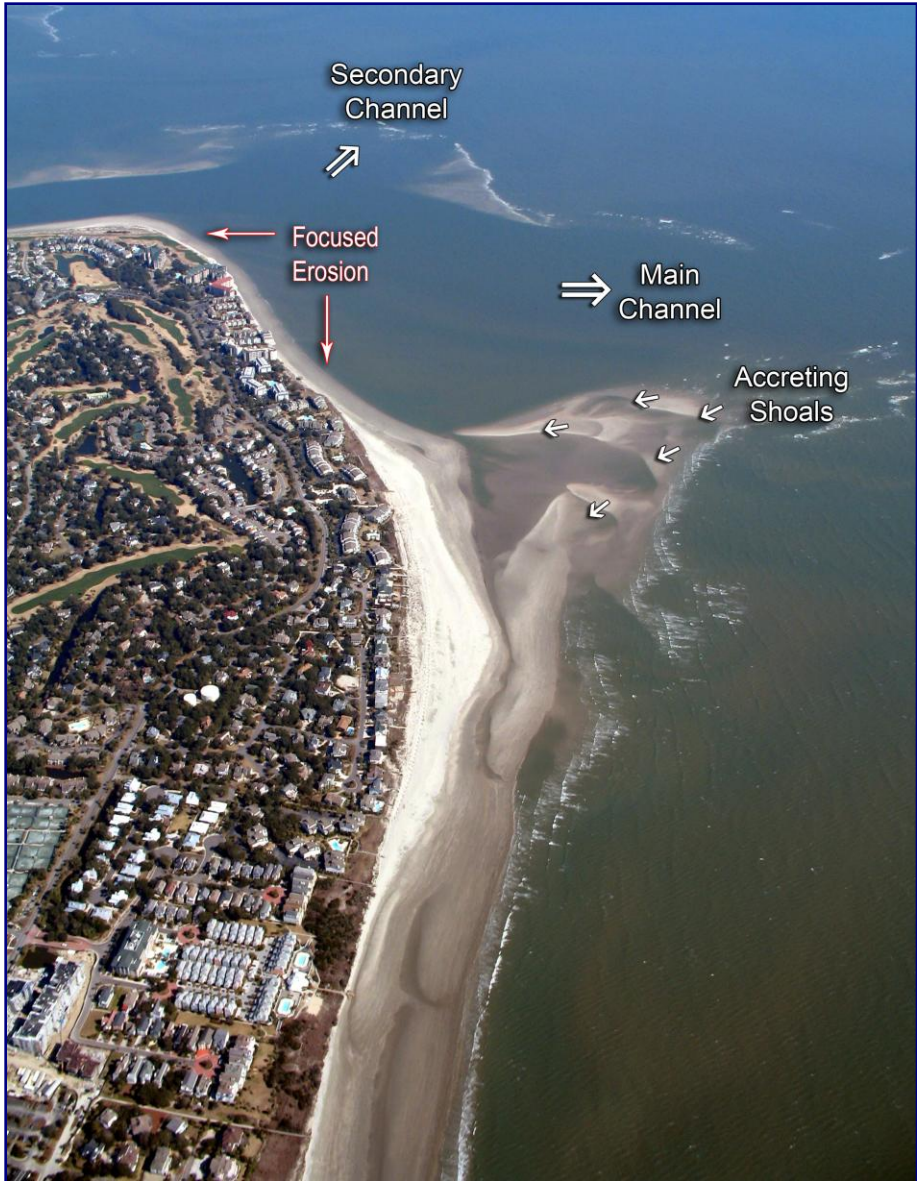
**FIGURE 1.3.**

Prior to the 2008 project, little to no beach was present at low tide near the Ocean Club condominiums.

Prior to nourishment in June 2008, most of Reach 6 was severely eroded with profile volumes seaward of development well below an ideal condition. Property owners had piled sand bags against buildings for protection, and little or no dry beach was present (see Fig 1.3). The condition was beginning to improve just before the nourishment as the shoal attaching at the western end of the reach was in Stage 3 of the bypass cycle. Sand was moving from the shoal toward Dewees Inlet, but not quickly enough to restore the beach along most properties north of the Wild Dunes Property Owners Beach House.

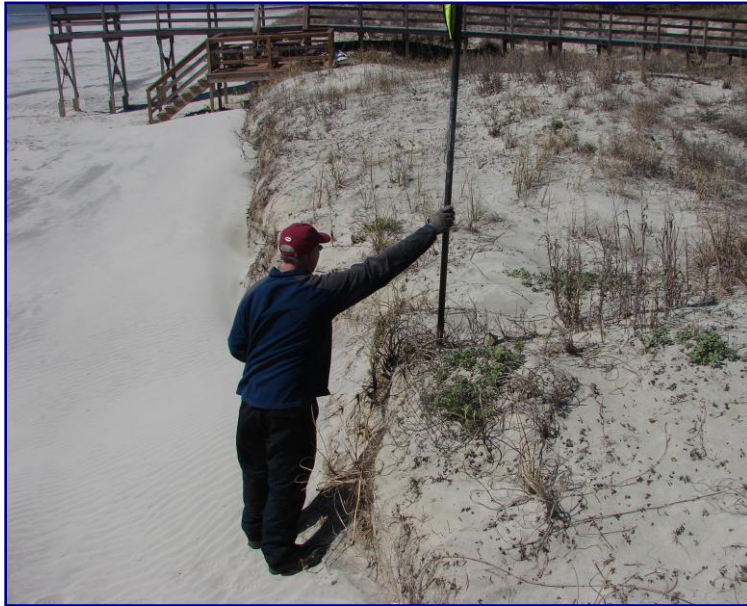
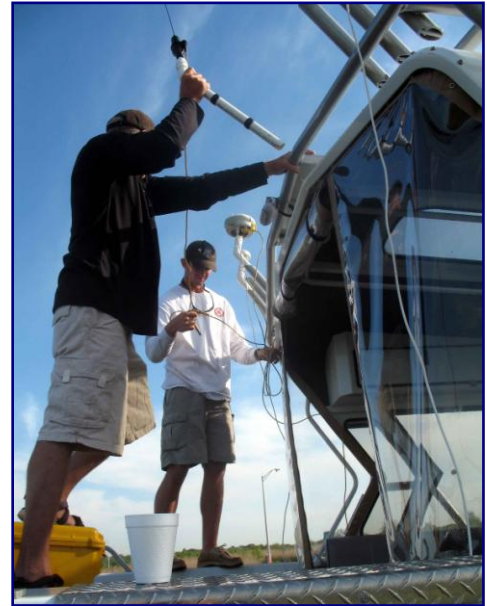
**FIGURE 2.2.** CSE beach monitoring methods include land-based data collection using Trimble™ RTK GPS from the backshore to low-tide wading depth and over-water work using RTK GPS linked to a precision echosounder aboard CSE's shallow draft boat (RV Congaree River).

Topographic data were collected via RTK-GPS (Trimble™ R8 GNSS), which provides position and elevation measurements at centimeter accuracy. Beach profiles were obtained by collecting data at low tide along the dunes, berm, and active beach to low-tide wading depth. Over-water work was then performed at high tide to overlap the land-based work (Fig 2.2) and was collected with RTK-GPS coupled with an Odom CV100™ precision echo sounder mounted on CSE's shallow-draft vessel, the *RV Congaree River*. Profiles were collected from the most landward accessible point in the dune system to a minimum of 1,500 ft from the baseline. Profiles in the project area extended up to 6,000 ft offshore to encompass the shoals associated with Dewees Inlet. Alongshore spacing of the profiles ranged from 200 ft to 1,000 ft with the more closely spaced profiles in the project area and along Breach Inlet. Comparative profiles from CSE's monitoring efforts are shown in Appendix A. The complexity of areas impacted by inlets requires more detailed analysis (closer profile spacing) to fully incorporate volume changes associated with shoal-bypassing events and inlet migration.

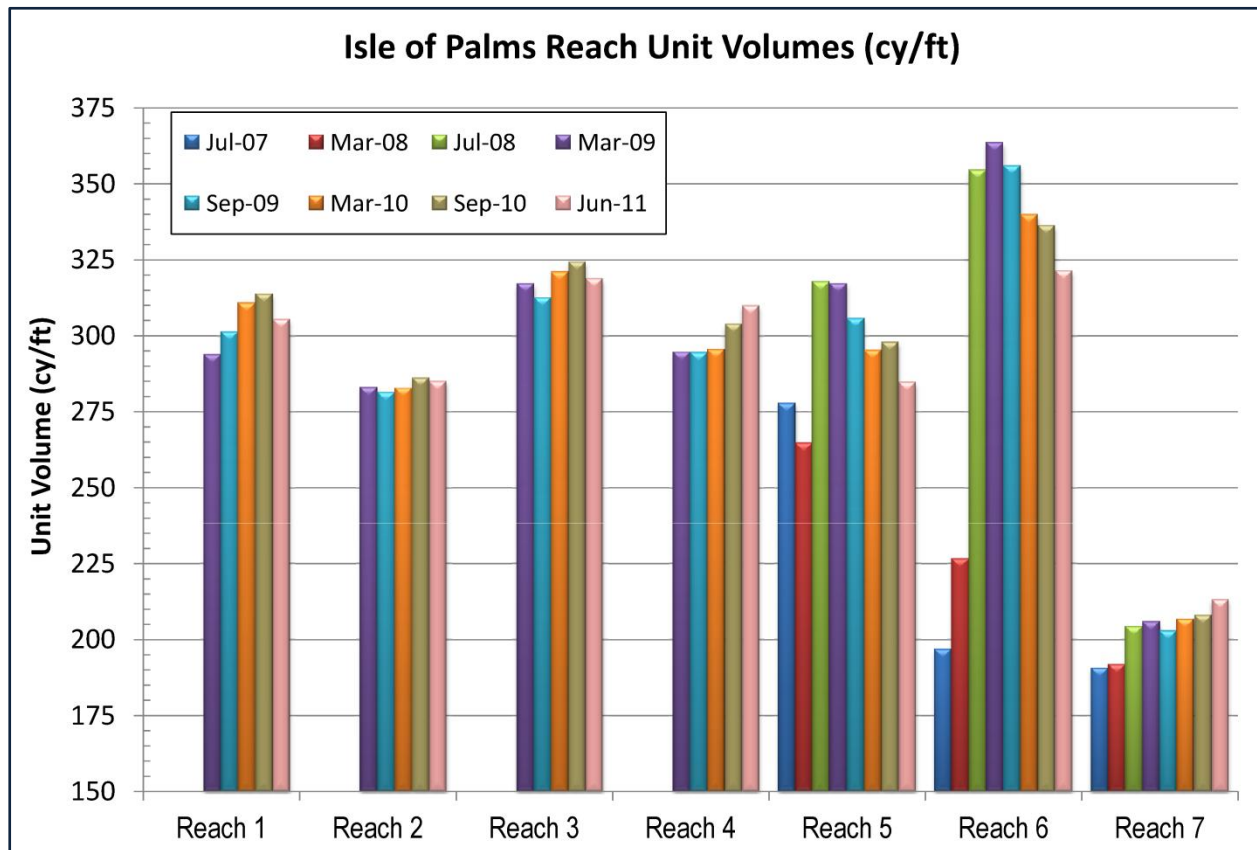
**FIGURE 3.1.** Average unit-width volumes for each monitoring reach at Isle of Palms. See Figure 2.3 for reach boundaries. Unit volumes were calculated from the primary dune to a profile-specific depth, generally between -9 ft and -13 ft NAVD for the beachfront. Nourishment occurred prior to the July 2008 data collection in Reaches 5, 6, and 7. Design-fill unit volumes for full sections were ~75 cy/ft in Reach 5, ~140-180 cy/ft in Reach 6, and ~27 cy/ft in Reach 7. See Figure 2.1 for beach nourishment locations.

Results of the 2012 monitoring survey show that the central portion of the island (5<sup>th</sup> Ave – 54<sup>th</sup> Ave) was consistently accretional while the east end was variably erosional or accretional. **Overall, the island lost ~95,000 cy (2.6 cy/ft) of sand from June 2011 to July 2012.** The most significant erosion was observed near the Wild Dunes Property Owners Beach House. High erosion rates were also observed in the eastern end of the 2008 project Reach A, and at the western end of the island near Breach Inlet. Volume change data for each monitoring station and reach are given in Figure 3.1, and Tables 3.1 and 3.2.

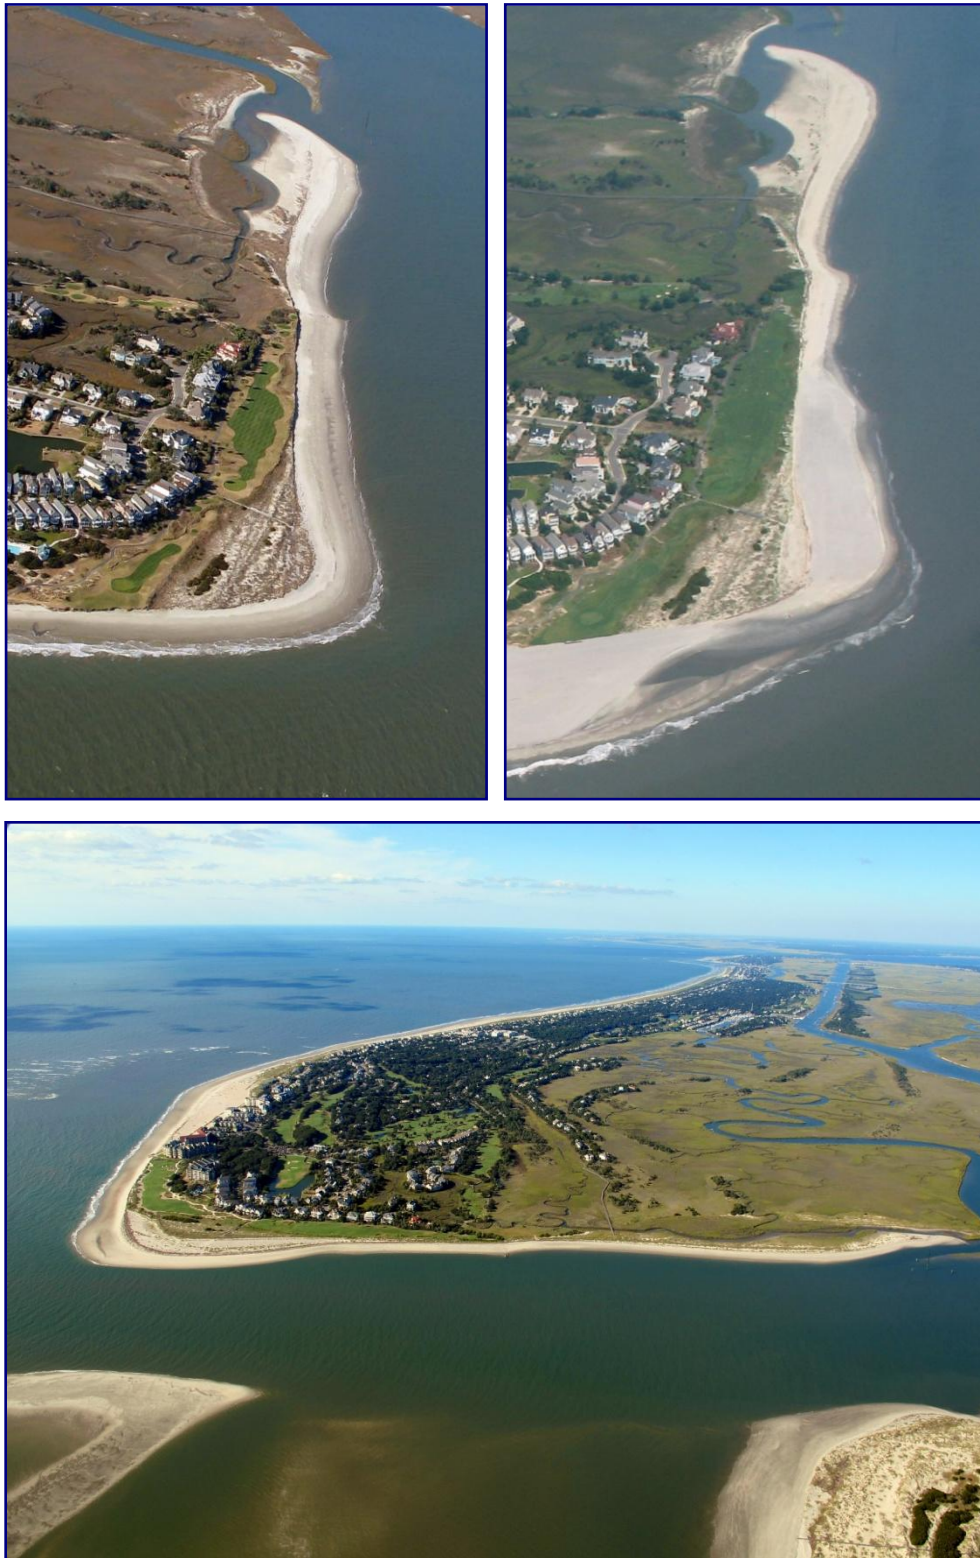
**FIGURE 3.2.** [UPPER LEFT] Reach 7 in December 2007. [UPPER RIGHT] June 2008 near the end of the project. [LOWER] September 2012. [Upper images by TW Kana] [Lower image by S Traynum]

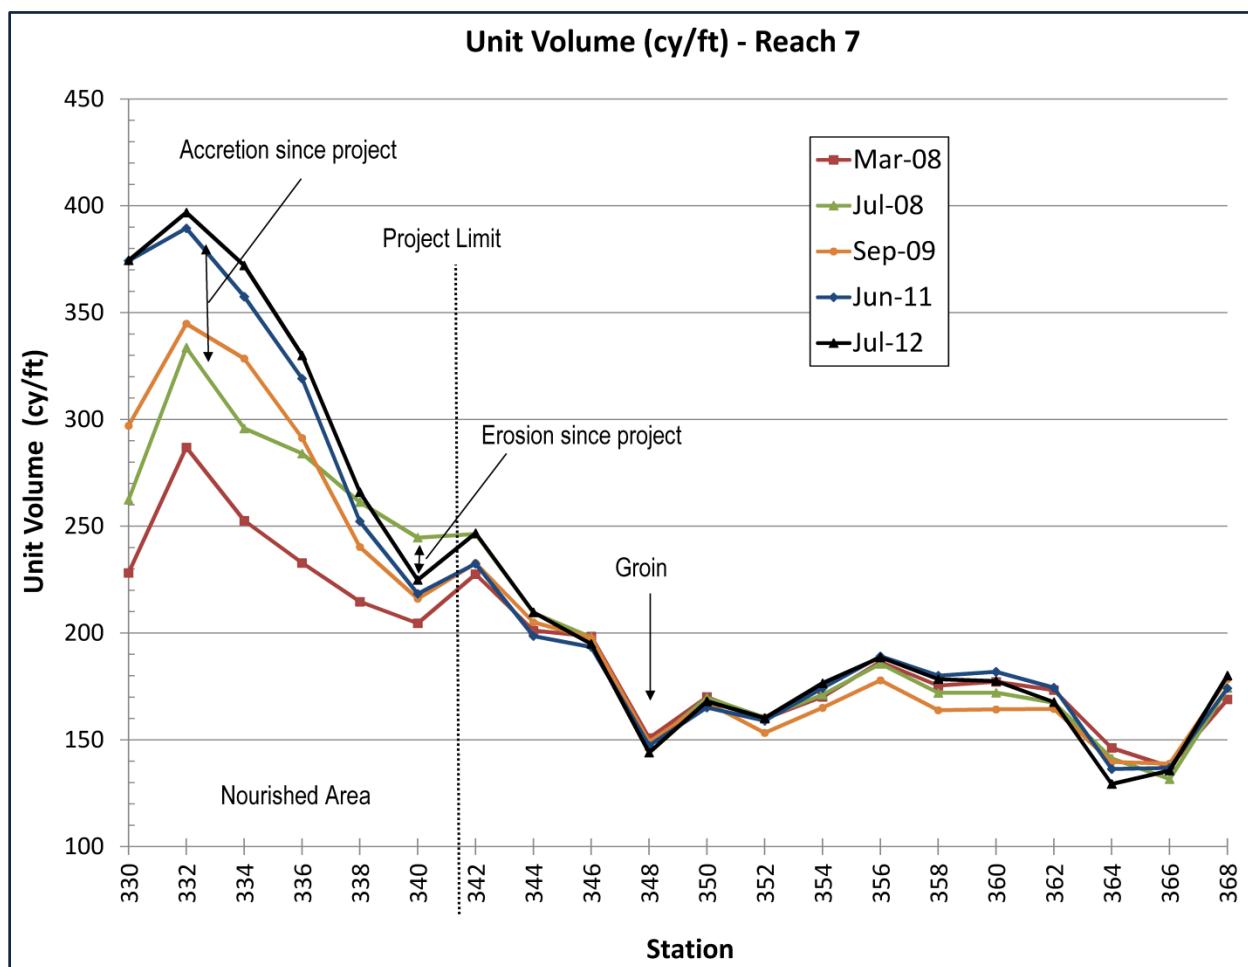
**FIGURE 3.4.** [UPPER] Cumulative unit volumes for Reach 7 from 2007 to 2012. [LOWER] Unit volumes for stations in Dewees Inlet. Profiles in the southwestern portion of the reach (17<sup>th</sup> green – 18<sup>th</sup> tee) have accreted following the project, while the remaining stations have been stable or have eroded. The difference between 2012 (black line) and post-nourishment (green line) shows the volume change since nourishment.

Reach 7 has consistently accreted since 2007 (Fig 3.4, upper) with the accretion being mostly restricted to the area seaward of the groin near the 17<sup>th</sup> tee (Fig 3.4, lower). The shoreline between the groin and Cedar Creek has been mostly stable since 2008. From June 2011 to July 2012, stations 330–348 have shown a net gain of ~15,600 cy, which is an average gain of 8.8 cy/ft. Since July 2008, these stations have gained an average of 31.1 cy/ft, yielding a total volume gain since nourishment of 44,500 cy. The inland beach (northwest of the groin) shows a net loss of ~4,000 cy since nourishment. Moderate erosion was observed at stations 360–364 over the past year, ranging from 4.3 cy/ft to 7.0 cy/ft.

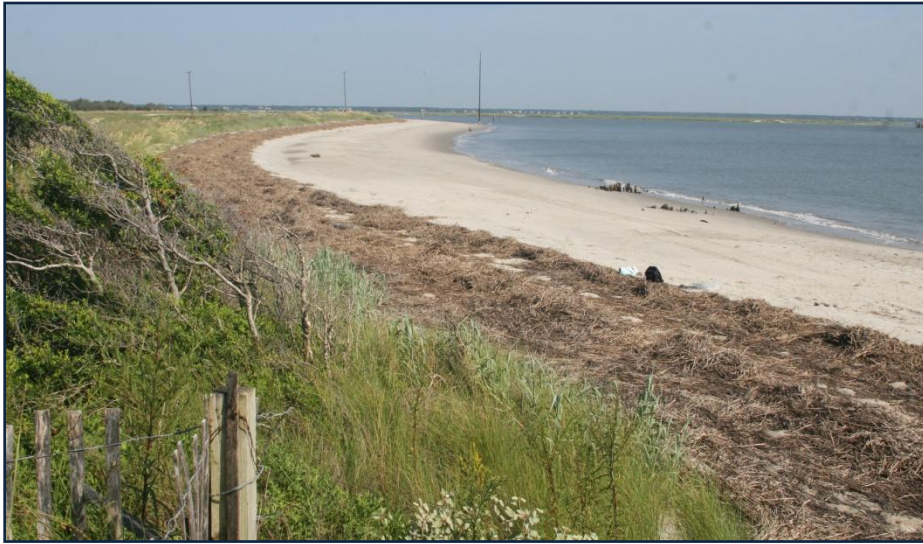
**FIGURE 3.6.** [UPPER] View inland of Reach 7 from the 17<sup>th</sup> tee. [MIDDLE] View seaward of Reach 7 from the 17<sup>th</sup> tee. [LOWER] View seaward of the nourished area of Reach 7. Vegetation has become well established seaward of the sand fencing. The pre-project dune line (red dotted line) is the dense vegetation ~25 ft to the right of the fencing in the image. [July 2012 –Photos by S Traynum]

Ground photos of Reach 7 show that vegetation has spread and matured along the 2008 fill area (Fig 3.6). The escarpment which ran along the 17<sup>th</sup> green prior to nourishment has healed and is now well set back from the water. A substantial amount of wrack (dead marsh grass) has accumulated along the shoreline in this reach. The wrack facilitates dune growth and is a benefit to beach organisms. USFWS generally discourages removal of wrack from the beach.

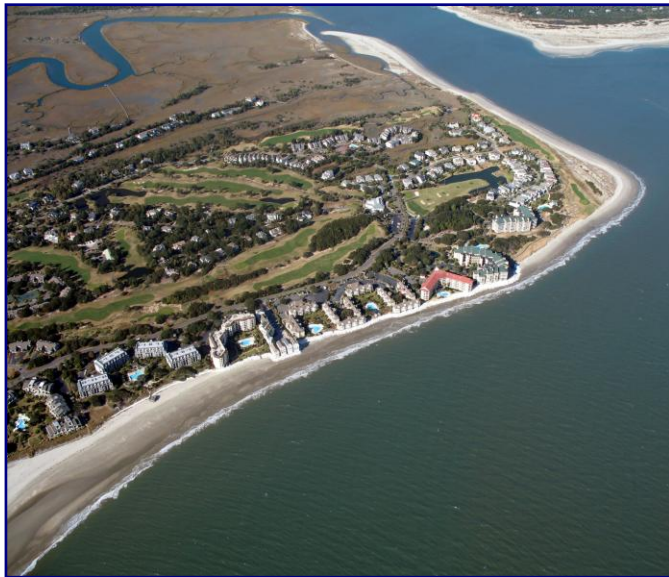
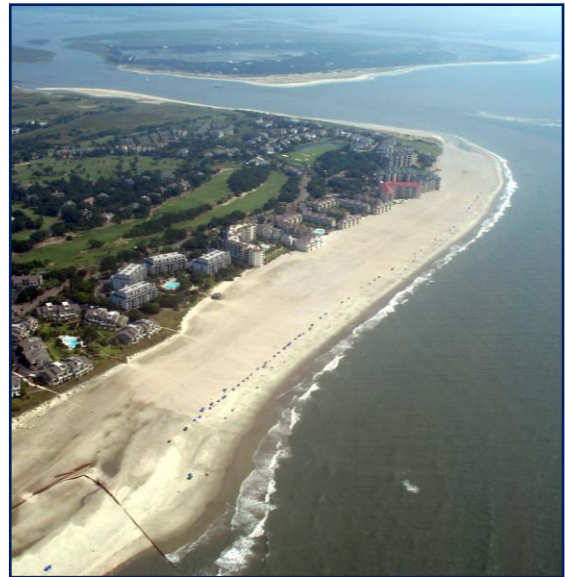
**FIGURE 3.7.** Reach 6 in December 2007 (upper left), June 2008 near the end of the project (upper right), September 2009 (lower left) and September 2012 (center right).

Reach 6 (Fig 3.7, previous page) extends from the Wild Dunes Property Owners Beach House ~4,900 ft northeast to the 18<sup>th</sup> fairway, where the beach turns into Dewees Inlet (station 280+00 to station 328+00, Fig 3.8). Shoal-bypassing events have highly impacted this area since the island's formation. Depending on the location and timing of the bypass events, the shoreline can change hundreds of feet over a period of several months (Kana et al 1985, Gaudio 1998). As was the case in 2007-2008, the shoreline may encroach on development in this reach when shoal-bypass events are prolonged.

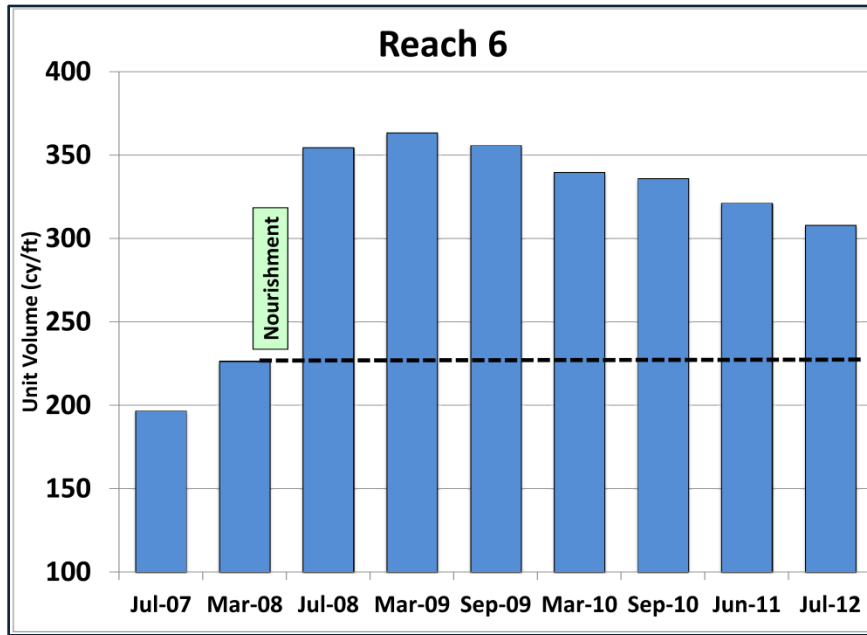
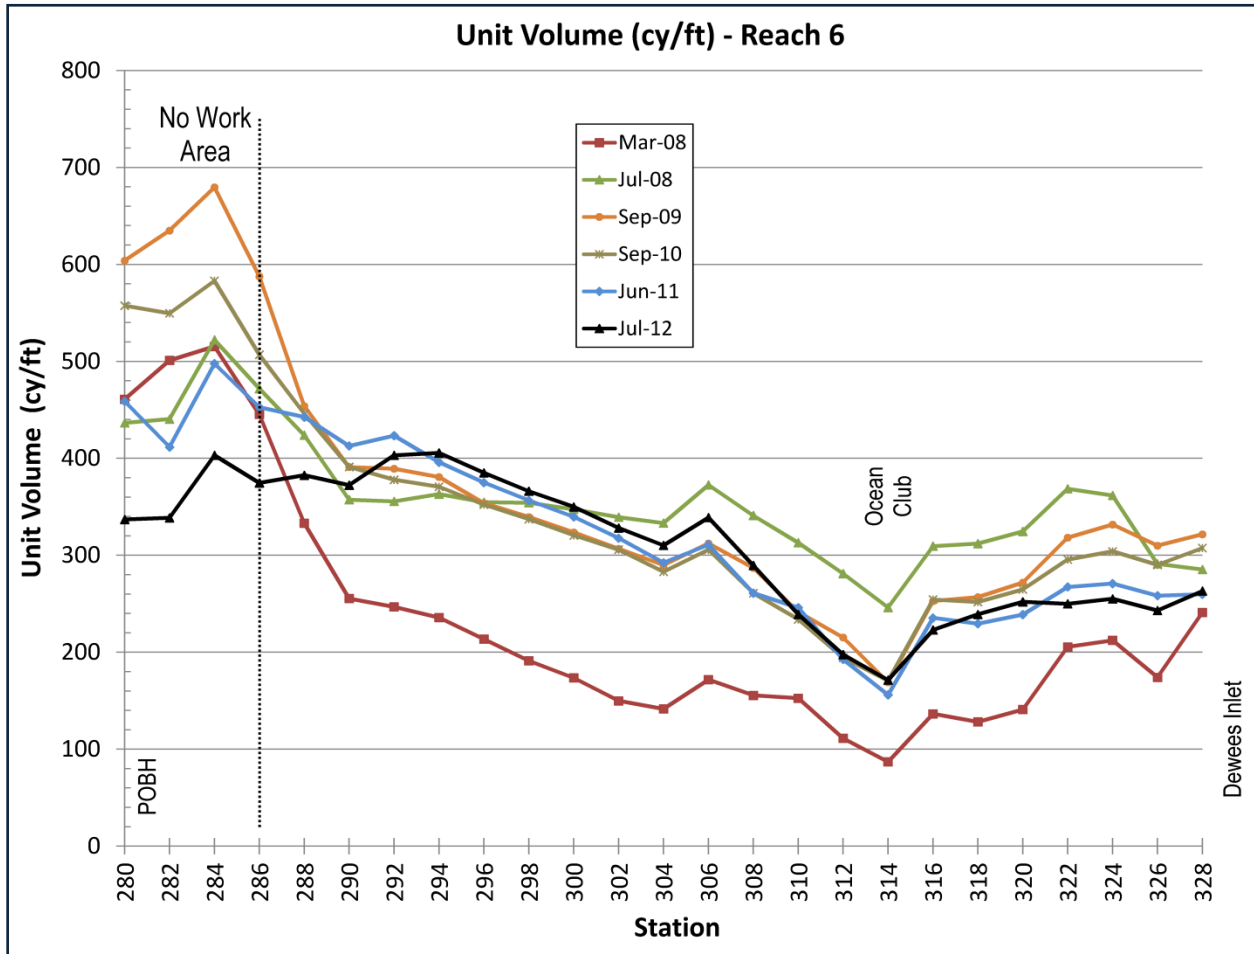
**FIGURE 3.9.** [UPPER] Bar graph showing beach unit volumes calculated to -10 ft NAVD in Reach 6. Overall, this reach has over 100 cy/ft more sand in July 2012 than in July 2007 (prior to shoal attachment and nourishment). [LOWER] Profile unit-width volumes for stations in Reach 6. Erosion has dominated the ends of the reach. The beach was much more stable from 2009 to 2012.

Additional sand was needed to supplement the natural sand transport condition. Between March and July 2008, ~628,000 cy of sand were added to the reach through nourishment and natural spreading of sand from the shoal (the design volume for this reach was 550,000 cy). Average profile unit volumes increased from 226 cy/ft to 355 cy/ft (calculated to -10 ft NAVD) (Fig 3.9, upper).

Overall, Reach 6 lost ~65,000 cy (13.3 cy/ft) over the past year. This is similar to losses during the previous year. The reach still shows ~400,000 cy (81.6 cy/ft) more sand than the pre-nourishment condition.

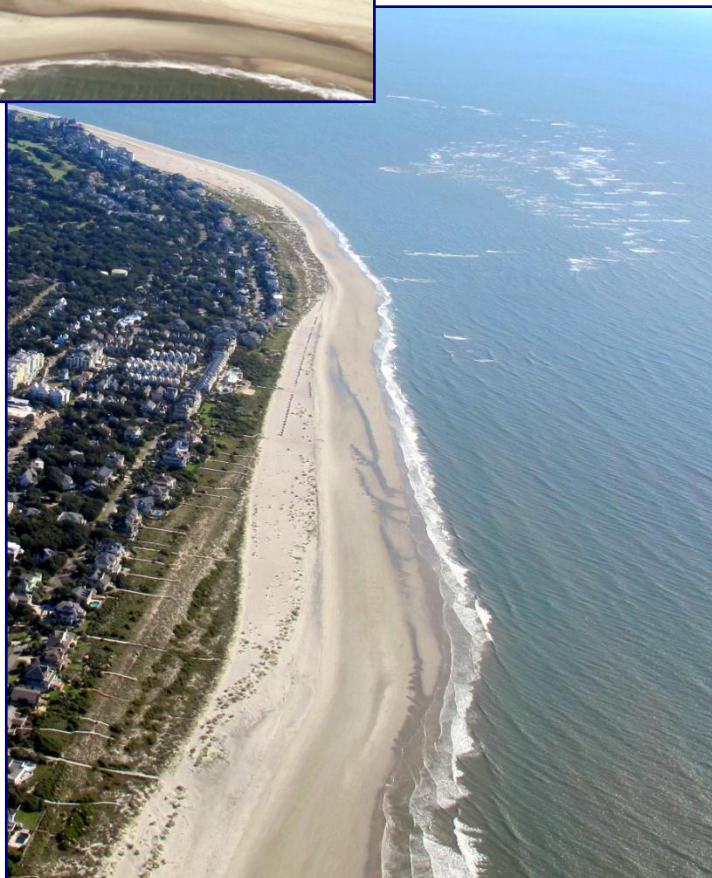
Reach 5 (Fig 3.12, previous page) spans ~6,000 ft between 53<sup>rd</sup> Avenue and the Wild Dunes Property Owners Beach House and encompasses project Reach A (Fig 3.13, stations 222+00 thru 280+00). Like Reach 6, this area is greatly influenced by shoal-bypass events, especially at the northern end of the reach where the majority of shoals attach to the beach.

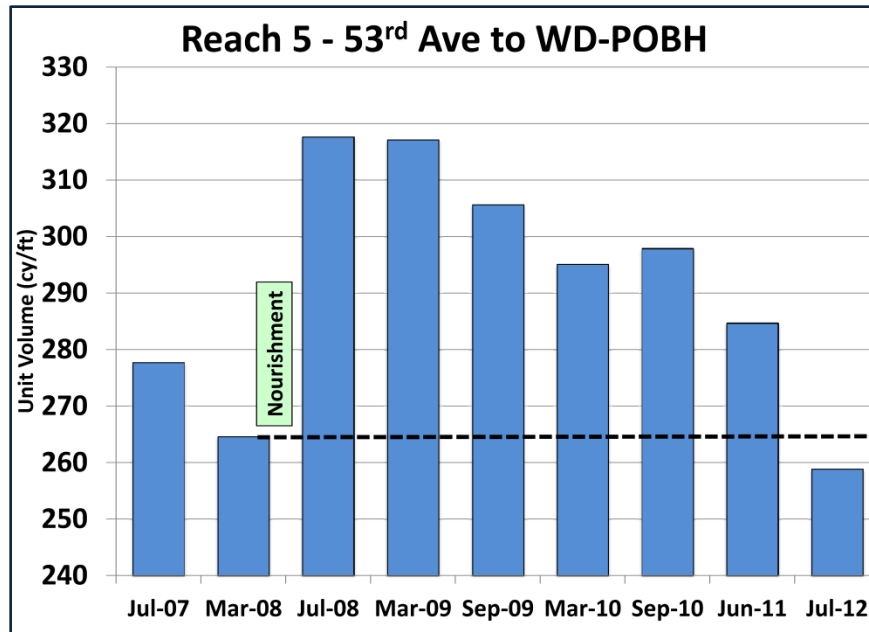
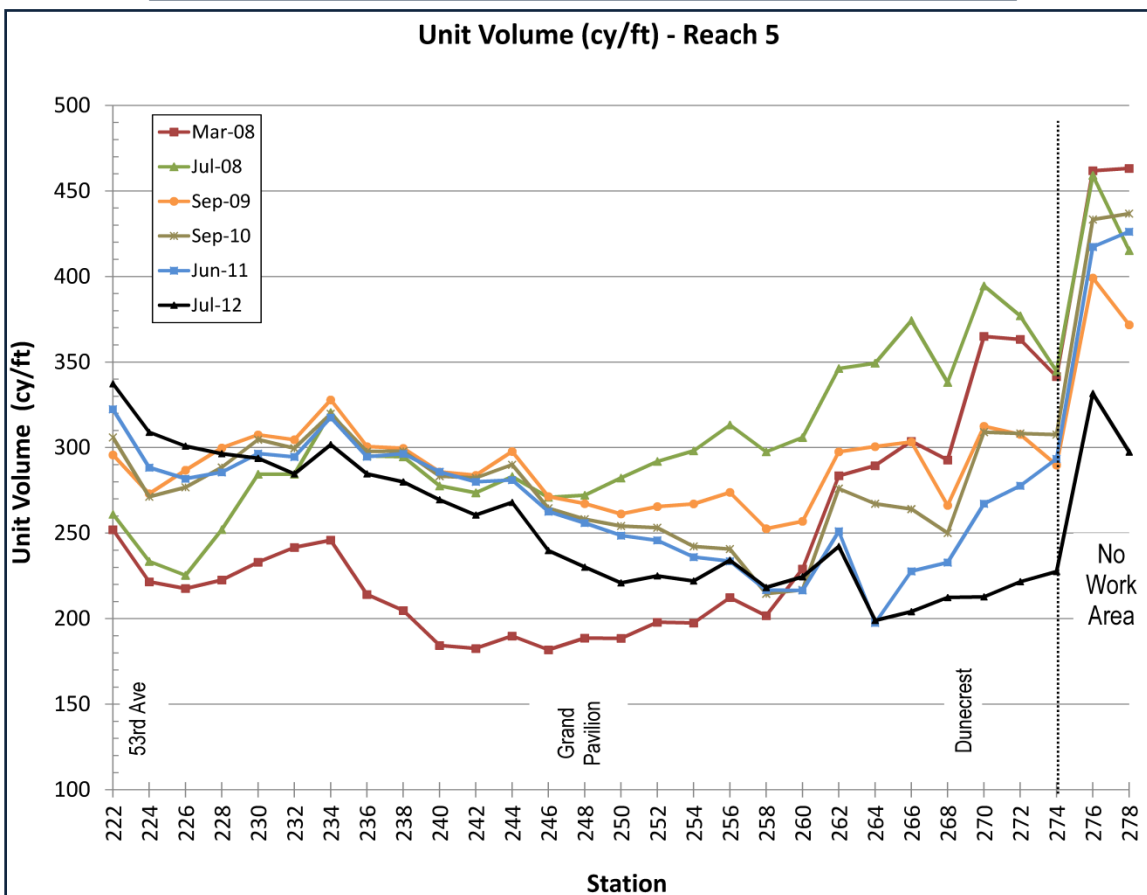
**FIGURE 3.15.** [UPPER] Bar graph showing beach unit volumes calculated to -10 ft NAVD in Reach 5. While the 2012 average sand volume is less than the pre-nourishment condition, stations 222–258 (3,600 ft of a total of 6,000 ft of Reach 5) still hold ~210,600 cy (58.5 cy/ft) more sand than the pre-nourishment condition. [LOWER] Profile unit-width volumes for stations in Reach 5. Erosion has dominated the northern part of the reach (stations 250–278) and is associated with excess sand resulting from shoal attachment events in 2006, 2009, and 2010.

Reach 5 showed distinct areas of erosion and accretion over the past year. The most significant change was at the eastern end of the reach from station 266 to station 278 (Dunecrest and Beach Club Villas I); this area lost between 20 cy/ft and 130 cy/ft (Fig 3.16). The high erosion rates are attributed to continued spreading of the 2007 salient, which existed prior to the 2008 project. Sand borrowing during the 2012 shoal management project also contributed to the high erosion observed. The beach near Dunecrest Lane currently has the lowest unit volumes along Reach 5.

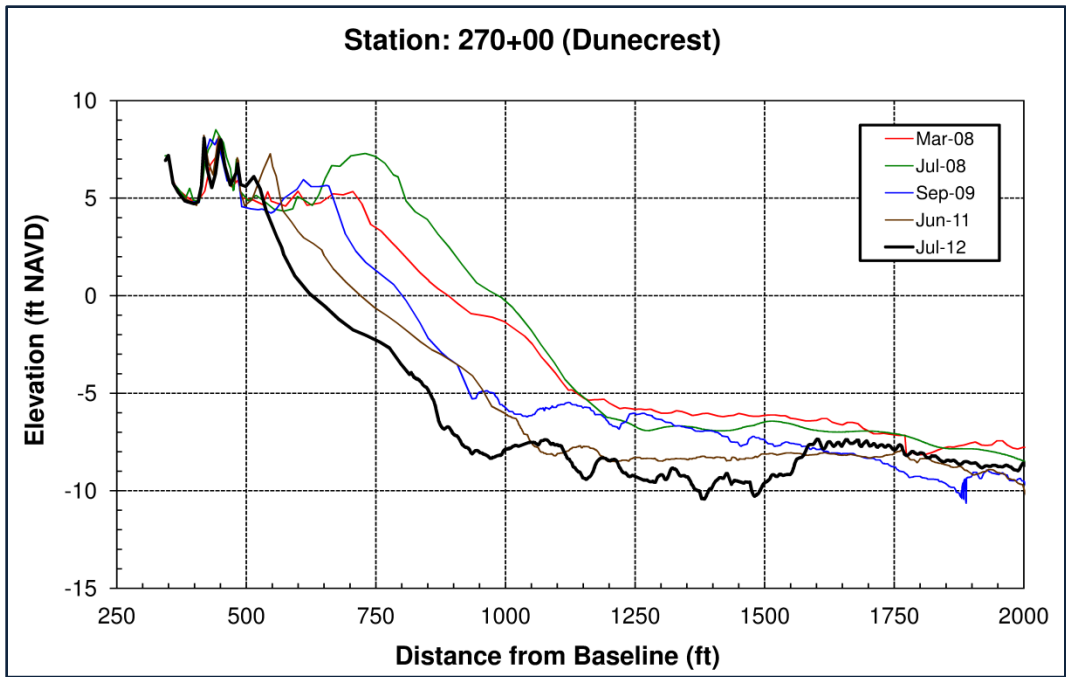
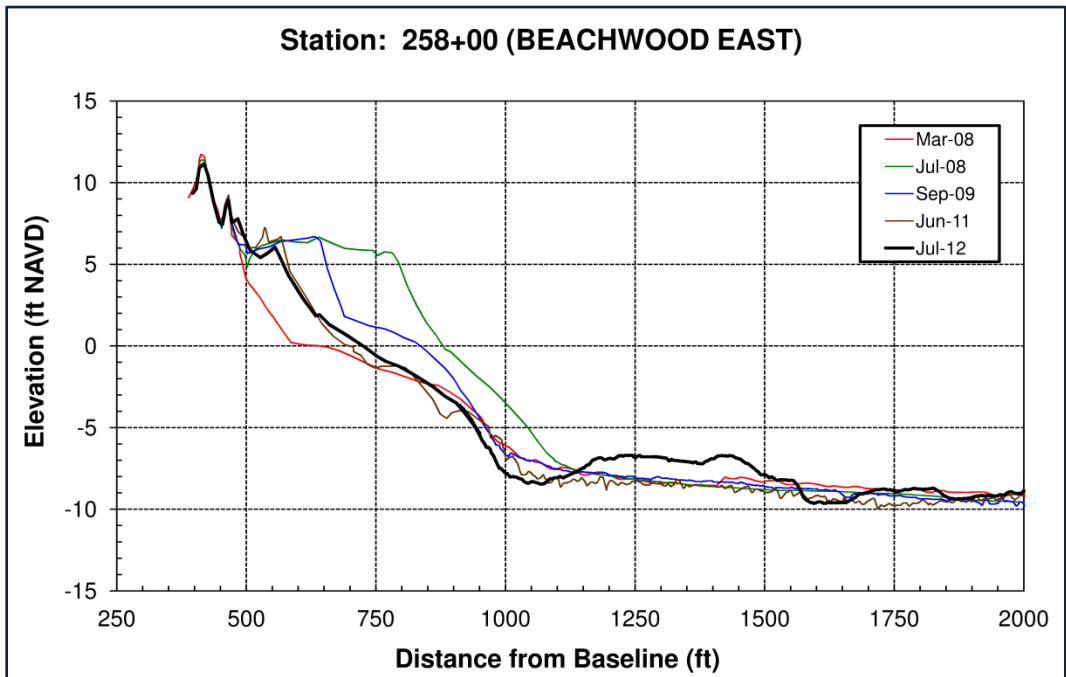
**FIGURE 3.16.** Profiles from station 270+00 (upper) and 258+00 (lower) in Reach 5. Generally, the eastern portion of the reach has been highly erosional since 2008, while the central portion has eroded slowly and the western portion has accreted.

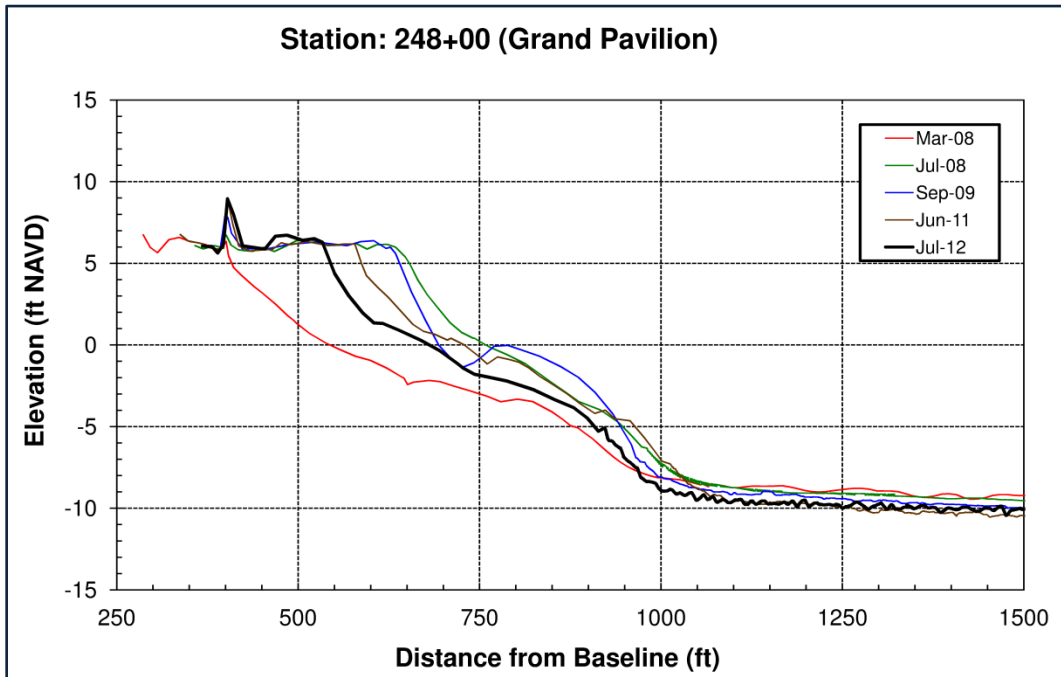
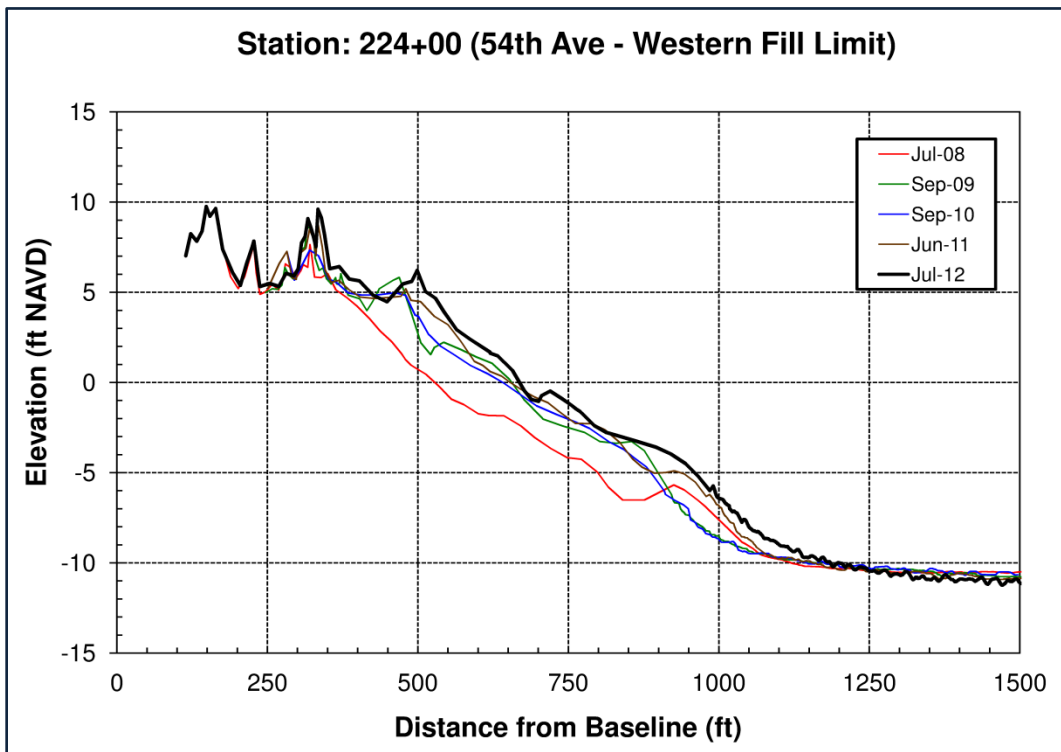
**FIGURE 3.17.** Profiles from station 248+00 (upper) and 224+00 (lower) in Reach 5. Generally, the eastern portion of the reach has been highly erosional since 2008, while the central portion has eroded slowly and the western portion has accreted.

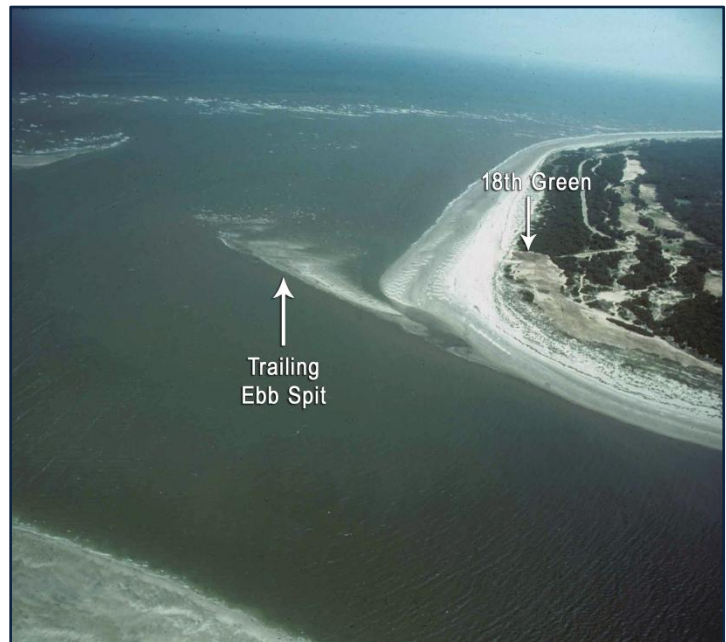
1980 aerial image of a trailing ebb spit at the northeast end of Isle of Palms  
[Photo by TW Kana]

- 1) The area from Beachwood East to Beach Club Villas II continues to lose sand that attached in 2007, 2009, and 2010 during discrete bypass events.
- 2) Areas west of the Wild Dunes Grand Pavilion receive sand lost from upcoast (east) and continue to accrete.
- 3) An erosion hot spot, centered near the 18<sup>th</sup> hole, is likely a result of wave focusing through the channel break in the Dewees Inlet delta.
- 4) Sand continues to accumulate at the northeastern point of the island, forming a “trailing ebb spit” (see photo) from sand lost from the project areas.

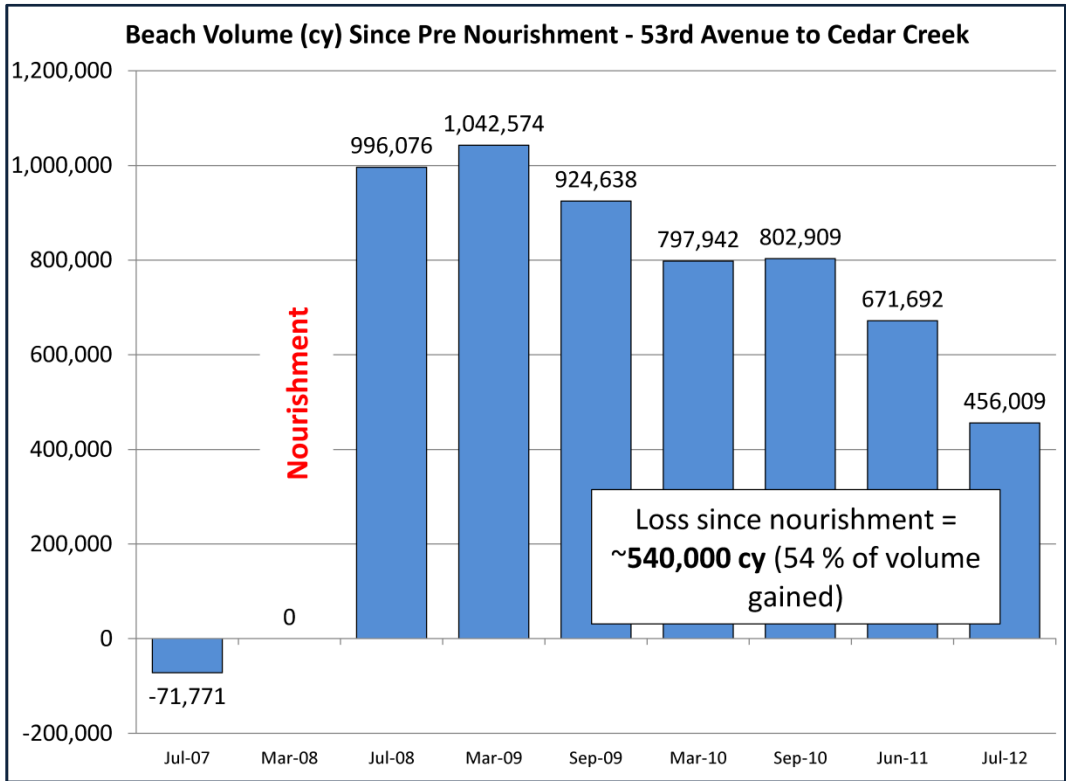
**FIGURE 3.19.** Beach volume relative to March 2008 (pre-nourishment). The values shown include all areas (both nourished and non-nourished) and do not account for sand accumulated at the turn in the baseline at the northeastern point, which is estimated to have gained over 50,000 cy since March 2008.

While a portion of Reaches 5–7 (stations 260–286 and some areas of Reach 7) currently contains less volume than the pre-nourishment condition, the majority of the nourishment area remains in much better condition than before restoration. Overall, Reaches 5–7 retain ~456,000 cy (30.6 cy/ft) more sand than the March 2008 condition (Fig 3.19); this number includes areas not nourished. Over the same time period, Reaches 5–7 have lost 540,000 cy or 54 percent of the volume gained (March to July 2008 changed).

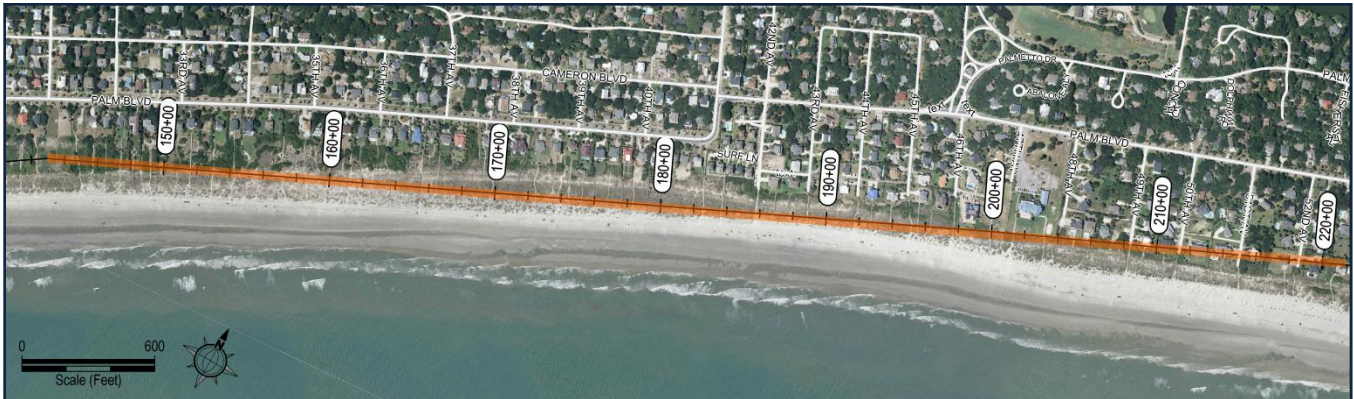
**FIGURE 3.22.** Reach 4 spans from stations OCRM 3140 (31<sup>st</sup> Avenue) to CSE 222+00 (53<sup>rd</sup> Avenue) — noted by the orange-highlighted bar.

Reach 4 spans 7,910 ft between 31<sup>st</sup> Avenue and 53<sup>rd</sup> Avenue (stations OCRM 3140 to CSE 222+00) (Fig 3.22). Being immediately downdrift of the 2008 nourishment project, it should, therefore, benefit from losses of nourishment sand from the project area. Reach 4 was stable from March to September 2009 and has accreted between each monitoring event since then (see Table 3.2). From June 2011 to July 2012, the reach gained 104,100 cy (13.2 cy/ft) of sand.
