**2008 BEACH RESTORATION PROJECT  
ISLE OF PALMS SOUTH CAROLINA**

**Monitoring Report No 4  
November 2012**

## YEAR 4 MONITORING REPORT

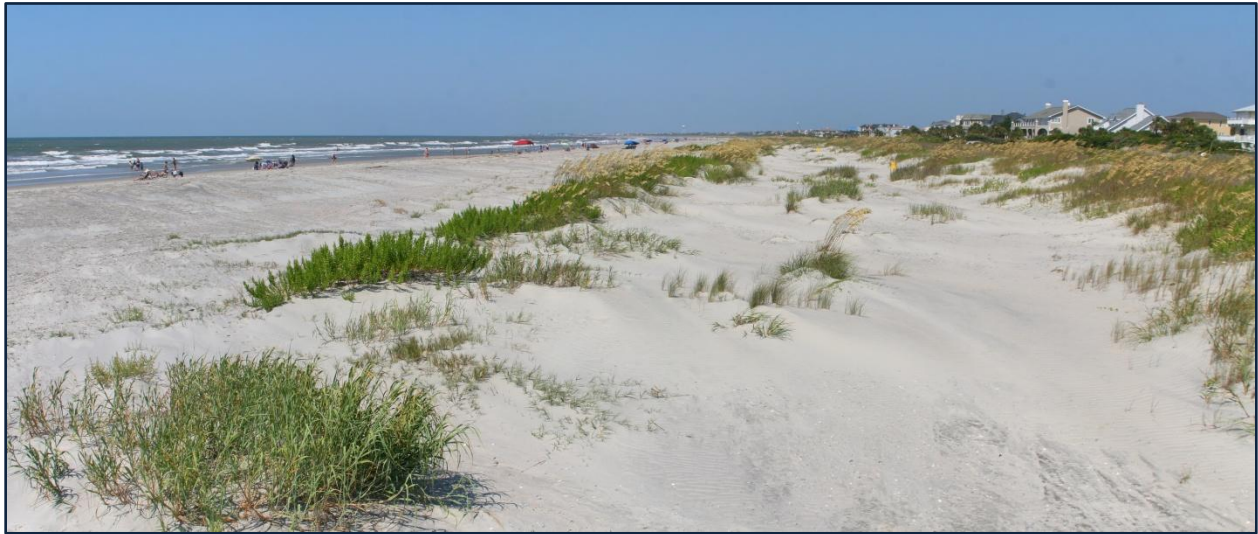
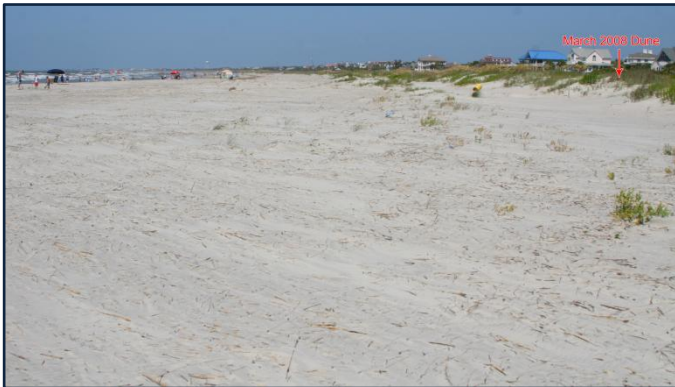
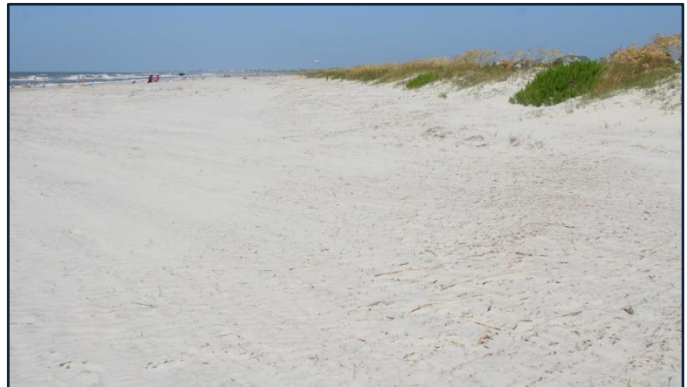
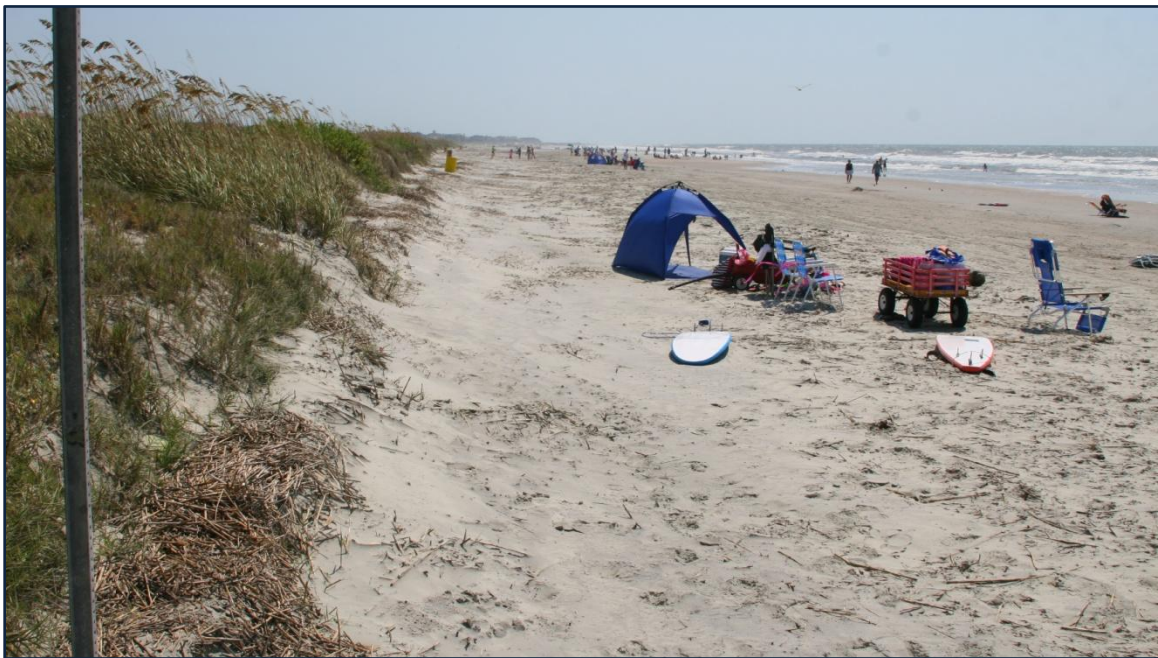
**FIGURE 3.24.** July 2012 photos from Reach 4. [TOP] Near 53<sup>rd</sup> Avenue. [CENTER LEFT] Near 48<sup>th</sup> Avenue. [CENTER RIGHT] Near 40<sup>th</sup> Avenue. [BOTTOM] Near 33<sup>rd</sup> Avenue. [Photos by S Traynum]

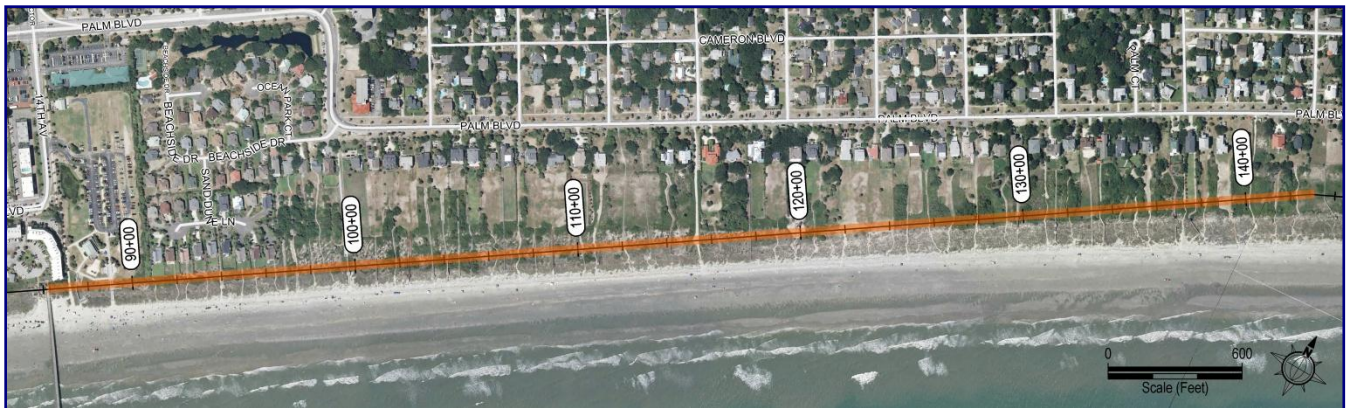
**FIGURE 3.25.** Reach 3 spans from station OCRM 3125 (pier) to station OCRM 3140 (31<sup>st</sup> Avenue) — noted by the orange-highlighted bar.

Reach 3 spans the oceanfront between the Sea Cabins Pier and 31<sup>st</sup> Avenue (OCRM monuments 3125 to 3140, Fig 3.25). As previously mentioned, the long-term trend in this area is stable to accretional. Profiles from OCRM station 3135 (near 27<sup>th</sup> Avenue) show the beach in this area has gained ~40 ft in width at the +5-ft NAVD contour (Fig 3.26) over the past ten years. A similar trend is evident at OCRM station 3125 (14<sup>th</sup> Avenue) with dune growth and beach widening over the past ten years.

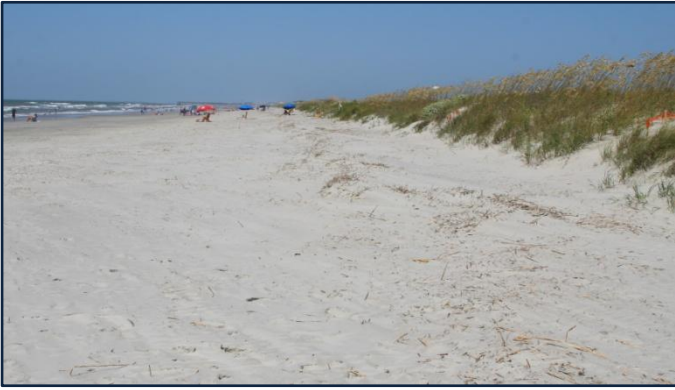
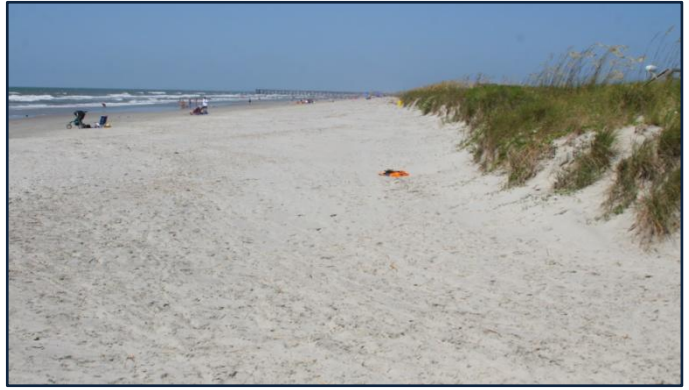
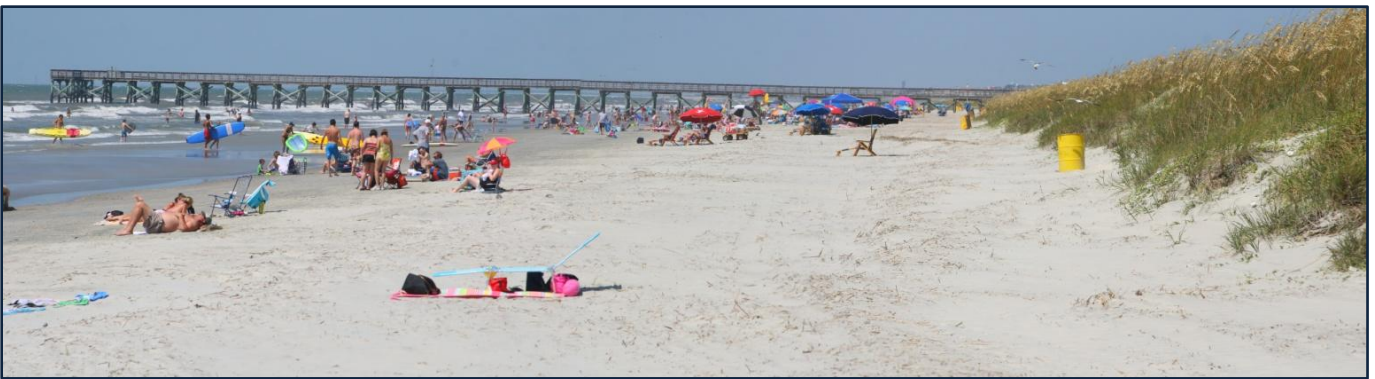
**FIGURE 3.27.** Ground photos of Reach 3 at 29<sup>th</sup> Avenue (upper left), 25<sup>th</sup> Avenue (upper right), 21<sup>st</sup> Avenue (center), and the County Park (lower). [Photos by S Traynum]

Accretion was most significant near the Sea Cabins Pier and between 24<sup>th</sup> and 26<sup>th</sup> Avenues. Photos show that a dry beach is present, though somewhat narrow (Fig 3.27). During moderate storm events (such as Hurricane *Irene* in August 2011), high water levels and wave runup can erode the dry beach and lead to minor scarping of the dune. Calmer conditions allow the dune to heal over time and the dry beach to reform. The resulting dune is somewhat truncated on the seaward side compared to areas with greater rates of accretion and wider dry beaches (such as around 53<sup>rd</sup> Avenue). Figure 3.28 shows the beach condition on 25 September 2012.

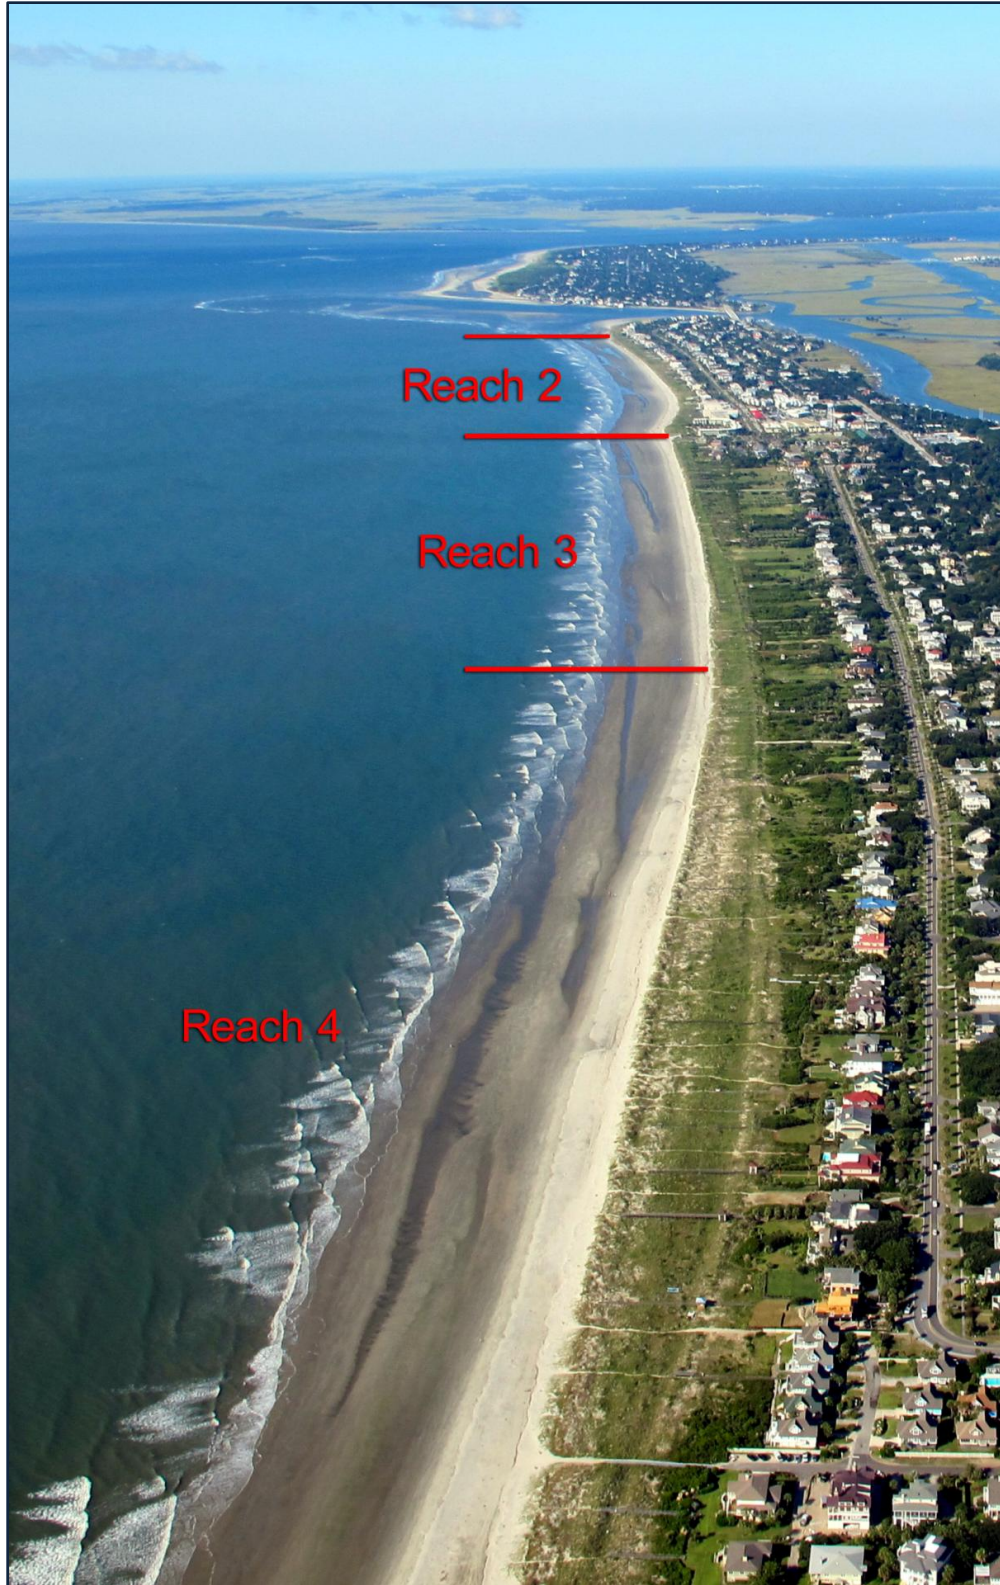
**FIGURE 3.28.** Aerial view of central and southern Isle of Palms on 25 September 2012. Properties in Reach 3 and Reach 4 are set back a few hundred feet from the beach. The seaward edge of the wax myrtles (dark green vegetation) marks an earlier foredune/shoreline position. [Photo by SB Traynum]

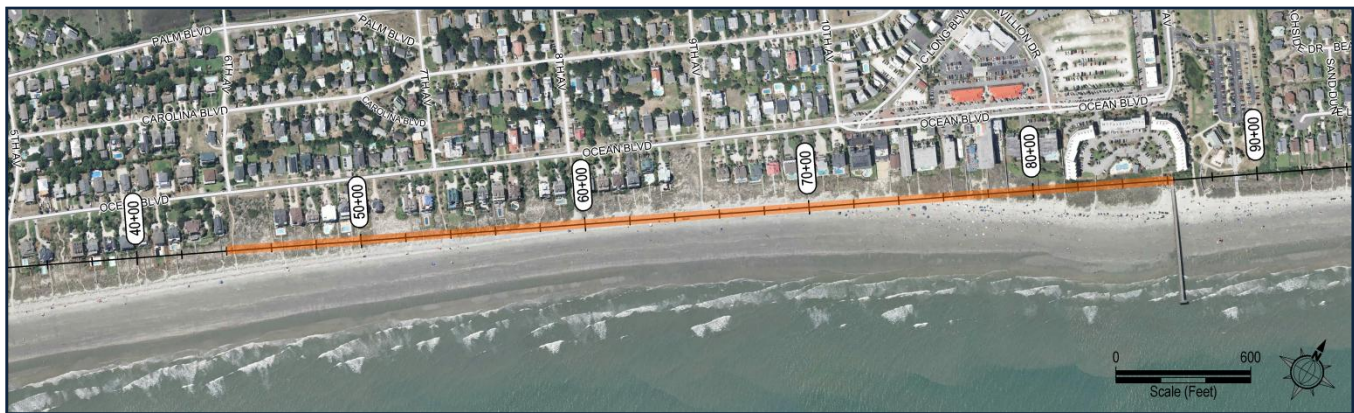
**FIGURE 3.29.** Reach 2 spans from OCRM 3115 (6<sup>th</sup> Avenue) to OCRM 3125 (Sea Cabins Pier) — noted by the orange-highlighted bar.

Reach 2 spans 4,280 ft between 6<sup>th</sup> Avenue and the Sea Cabins Pier (OCRM monuments 3115–3125) (Fig 3.29). Reach 2 shows an erosion-accretion pattern similar to Reach 3 with net accretion since 2009 although the magnitude of volume change is generally smaller in Reach 2. The reach eroded from March to September 2009 (–1.6 cy/ft), then accreted from September 2009 to March 2010 (1.4 cy/ft) and again to September 2010 (3.4 cy/ft). Erosion was observed from September 2010 to June 2011 (–1.1 cy/ft). Over the past year, the reach gained ~50,000 cy (11.7 cy/ft) of sand. Individual stations gained from 8.3 cy/ft to 15.0 cy/ft (eg – Fig 3.21). Since March 2009, the reach has gained ~59,000 cy (annual rate of 4.1 cy/ft per year). Like Reach 3, most of this accretion since 2009 is attributed to gains over the past year.

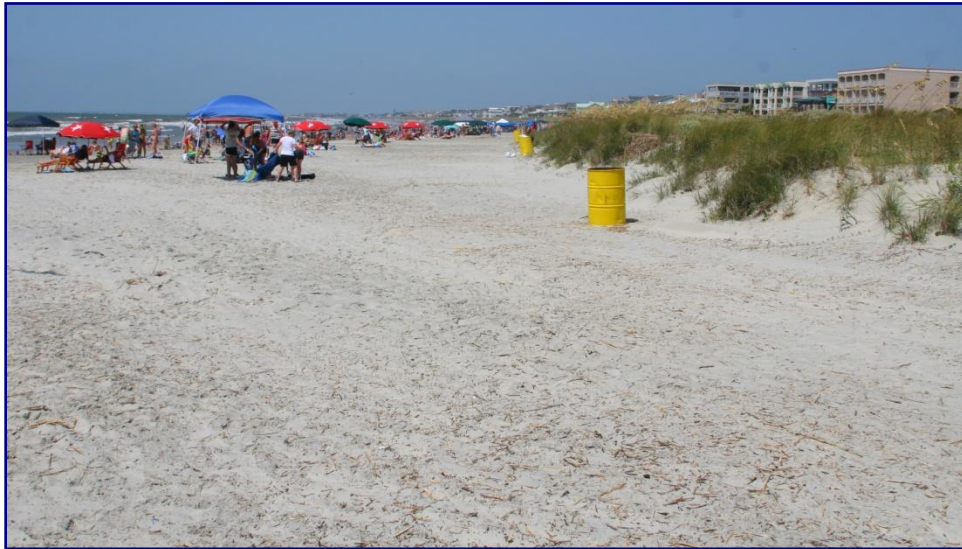
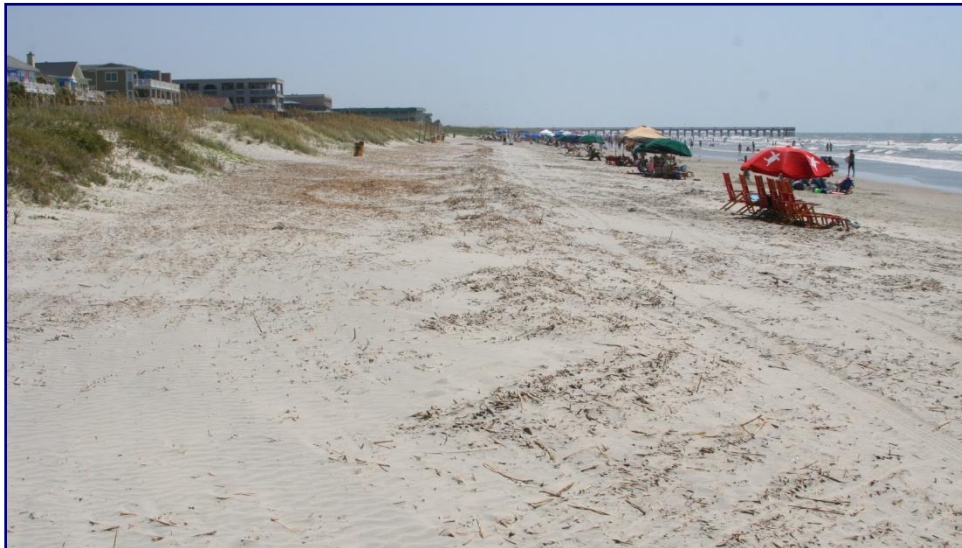
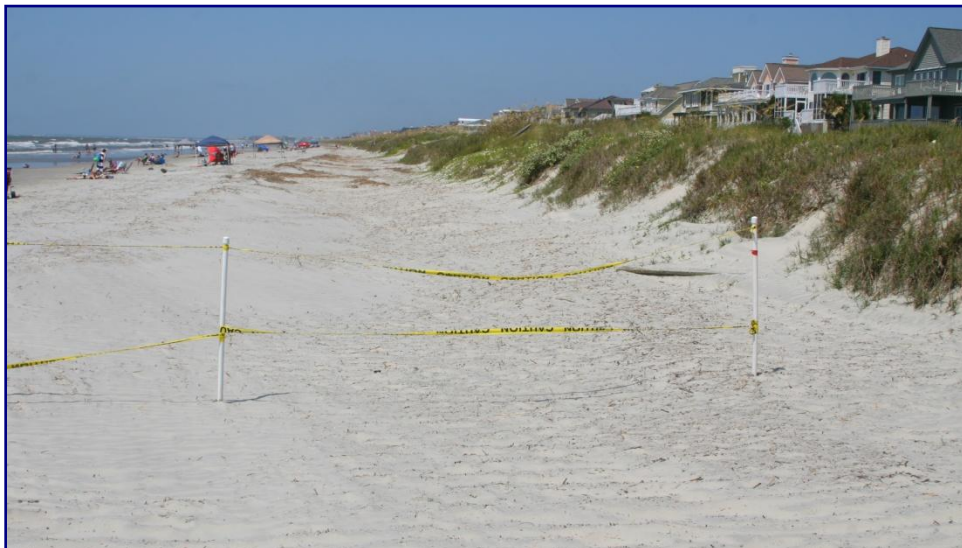
**FIGURE 3.31.** Reach 2 photos in July 2012, looking west from the Sea Cabins Pier (upper), east from 9<sup>th</sup> Avenue (center), and west from 6<sup>th</sup> Avenue (lower), where a healthy dune escarpment is visible.

Reach 2 is the location of the “Front Beach” commercial area and is the most widely used portion of the beach. Profiles show accretion of the dry-sand beach (elevation of +5 to +6 ft NAVD) since 2009 (Fig 3.30). Ground photos (Fig 3.31) confirm a moderately wide dry beach capable of supporting volleyball nets and recreational area as well as withstanding minor storms and large tides. Like Reach 3, moderate storms can create conditions which erode the dry beach and cause minor dune scarping. Remnants of a scarp were present near 6<sup>th</sup> Avenue in July 2012 (Fig 3.31).

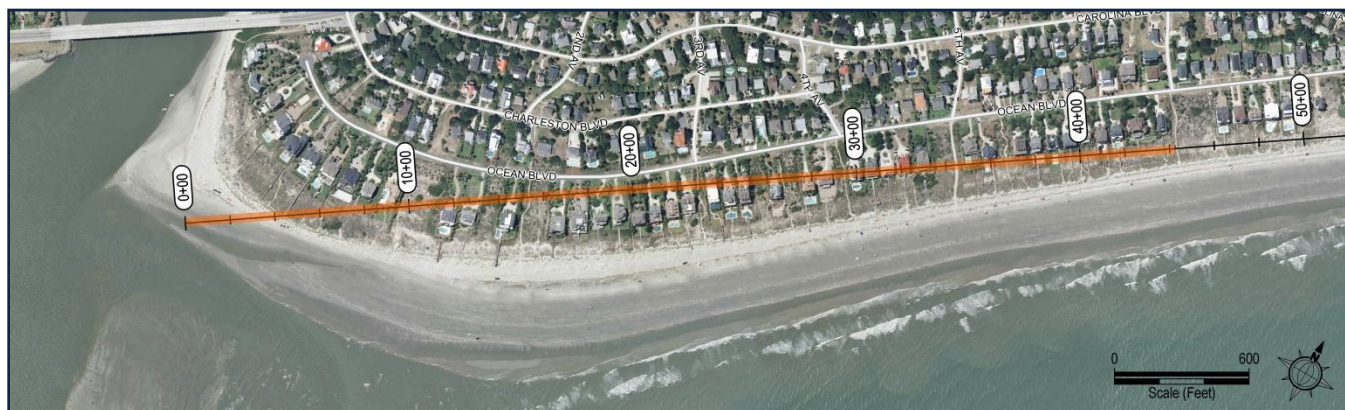
**FIGURE 3.32.** Reach 1 spans between Breach Inlet and 6<sup>th</sup> Avenue — noted by the orange-highlighted bar.

Reach 1, between Breach Inlet and 6<sup>th</sup> Avenue (Fig 3.32), is classified as an unstabilized inlet erosion zone due to the dynamic nature of the shoals associated with the inlet delta. While labeled as unstable, the long-term trend for this reach is accretional with an estimated growth of ~8.9 ft/yr (linear beach width). The historical accretion trend in this reach is due to a plentiful sand supply from upcoast and sand trapping by the Breach Inlet ebb-tidal delta.

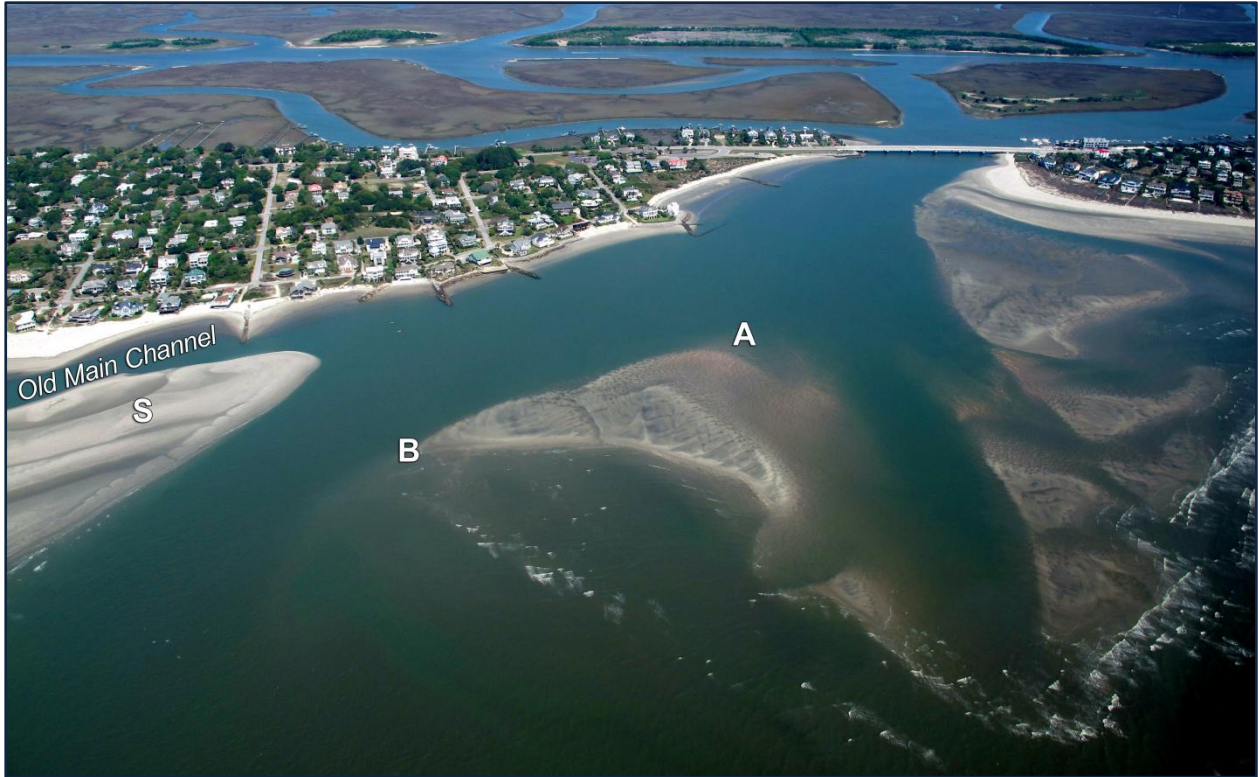
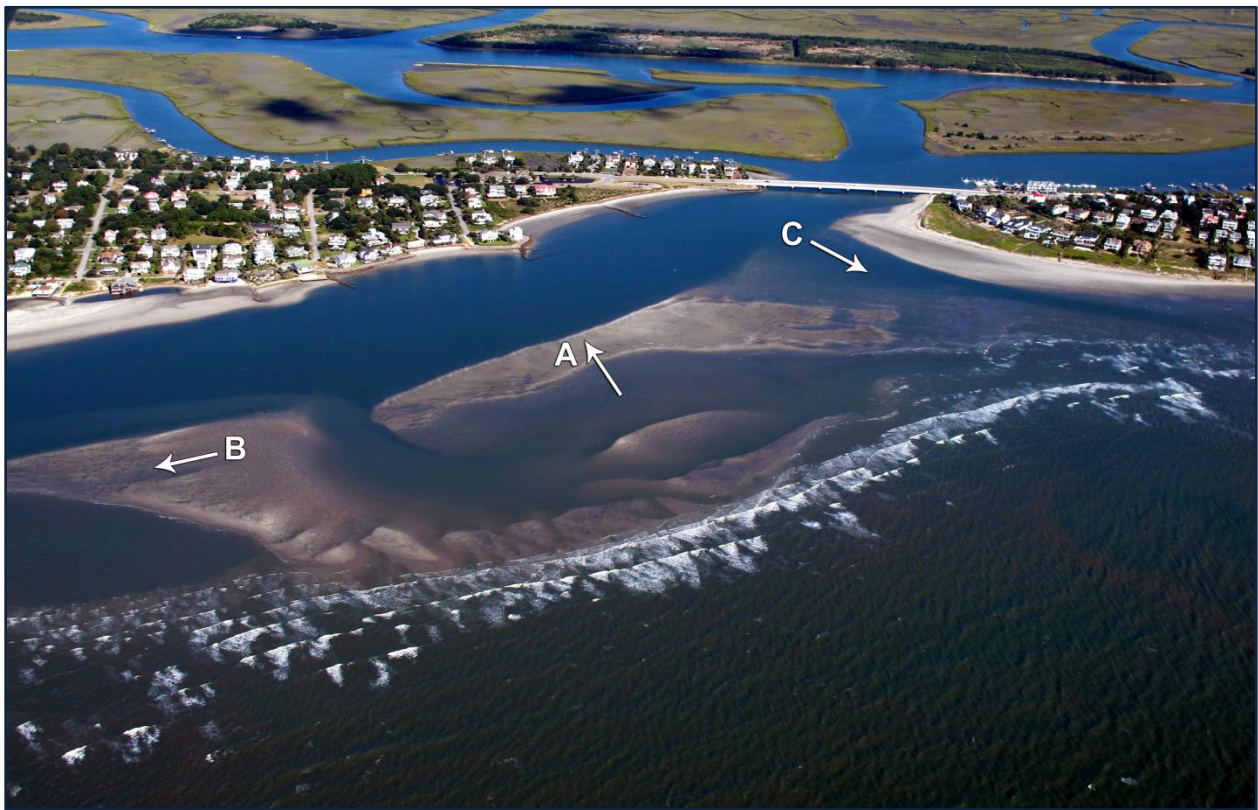
**FIGURE 3.35.** Aerial images of Breach Inlet in April 2011 (upper) and September 2012 (lower). Note the buildup of the exposed shoal at A, seaward expansion at B, development of a marginal flood channel at C. A recent channel avulsion event is reaching its final stage, where the old channel (labeled) is completely infilled with sand (S) which was originally on the IOP side of the inlet. [Photos by TW Kana and SB Traynum]

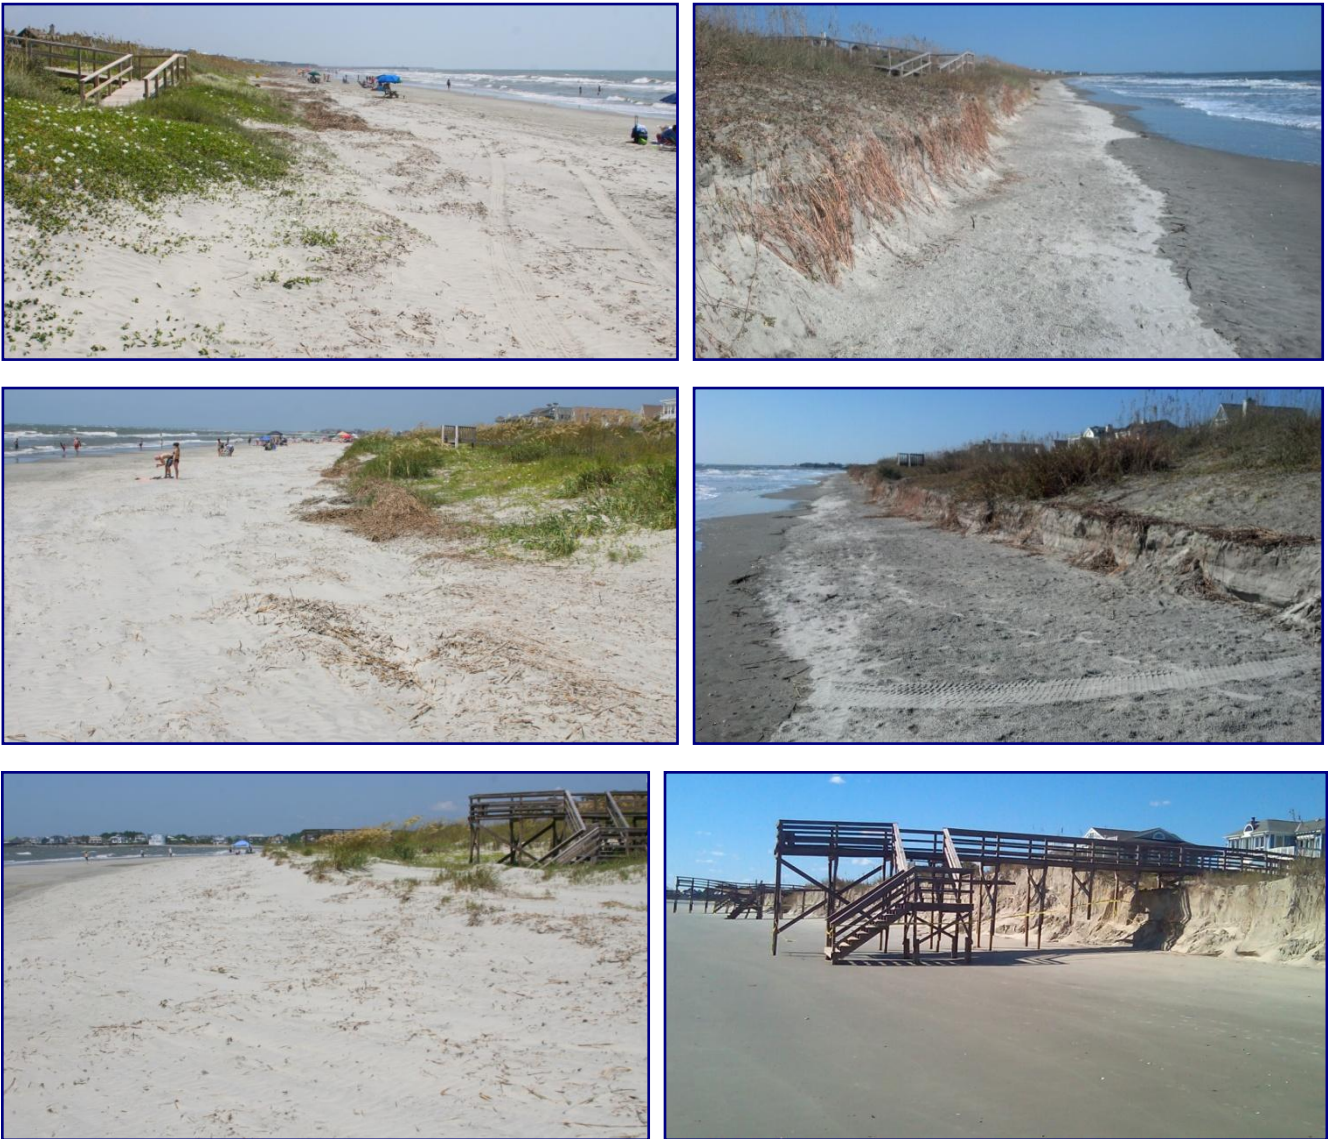
**FIGURE 3.36.**

**[1<sup>st</sup> & 2<sup>nd</sup> RIGHT]** 4<sup>th</sup> Avenue (5 November 2012) – After passage of Hurricane *Sandy*, severe dune erosion was observed between Breach Inlet and 6<sup>th</sup> Avenue.

**[3<sup>rd</sup> RIGHT]** Beach access 2 (29 October 2012) – Hurricane *Sandy* caused over 50 ft of dune erosion and damaged walkovers in this area. [Photo by D Kynoski]

Hurricane *Sandy* passed offshore of Isle of Palms in late October 2012. High surf from the hurricane caused significant dune erosion along the Breach Inlet reach. Ground photos from July and November 2012 show the beach condition before and after *Sandy* (Fig 3.36).

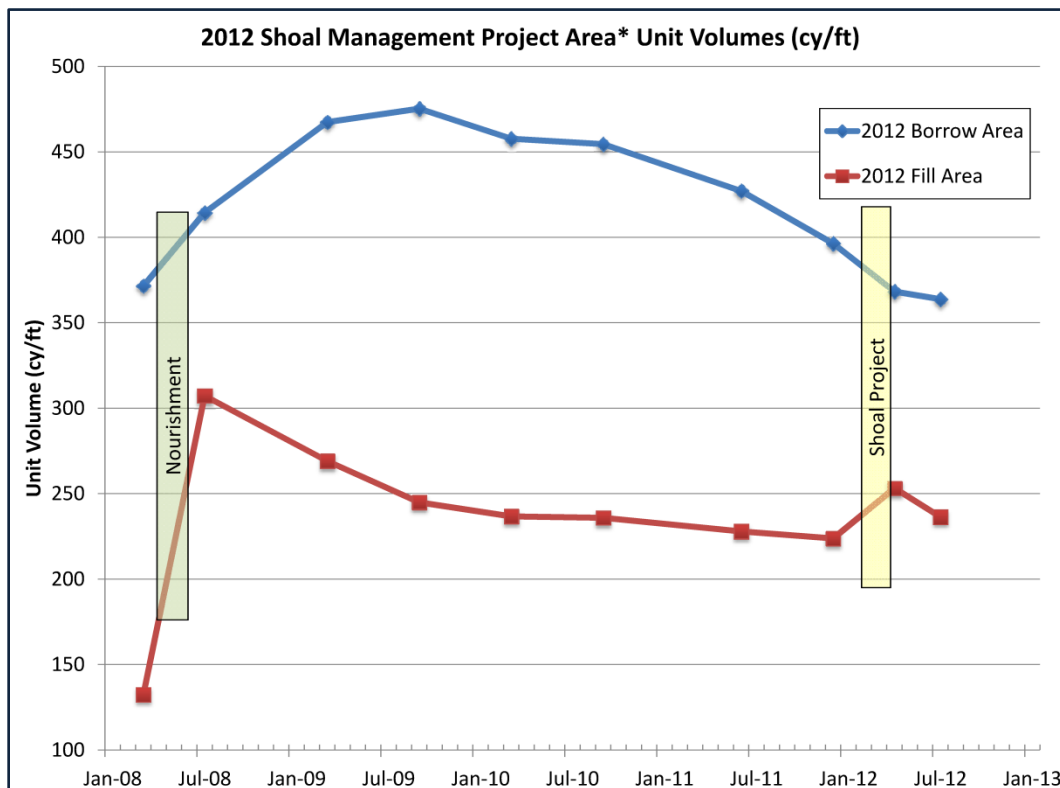
**FIGURE 3.37.** Unit volumes for the 2012 shoal management project borrow area (\*blue, stations 276–298) and fill area (\*red, stations 306–320). Presently, the borrow area contains a similar volume of sand as it did in March 2008. The fill area lost sand rapidly after placement and appears to have reached its pre-2012 project condition following passage of Hurricane *Sandy* in October 2012.

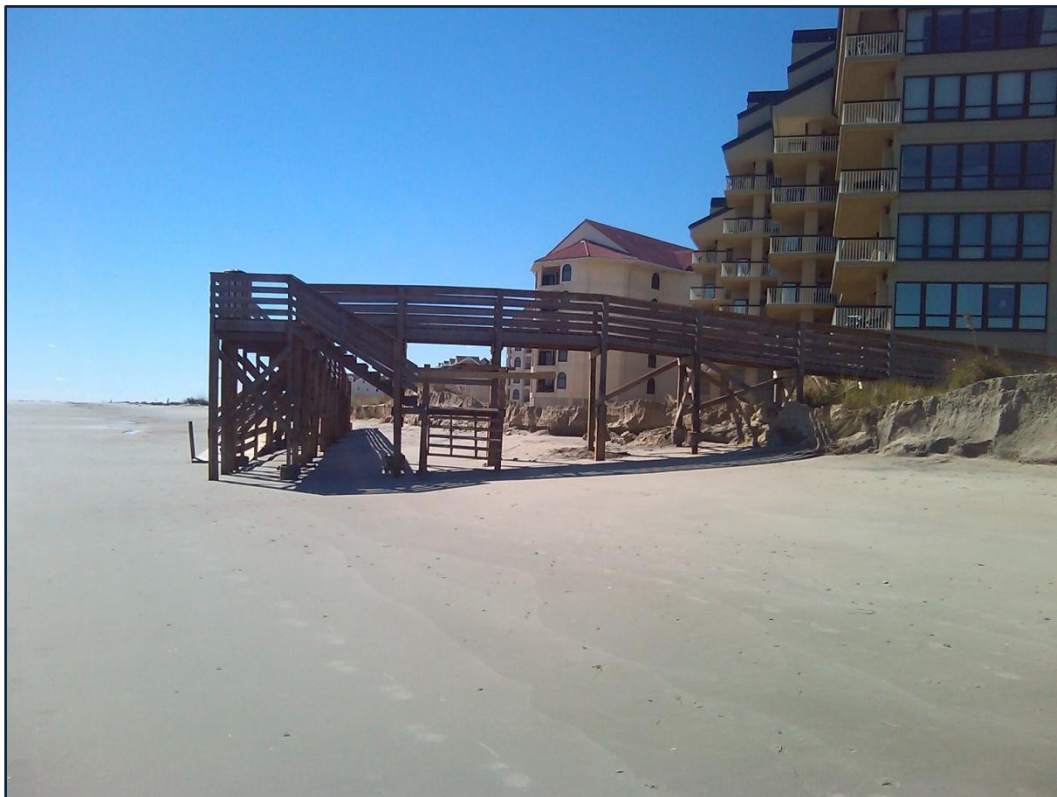
**FIGURE 3.38.** The boardwalk at the Ocean Club complex following passage of Hurricane *Sandy* in October 2012. Since this photo was taken, a small volume of sand from upland sources has been placed by property owners to rebuild the dune.

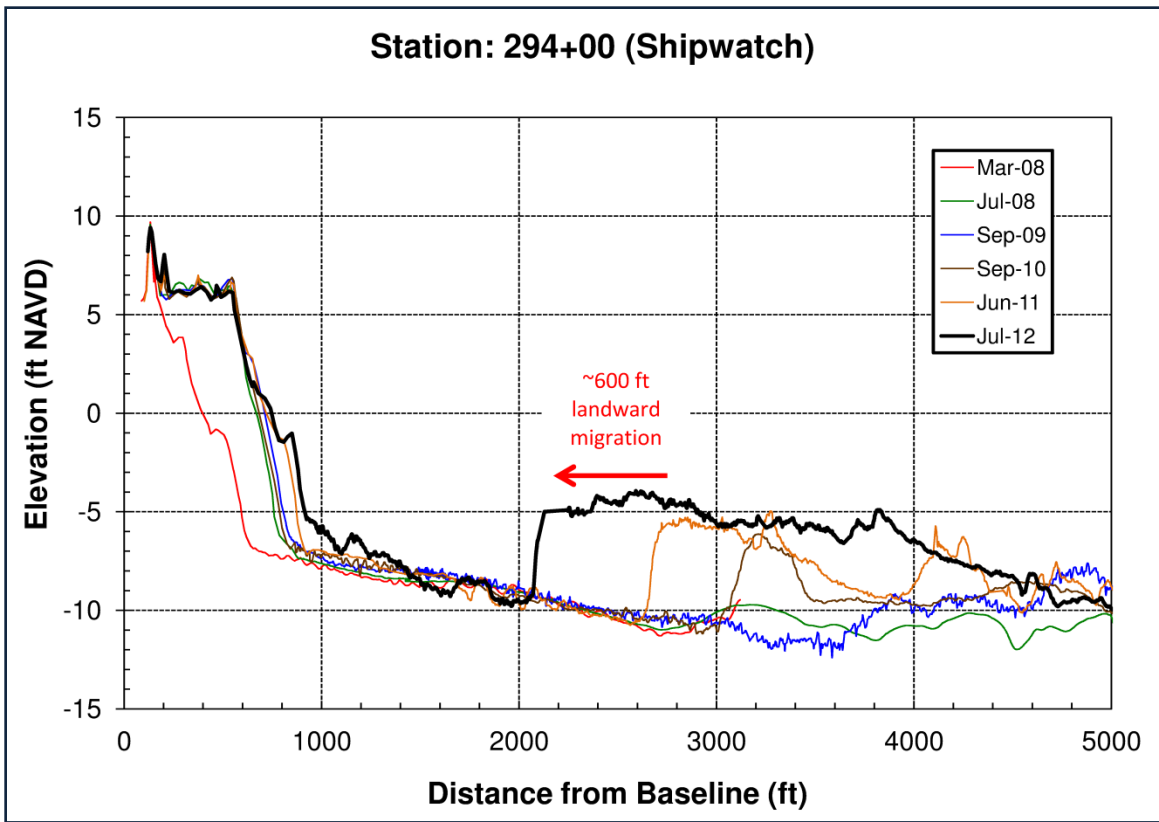
**FIGURE 3.40.** Profiles from station 294+00 (Shipwatch, upper) and station 282+00 (Beach Club Villas II, lower) extending to the Dewees Inlet delta. At both stations, the leading edge of the shoal migrated over 600 ft landward between June 2011 and July 2012.

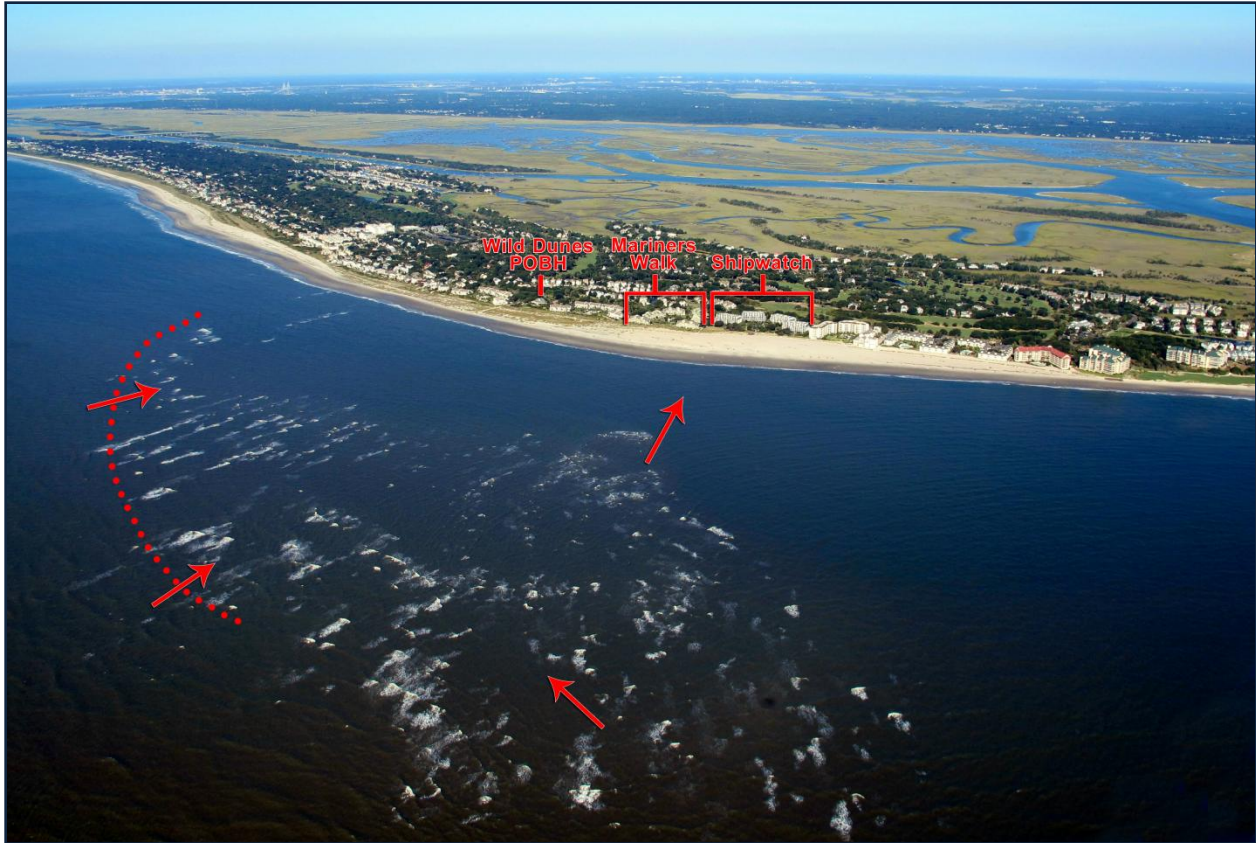
**FIGURE 3.41.** Aerial image of the migrating shoal offshore of northeast Isle of Palms. The general direction of sand movement is shown by the arrows. [Photo taken 25 September 2012 by SB Traynum]

The shoreline west of the shoal attachment is sheltered by the remnant of the 2007 delta lobe. Station 288 through station 304 all show volume gain in the lower beach from June 2011 through July 2012 and are expected to continue to accrete over the next year. This area may be a likely borrow source should another shoal project be needed and conditions meet appropriate thresholds to enact a project.

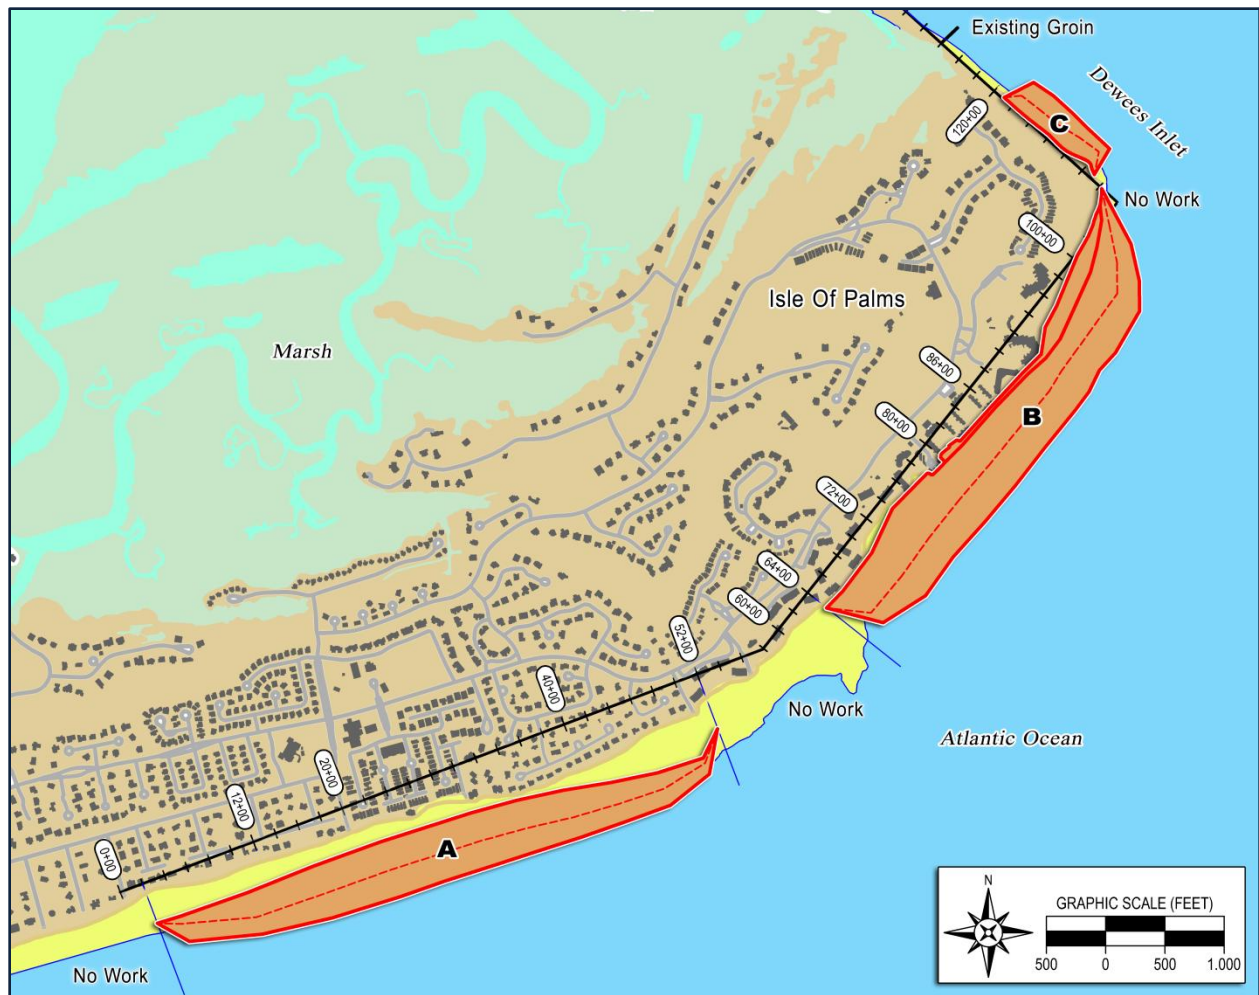
**FIGURE 3.42.** Reaches for the 2008 nourishment project. The graphic shows the project baseline with 0+00 located at 53<sup>rd</sup> Avenue (monitoring station 222+00).

Within the fill limits of the Deweese Inlet project area (nourishment Reach C, Fig 3.42), the beach continued to gain sand. **Overall, the project reach gained ~11,300 cy (11.3 cy/ft) since June 2011, leaving it with 165 percent of the nourishment volume remaining** (Fig 3.43). As of July 2012, Reach C contained ~70,550 cy more sand than the pre-nourishment condition. Accretion between station 330+00 and station 338+00 (area of the 18<sup>th</sup> tee and fairway) is likely due to losses in Reach 6. The volume change trends along the 18<sup>th</sup> fairway of the Wild Dunes Links Course, which wraps around the northeastern point of the island, provide an indicator of net sand transport from the oceanfront to the inlet shoreline in this area, consistent with the findings of Kana and Dinnel (1980).

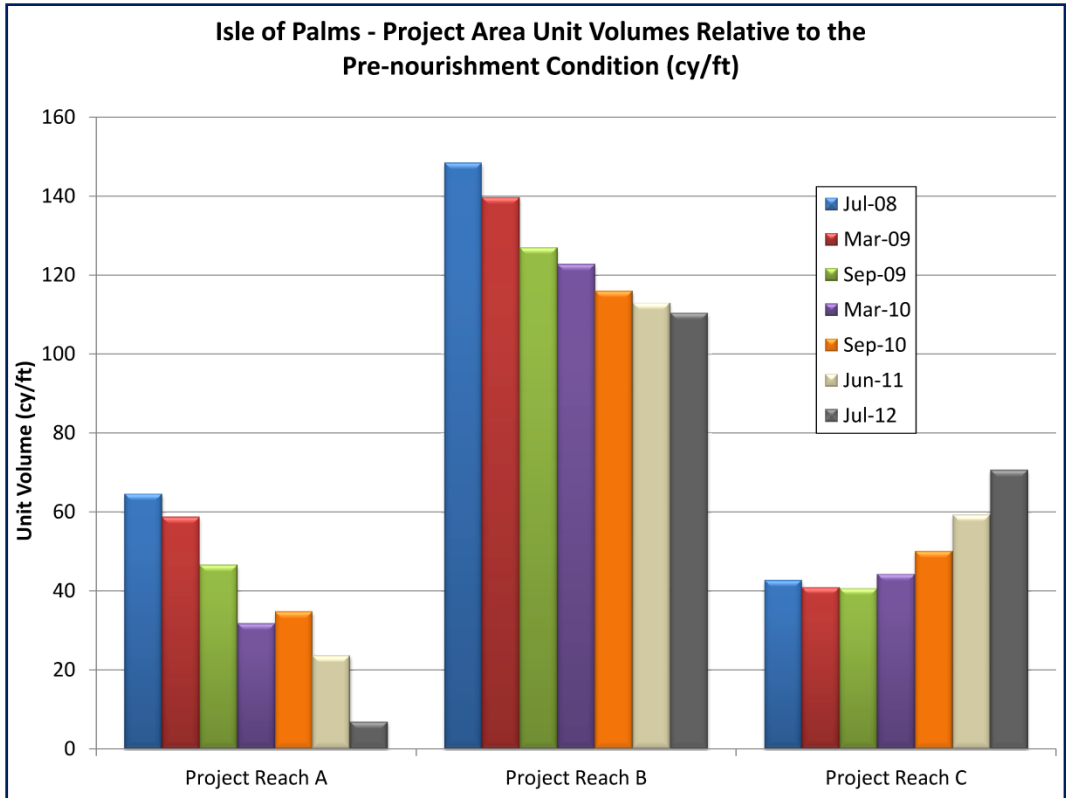
**FIGURE 3.43. [UPPER]** Project area unit volumes relative to the pre-nourishment (March 2008) condition, which is zero on these graphs. [Note that the project area limits differ from monitoring reach limits.] **[LOWER]** Percent of nourishment volume remaining in each project area.

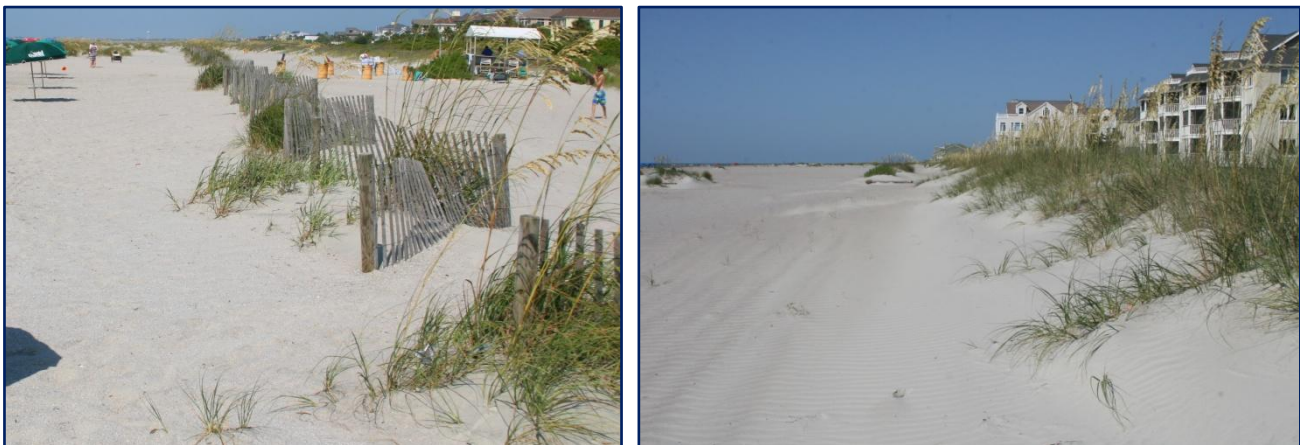
**FIGURE 3.44.** [LEFT] Sand fencing in Reach 5 in July 2012. There is less dune growth in this area than in Reach 6. [RIGHT] Sand fencing and vegetation in Reach 6 near Port O'Call in July 2012. [Photos by SB Traynum]

It is preferable for natural dune building to occur at the most landward portion of the dry beach. This results in formation of a larger dune in a more stable part of the beach. CSE recommends evaluating future placement of fencing prior to installation to encourage maximum dune growth at stable locations.

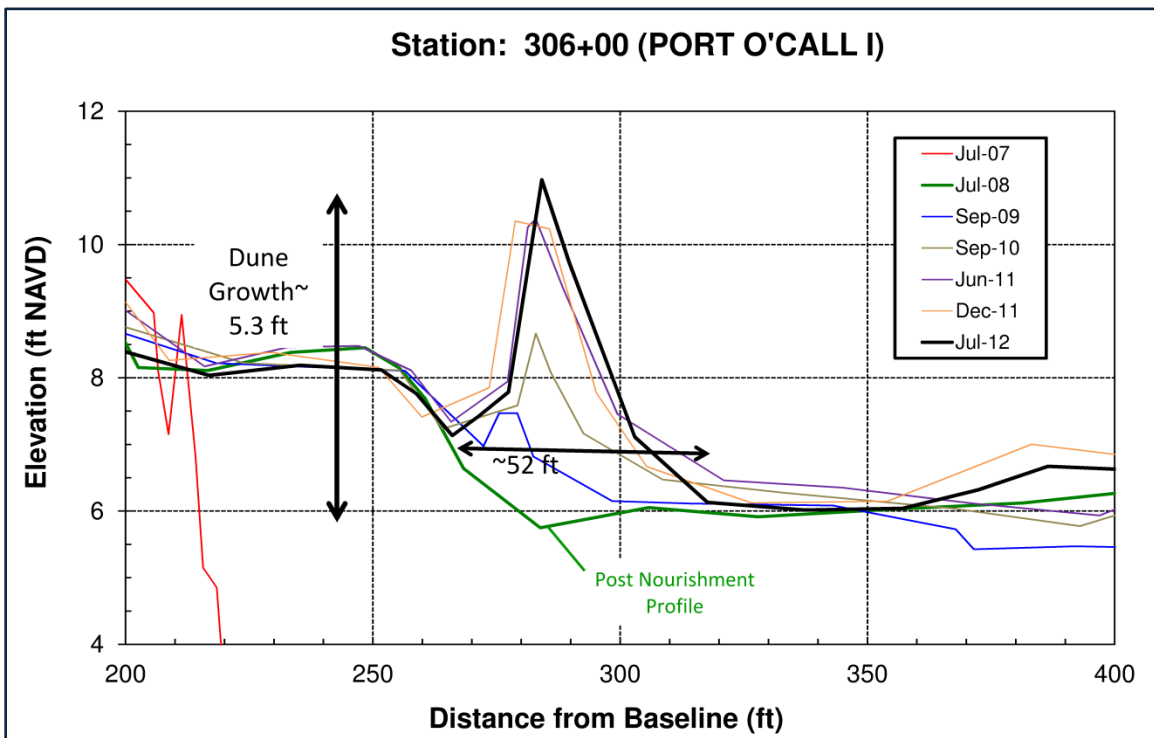
**FIGURE 3.45.** Evidence of dune growth at station 248+00 (adjacent to the Wild Dunes Grand Pavilion) following nourishment (May-June 2008). Elevation of the dune has increased ~3 ft naturally since the pre-project condition. Dune growth has been more rapid at station 306+00 (near Port O'Call). A wider dry beach here facilitates wind-blown sand transport, leading to higher dunes. Note vertical exaggeration is ~1 on 12.
