**Beach Preservation Ad Hoc Committee
9:00 a.m., Monday, July 22, 2024
City Hall Council Chambers
1207 Palm Boulevard, Isle of Palms, SC 29451**

Beach Preservation Ad Hoc Committee
Recommendation Considerations
July 22, 2024

Isle of Palms Beach Management Planning Scenarios

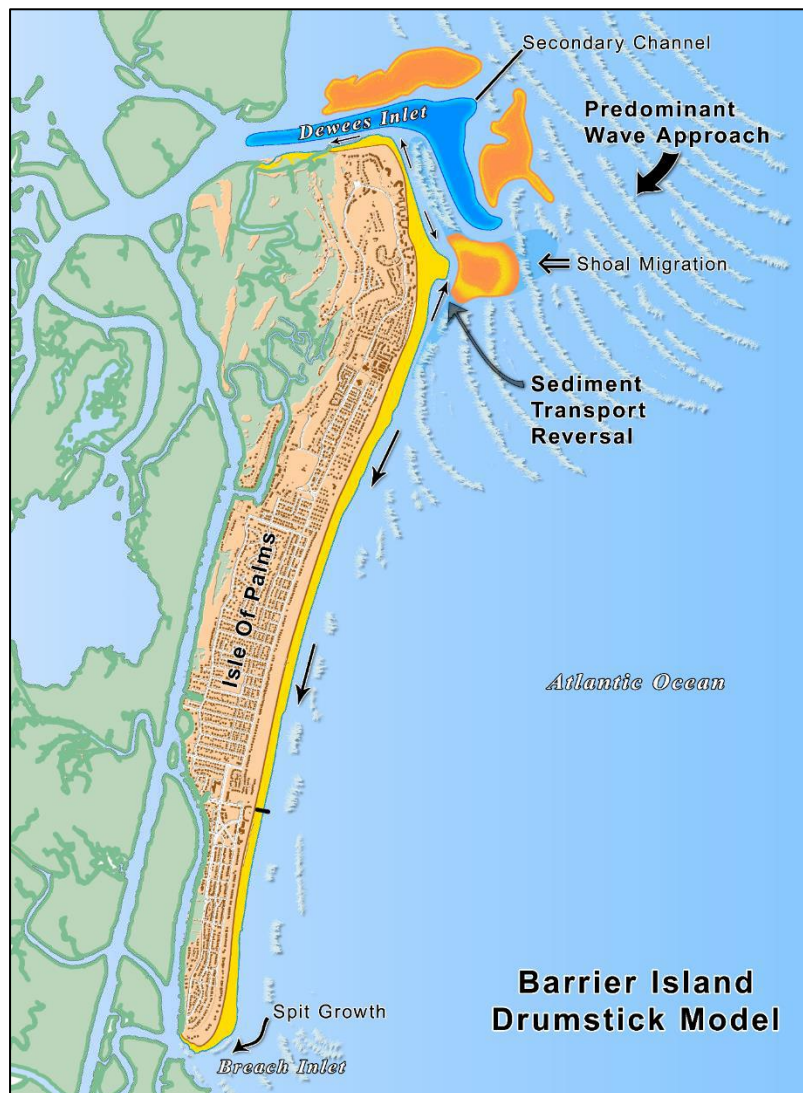
FIGURE 1. "Drumstick" barrier island model developed from Hayes (1979).

Isle of Palms (IOP) is a classic “drumstick” barrier island (Hayes 1979), with a bulbous updrift end at the northeast, and a narrow recurve spit on the southwest (Figure 1). Generally, sand comes to the island via shoal bypassing at Dewees Inlet and then migrates south, maintaining a historically stable shoreline along the central portion of the island. Sand eventually accumulates along the southern spit of the island and then into the shoals of Breach Inlet. The shorelines near the inlets are highly dynamic and are classified as “unstabilized inlet erosion zones” by SCDHEC-OCRM due to the episodic fluctuations in the shorelines. Figure 2 provides a map of the monitoring stations referenced herein.

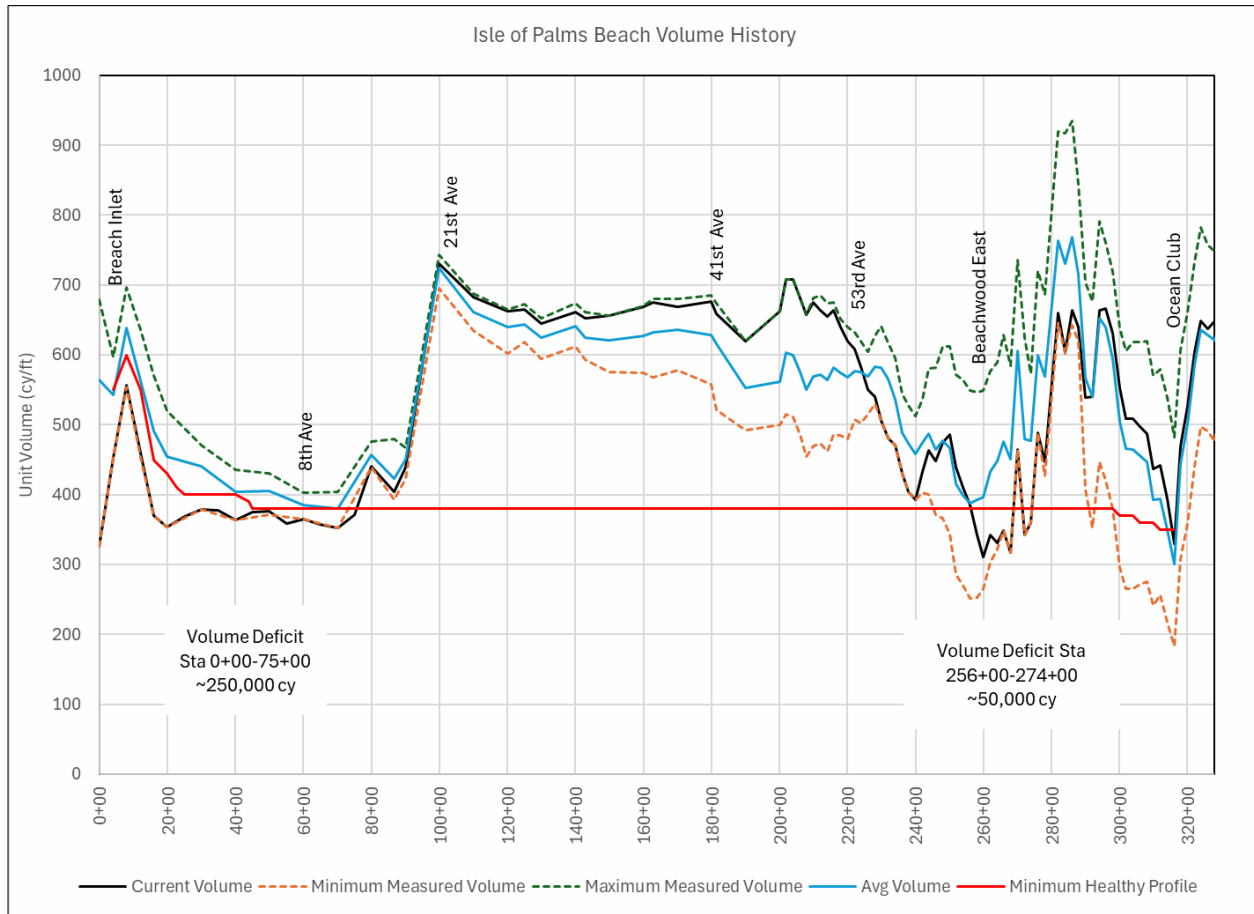
FIGURE 5. Volume summary for Isle of Palms 2009–2024. Note where the current condition (black line) is near the most eroded (orange line) or the healthiest (green line). The red line shows a site-specific minimum healthy beach volume.

1. Minimum Healthy Beach Volume = 380 cy/ft from areas away from the inlets and up to 600 cy/ft within Breach Inlet- as specifically shown on Figure 5 of attached report.

Figure 5 shows the historical beach volume envelope for the Isle of Palms (not including the Dewees Inlet shoreline). The plot shows the maximum and minimum beach volumes measured since 2008, as well as the current volume and average volume between 2008 and 2023/2024. The plot shows the beach volume seaward of the structure line, which results in areas with greater setbacks having higher volumes, and structures that protrude beyond adjacent properties having lower volumes. This means that the volumes may not necessarily reflect erosion trends, but do show relative levels of dune protection across the island. In addition, it’s important to note that the localized erosion patterns are highly dynamic near the inlets, and areas that are relatively healthy now may quickly change due to shoal-induced erosion.

The figure includes a line showing the minimum healthy beach volume across the island. At Breach Inlet, the value is higher due to the constant presence of sand in the shallow underwater profile from the northern shoal of Breach Inlet. This increases the total sand volume in the profile measured to -13 ft NAVD. The minimum profile volume decreases at the northern tip of the island, as the sheltering effects of the Dewees Inlet delta create a steeper beach slope, reducing the volume necessary to maintain a healthy profile. Away from the inlets, the minimum healthy profile is ~380 cy/ft.

The graph shows that the current beach condition is near the minimum measured volume south of the county park. The volume is near the maximum measured volume from the county park to 53rd Ave, and varies north of 53rd Ave as a result of shoal processes. Presently, ~7,500 linear feet (lf) of beach between Breach Inlet and 9th Ave is at or below the minimum ideal volume, as well as ~1,600 lf around Seagrove and Beachwood East in Wild Dunes. The station fronting the Ocean Club building is also just below the threshold volume.

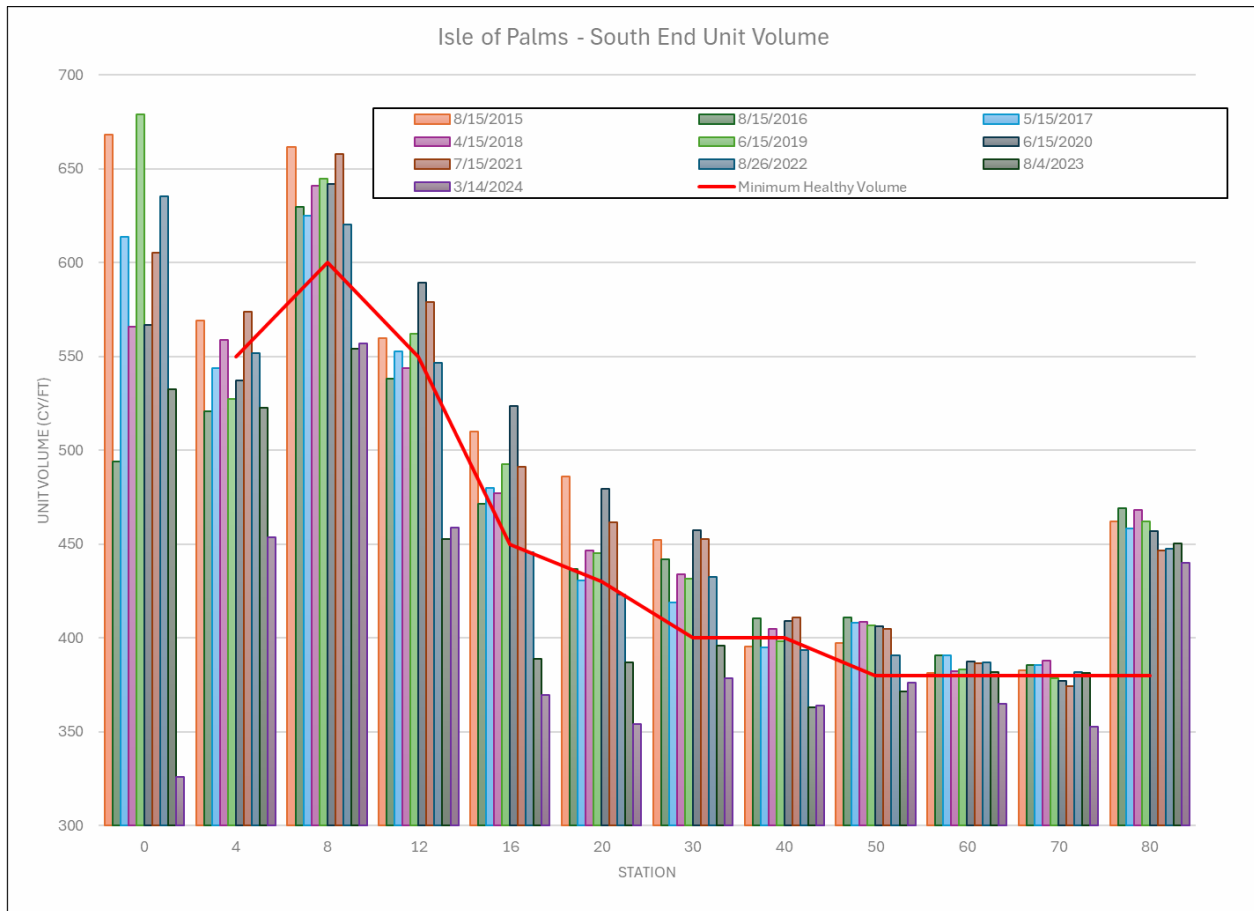
FIGURE 6. Beach Unit Volumes for the southern area of Isle of Palms. The local minimum healthy beach condition is shown in red. Note the dynamic trend south (left) of station 50 due to effects of Breach Inlet. Volume trends become more consistent away from the inlet (Stations 50–80).

Figure 6 shows unit volumes for monitoring stations along the southern end of IOP since 2015. The bars show the beach volume for each year at each station, and the variability in erosion and accretion trends is apparent through 2021. Beginning in 2022, an erosional event was beginning, decreasing beach volumes at stations south of 50+00. The erosion accelerated from 2022–2023, leaving stations 8+00–50+00 (Breach Inlet to 6th Ave) below the healthy beach condition. Additional erosion was present in many stations as of March 2024.

The data in Figure 6 are useful in trying to predict future volume change where erosional patterns are generally consistent. It is more difficult to predict when a beach may reach the minimum healthy volume when erosion patterns vary, as in the case of the south end of IOP. Volumes fluctuate up and down from year to year before falling off dramatically in 2023. Figure 7 shows a similar graphic from beach monitoring at Edisto Beach, SC. Here, the areas represented by Reaches 1–4 are the main project area and show relatively consistent erosion trends since the last nourishment was constructed in 2017. This makes forecasting future beach conditions easier, as annual losses can be projected with more confidence.

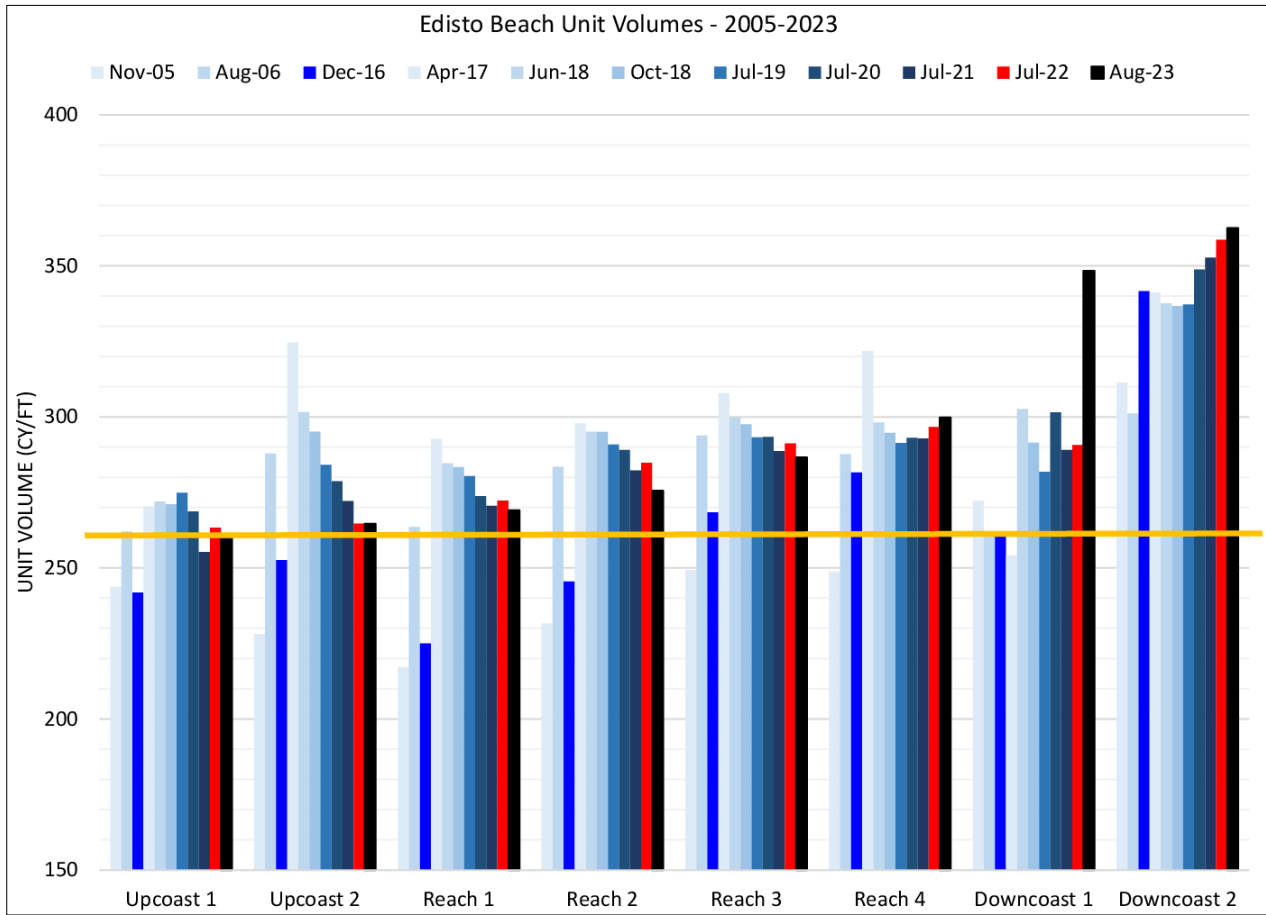
FIGURE 7. Beach Unit Volumes along Edisto Beach. Here, Reaches Upcoast 2 - Reach 3 represent the shoreline away from inlets and erosional trends are fairly consistent and predictable.
