Isle of Palms City Hall Assessment

May 2024

RE: IOP City Hall Assessment

Trident Construction and a team of consultants performed a thorough investigation and assessment of the existing Isle of Palms City Hall building. The assessment included a detail look into the structural, building envelope, mechanical, electrical, plumbing and programming layout requirements.

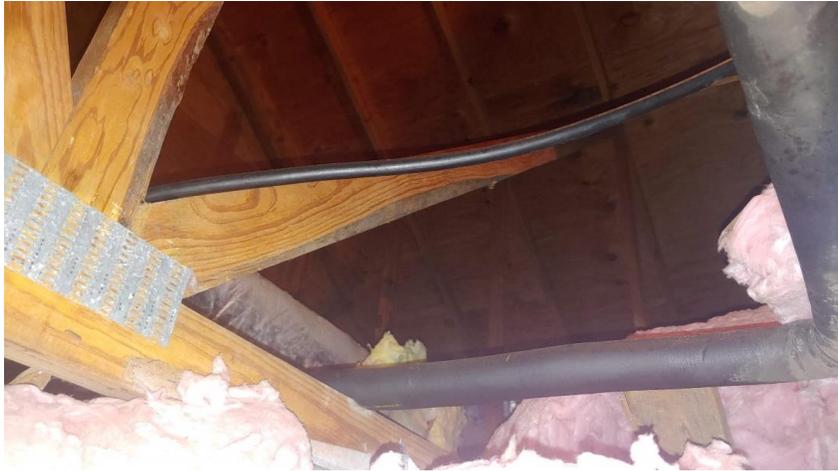
Photograph No. 1
Roof Framing: Metal Plate Connected Wood Trusses

- Roof Trusses with Plywood Sheathing (Photographs No. 1 & No. 2)
- HVAC unit above Second Floor Ceiling, supported by Roof Trusses (Photograph No. 3)

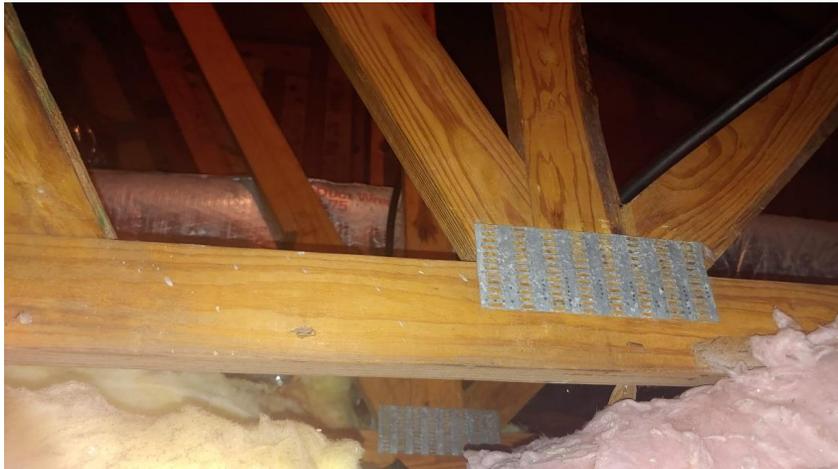
Photograph No. 2
Roof Framing: Metal Plate Connected Wood Trusses

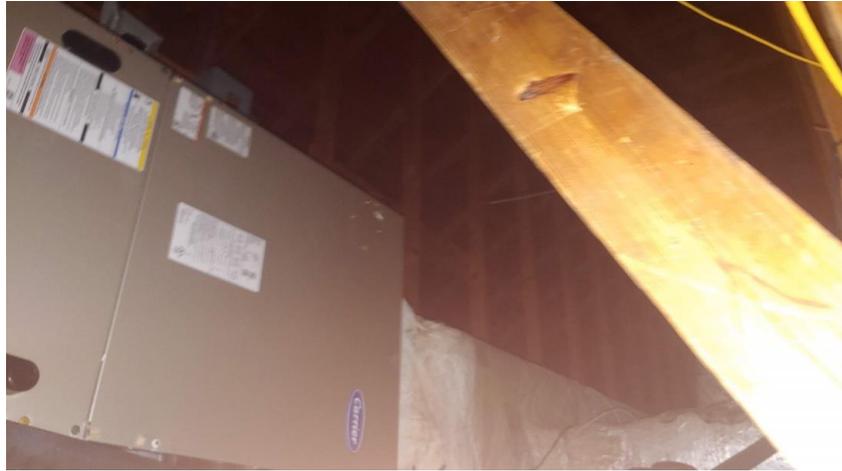
Photograph No. 3
HVAC Unit above ceiling, supported by Roof Trusses

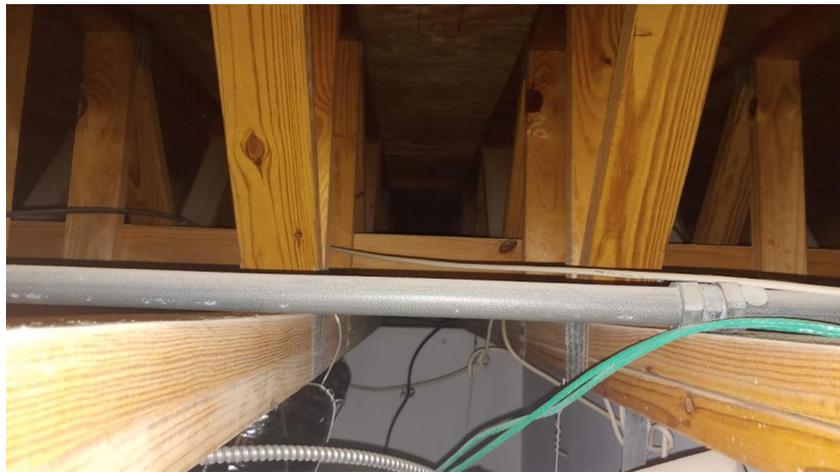
- Floor Trusses with Plywood Subfloor (Photographs No. 6, 7, 8)
- Floor Trusses with Double Bottom Chord (Photographs No. 6, 7)

Photograph No. 6
Second Floor Framing: Metal Plate Connected Wood Trusses

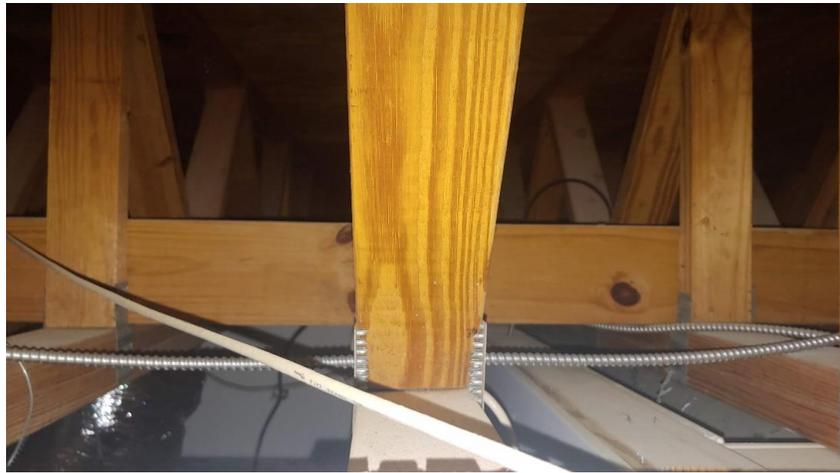
Photograph No. 7
Second Floor Framing: Metal Plate Connected Wood Trusses

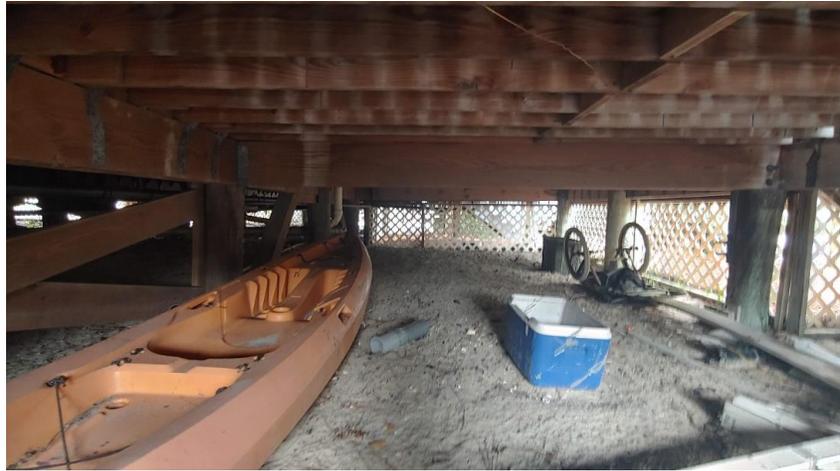
- First Floor Joists, Beams, Piles (Photograph No. 9)
- CMU at Elevator (Photograph No. 10)
- Pile to First Floor Beams consist of bolts and steel plates (Photographs No. 9, 12)

Photograph No. 9
First Floor Framing: Joists, Beams, Piles

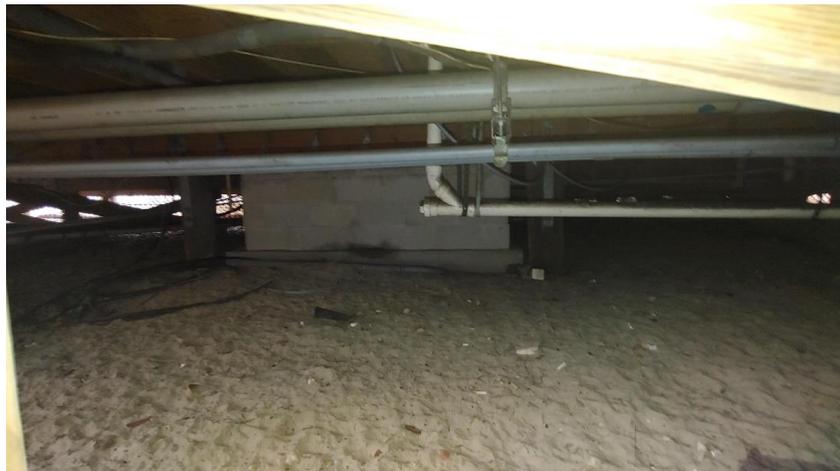
Photograph No. 10
First Floor Framing: CMU on Pile Cap at Elevator

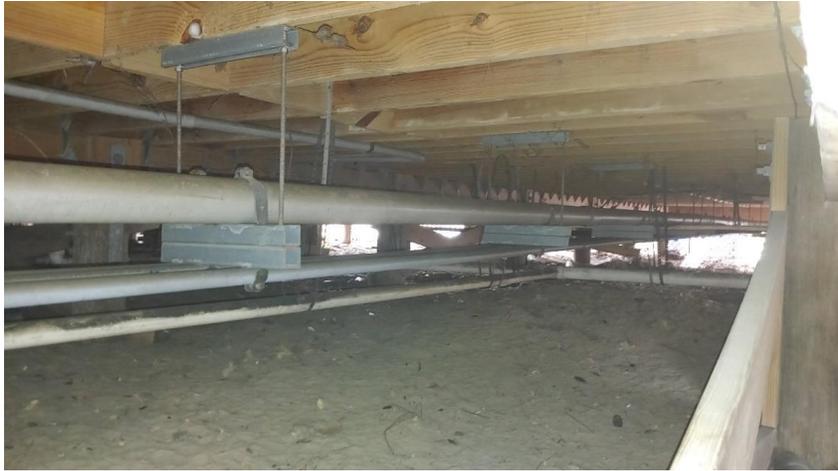
Photograph No. 11
First Floor Framing: Joists

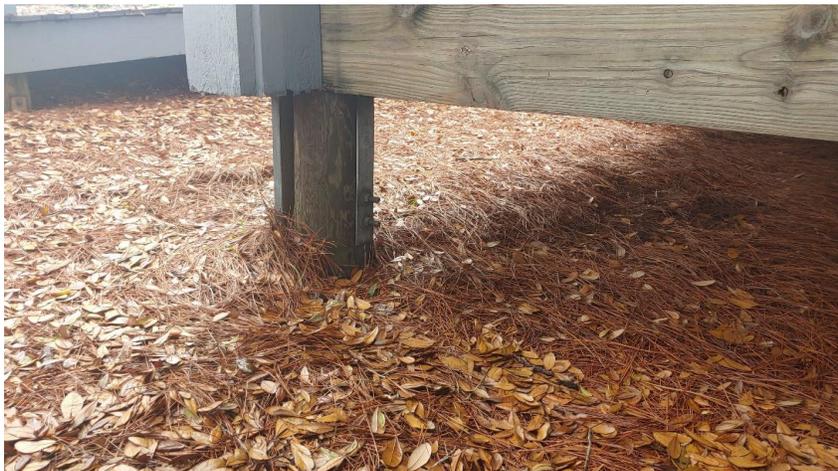
Photograph No. 12
First Floor Framing: Pile to Beam Connection

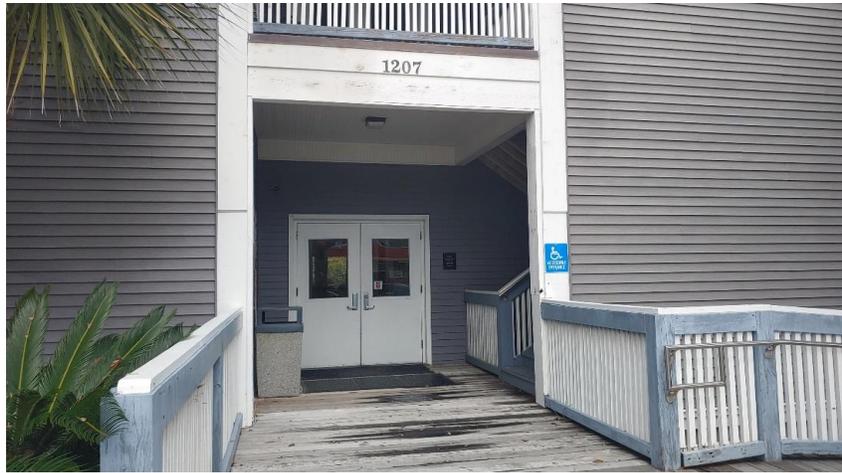
- Typical Exterior Wall Siding (Photographs No. 13, 14)

Photograph No. 13
Front Entrance

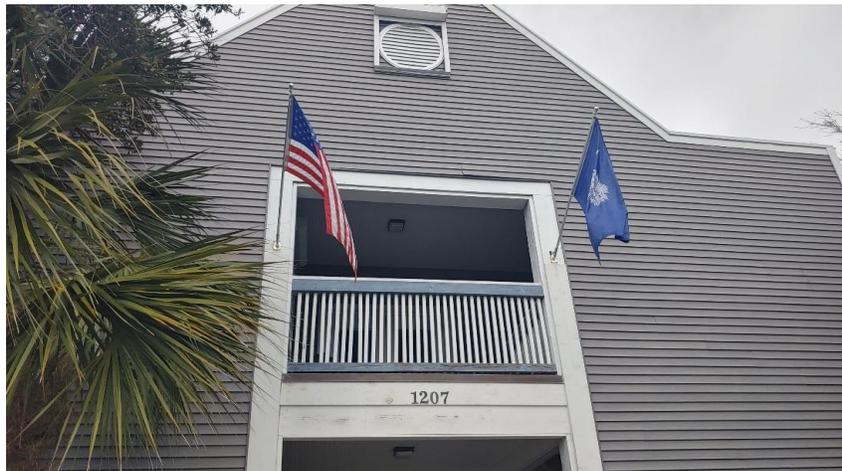
Photograph No. 14
Front Entrance

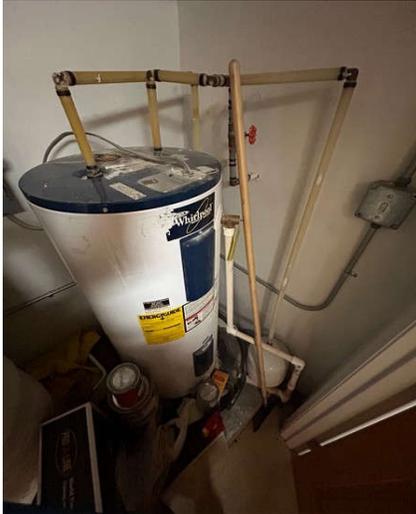
The water heater located in the 1st floor mechanical closet is a Whirlpool 50-gallon tall boy style. Based on the serial number it is approximately 23 years and in need of replacement. Piping fittings above the heater show evidence of corrosion.

Water Heater in 1st Floor Mech Room

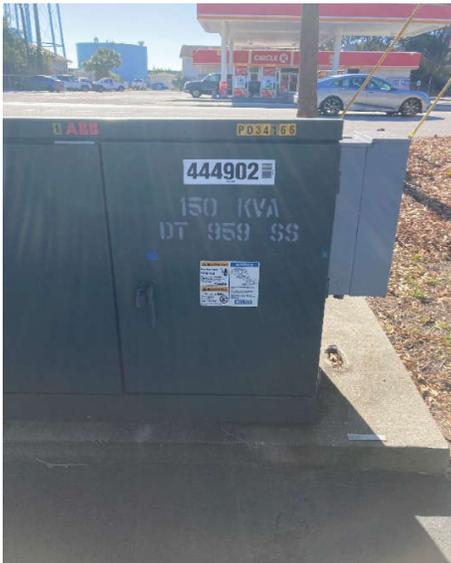
Photo 1

- The building is served with 120/208V volt, three-phase power by a Dominion Energy pad-mounted 150kVA transformer. The utility metering enclosure is located on the outside of the building (Photo 1). The metering enclosure has a significant amount of corrosion due to the exterior location and proximity to the ocean and is in poor condition (Photos 2 and 3).

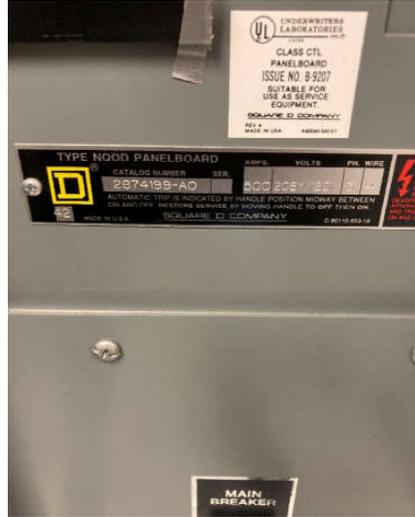
Photo 4

- It appears that the electrical service enters the building via conduits routed within the crawlspace underneath the building and terminates in a 500A rated Square D panelboard “MP” located in the first-floor electrical room. The panelboard schedule on the interior of the panelboard door has a date of January 1992 so we believe this panelboard is original to the building (Photos 4, 5 and 6). Despite the age of this panelboard, it appears to be in good condition.

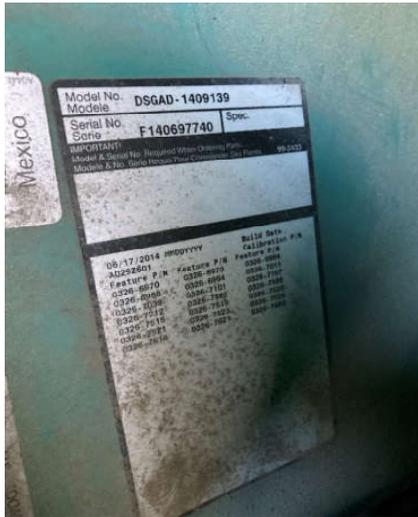
Photo 7

- The building has a Cummins diesel-electric emergency generator with a sub-base fuel tank mounted to an elevated platform on the exterior of the building. Based on the model number listed on the nameplate (Photo 7), the emergency generator appears to be a 175kVA unit installed in 2014, which is connected through an exterior mounted transfer switch. It is our understanding based on conversations with staff that the emergency generator system provides emergency power for the entire building, but the transfer switch does not operate automatically and requires manual operation to transition to emergency power. The emergency generator utilizes a weatherproof enclosure and as such, appears to be in good condition but does not include a catwalk or platform for maintenance access to the generator (Photos 8 and 9). The existing panelboards located on the interior of the building appear to be original to the building but seem to be in good condition. However, the exterior mounted transfer switch and associated distribution equipment show signs of corrosion and appear to be in poor condition (Photos 10 and 11).

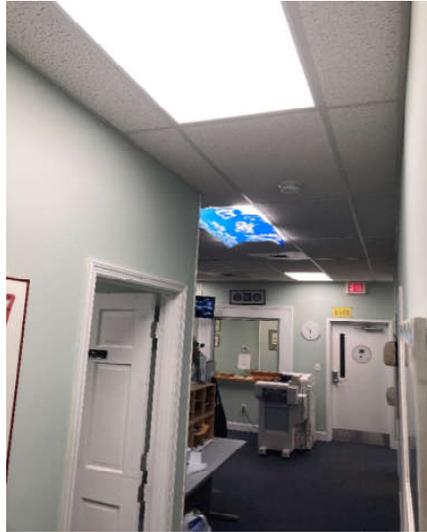
Photo 12

- The interior lighting is primarily fluorescent, the majority appearing to be utilizing T-12 lamps. The majority of the lighting fixtures utilized are recessed 2x2 and 2x4 troffers, but some areas utilize surface mounted track lighting for illuminating wall-mounted artwork (Photos 12 and 13). The existing fixtures are in fair condition for their age but have exceeded their rated life expectancy.
- It appears that occupancy sensors have been utilized in most spaces for lighting system control on a room-by-room basis.
- It is unclear how emergency egress lighting is currently connected. It is assumed that battery packs are utilized for override until the emergency generator can be manually transferred by staff.

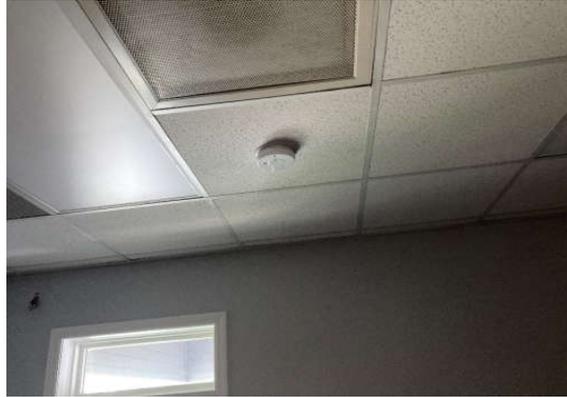
Photo 14

- Smoke detectors are utilized throughout the building, but they are all independent of each other and are not connected to a centralized fire alarm system. Based on our visual observation, there is not a fire alarm system currently installed within the building (Photo 14).

- The new lighting system would utilize battery backup devices in select fixtures to provide adequate egress lighting for the override period until the emergency generator is online.
- Provide new occupancy sensors (ceiling and/or wall mounted) as required for lighting control to comply with 2009 IECC.
- Provide covers for all junction boxes and secure appropriately. There should be no open junction boxes or enclosures and all knock outs not used should be sealed.
- Tighten all conduit fittings and ensure that fittings are installed for appropriate knockout size.
- All electrical panelboards and enclosures need to be cleaned and a normal preventive maintenance schedule should be implemented.
- Coordinate with Architect and building classification and provide fire alarm notification system as required to comply with IBC and NFPA 72.

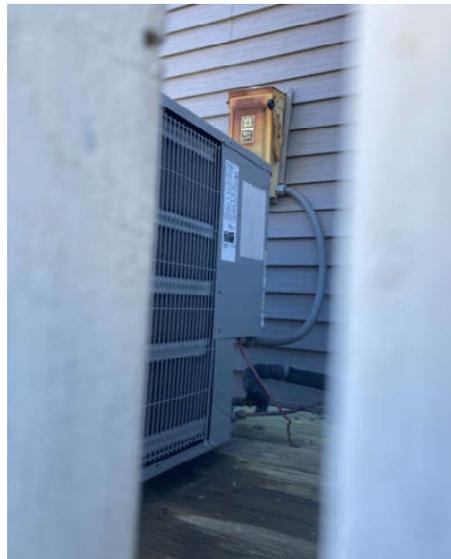
Photo 15

- In general, most of the existing electrical infrastructure on the exterior of the building to include disconnects, conduits, supports, etc. are in poor condition due to age and exposure to salt air/water (Photo 15).

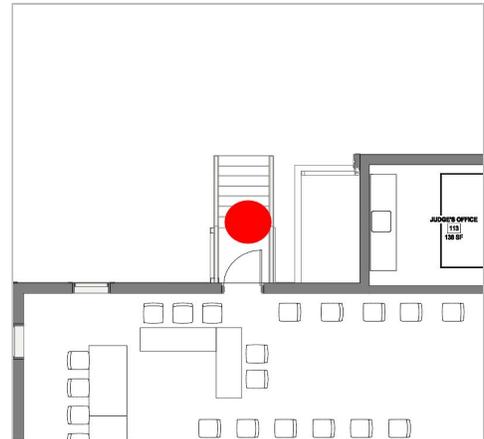
#15: Existing Condition

Description	Wood rot on railing
Assigned to	—
Created by	Jarret Hudson (McMillan Pazdan Smith Architecture)
Created on	Mar 22, 2024
Location	01 CITY HALL > EXTERIOR > STAIRS
Location details	—
Due date	—
Start date	—
Placement	A110 (LEVEL 1 OVERALL PLAN)
Root cause	—

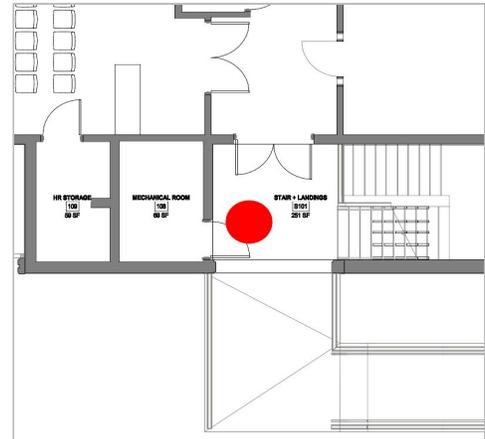
#11: Existing Condition

Description	Rust present on hollow metal door frame
Assigned to	—
Created by	Jarret Hudson (McMillan Pazdan Smith Architecture)
Created on	Mar 22, 2024
Location	01 CITY HALL > INTERIOR > LEVEL 1 > STAIR + LANDINGS S101
Location details	—
Due date	—
Start date	—
Placement	A110 (LEVEL 1 OVERALL PLAN)
Root cause	—

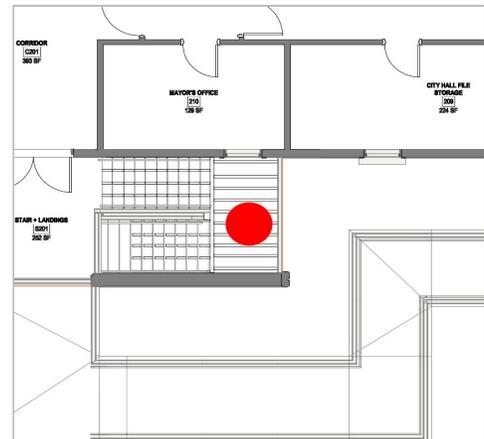
#12: Existing Condition

Description	Wood rot at exterior railings, present in multiple locations
Assigned to	—
Created by	Jarret Hudson (McMillan Pazdan Smith Architecture)
Created on	Mar 22, 2024
Location	01 CITY HALL > EXTERIOR > STAIRS
Location details	—
Due date	—
Start date	—
Placement	A120 (LEVEL 2 OVERALL PLAN)
Root cause	—

Wood railings throughout are showing rot and deterioration in various locations.

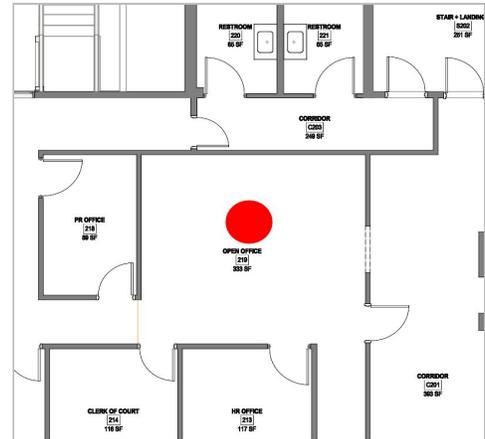
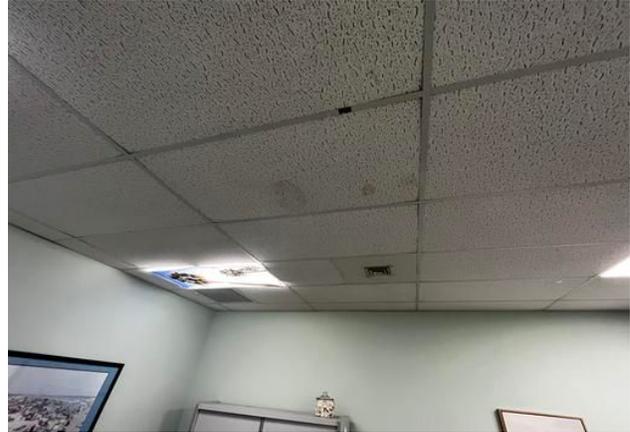
#9: Existing Condition

Description	Ceiling tiles are stained indicating presence of water at some point in time.
Assigned to	—
Created by	Jarret Hudson (McMillan Pazdan Smith Architecture)
Created on	Mar 22, 2024
Location	01 CITY HALL > INTERIOR > LEVEL 2 > OPEN OFFICE 219
Location details	—
Due date	—
Start date	—
Placement	A120 (LEVEL 2 OVERALL PLAN)
Root cause	—

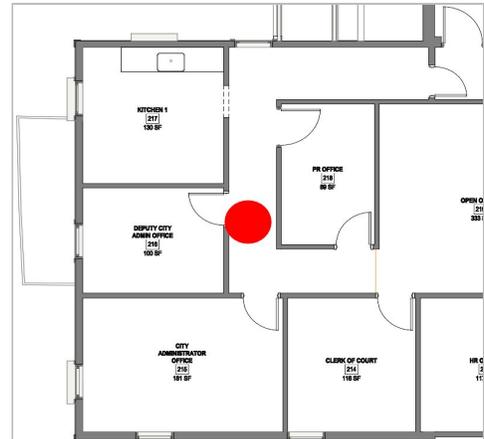
#8: Existing Condition

Description	Ceiling tiles are stained, indicating moisture presence at some point in time
Assigned to	—
Created by	Jarret Hudson (McMillan Pazdan Smith Architecture)
Created on	Mar 22, 2024
Location	01 CITY HALL > INTERIOR > LEVEL 2 > CORRIDOR C203
Location details	—
Due date	—
Start date	—
Placement	A120 (LEVEL 2 OVERALL PLAN)
Root cause	—

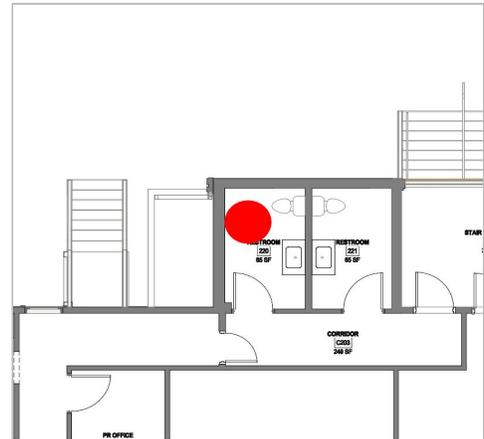
Description	Grab bars non-compliant with current IBC
Assigned to	—
Created by	Jarret Hudson (McMillan Pazdan Smith Architecture)
Created on	Mar 22, 2024
Location	01 CITY HALL > INTERIOR > LEVEL 2 > RESTROOM 220
Location details	—
Due date	—
Start date	—
Placement	A120 (LEVEL 2 OVERALL PLAN)
Root cause	—

Bathrooms do not appear to comply with current accessibility standards. At the least, vertical grab bars are not present in any bathroom. It is likely that bathrooms do not follow other accessibility standards since the building was constructed at approximately the same time that accessibility codes were introduced.

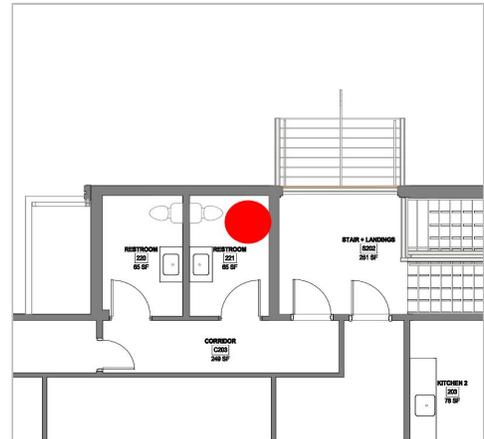
Description	Grab bars non-compliant with current IBC
Assigned to	—
Created by	Jarret Hudson (McMillan Pazdan Smith Architecture)
Created on	Mar 22, 2024
Location	01 CITY HALL > INTERIOR > LEVEL 2 > RESTROOM 221
Location details	—
Due date	—
Start date	—
Placement	A120 (LEVEL 2 OVERALL PLAN)
Root cause	—

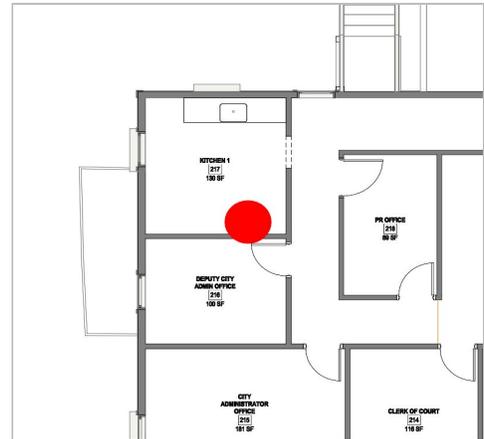
#3: Existing Condition

Description	Plastic laminate casework and countertop showing signs of wear.
Assigned to	—
Created by	Jarret Hudson (McMillan Pazdan Smith Architecture)
Created on	Mar 22, 2024
Location	01 CITY HALL > INTERIOR > LEVEL 2 > KITCHEN 1 217
Location details	—
Due date	—
Start date	—
Placement	A120 (LEVEL 2 OVERALL PLAN)
Root cause	—

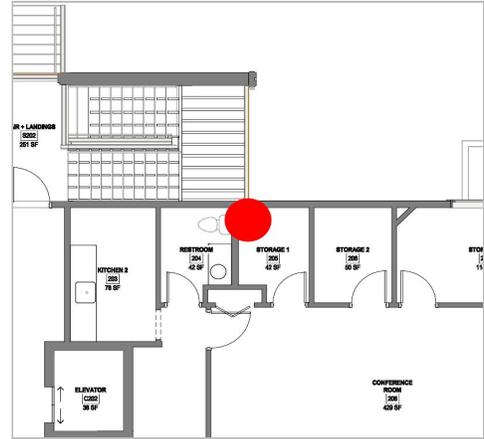
#1: Existing Condition

Description	Termite damage, duct laying on ceiling grid
Assigned to	—
Created by	Jarret Hudson (McMillan Pazdan Smith Architecture)
Created on	Mar 20, 2024
Location	01 CITY HALL > INTERIOR > LEVEL 2 > STORAGE 1 205
Location details	—
Due date	—
Start date	—
Placement	A120 (LEVEL 2 OVERALL PLAN)
Root cause	—
