**Beach Preservation Ad Hoc Committee
9:00 a.m., Friday, July 12, 2024
City Hall Council Chambers
1207 Palm Boulevard, Isle of Palms, SC 29451**

Beach Preservation Ad Hoc Committee
Recommendation Considerations
July 12, 2024

Isle of Palms Beach Management Planning Scenarios

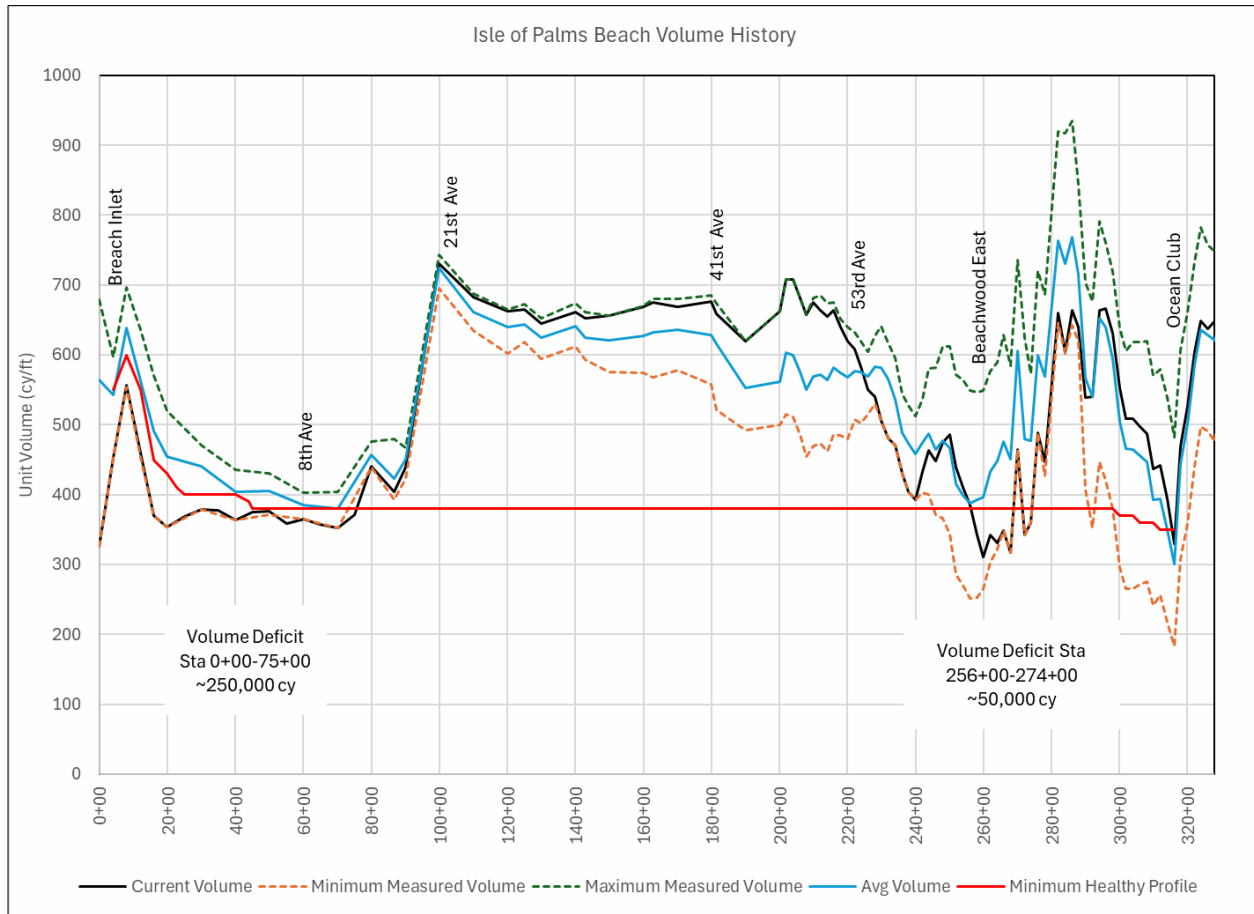
FIGURE 5. Volume summary for Isle of Palms 2009–2024. Note where the current condition (black line) is near the most eroded (orange line) or the healthiest (green line). The red line shows a site-specific minimum healthy beach volume.

1. Minimum Healthy Beach Volume = 380 cy/ft from areas away from the inlets and up to 600 cy/ft within Breach Inlet- as specifically shown on Figure 5 of attached report.

Figure 5 shows the historical beach volume envelope for the Isle of Palms (not including the Dewees Inlet shoreline). The plot shows the maximum and minimum beach volumes measured since 2008, as well as the current volume and average volume between 2008 and 2023/2024. The plot shows the beach volume seaward of the structure line, which results in areas with greater setbacks having higher volumes, and structures that protrude beyond adjacent properties having lower volumes. This means that the volumes may not necessarily reflect erosion trends, but do show relative levels of dune protection across the island. In addition, it’s important to note that the localized erosion patterns are highly dynamic near the inlets, and areas that are relatively healthy now may quickly change due to shoal-induced erosion.

The figure includes a line showing the minimum healthy beach volume across the island. At Breach Inlet, the value is higher due to the constant presence of sand in the shallow underwater profile from the northern shoal of Breach Inlet. This increases the total sand volume in the profile measured to -13 ft NAVD. The minimum profile volume decreases at the northern tip of the island, as the sheltering effects of the Dewees Inlet delta create a steeper beach slope, reducing the volume necessary to maintain a healthy profile. Away from the inlets, the minimum healthy profile is ~380 cy/ft.

The graph shows that the current beach condition is near the minimum measured volume south of the county park. The volume is near the maximum measured volume from the county park to 53rd Ave, and varies north of 53rd Ave as a result of shoal processes. Presently, ~7,500 linear feet (lf) of beach between Breach Inlet and 9th Ave is at or below the minimum ideal volume, as well as ~1,600 lf around Seagrove and Beachwood East in Wild Dunes. The station fronting the Ocean Club building is also just below the threshold volume.
